These are pictures from the failure of an air compressor. The owner hadn't kept moisture from accumulating in the vessel, and ultimately it failed along one of the vessel's welded seams. Water will condense from the air and collect in the tank. If not drained periodically, this can happen. The tank also has a hydrotest interval, beyond which it shouldn't be used unless a hydrotest is performed by a competent person

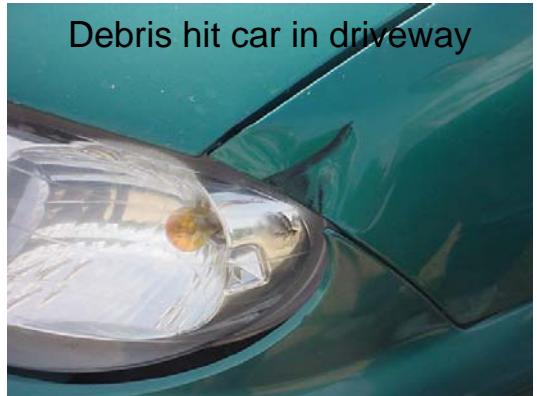
Debris hit car in driveway

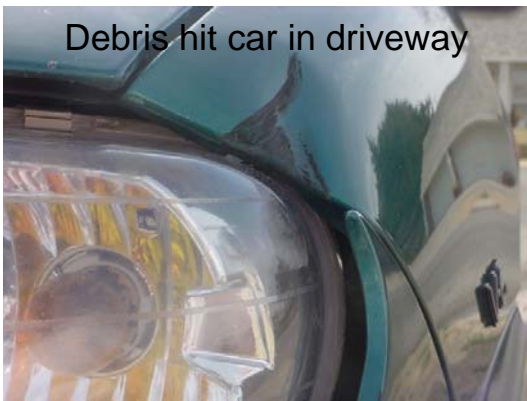
Debris hit car in driveway

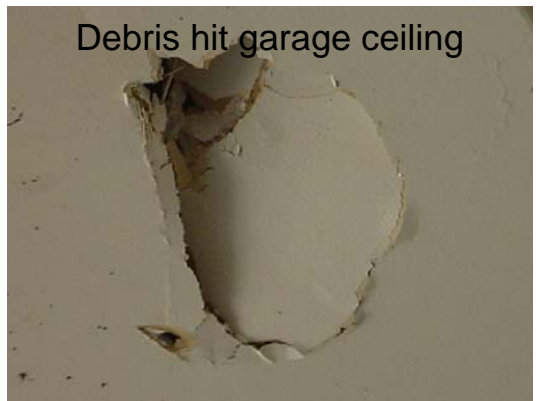
Debris hit garage ceiling

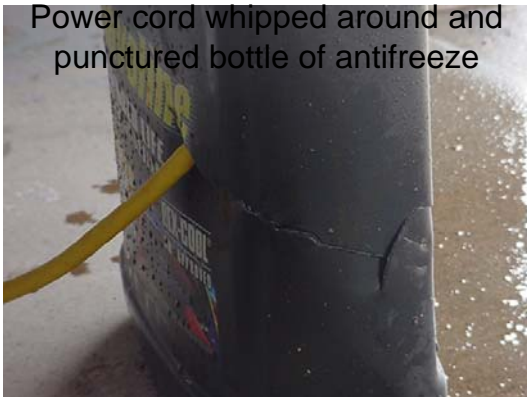
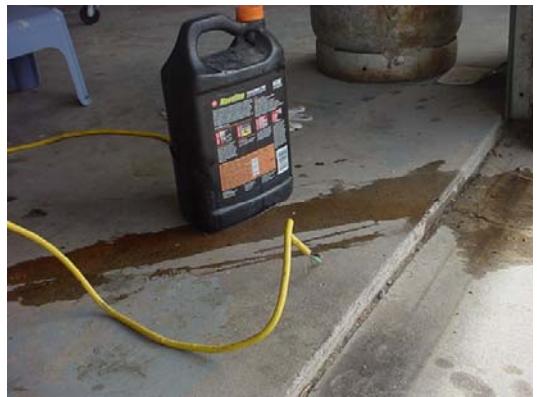
Power cord whipped around and punctured bottle of antifreeze

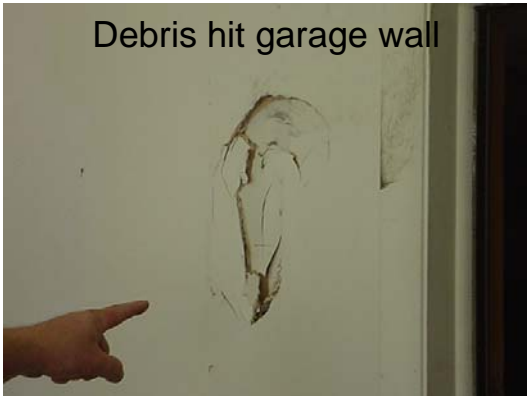
Debris hit garage wall

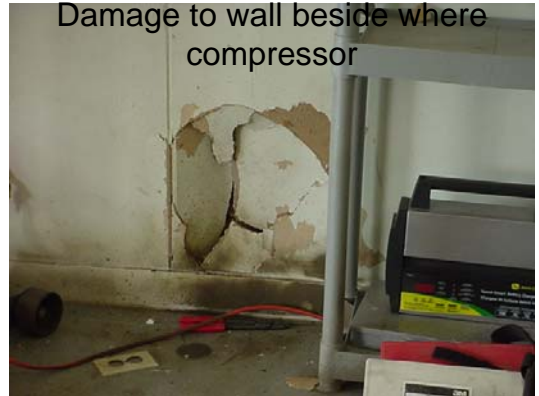
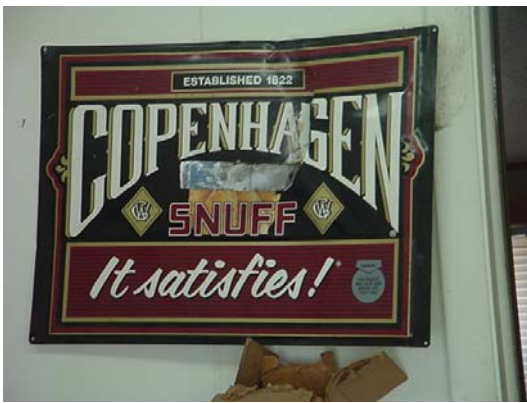
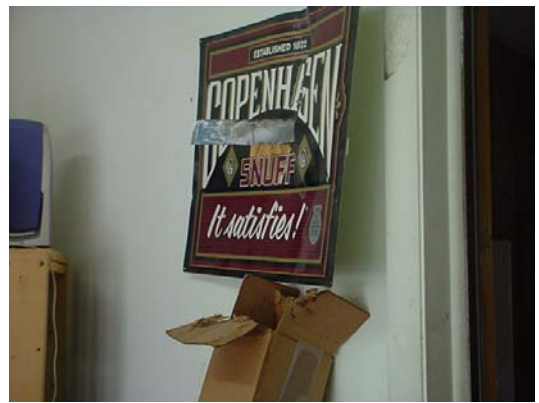
Damage to wall beside where compressor

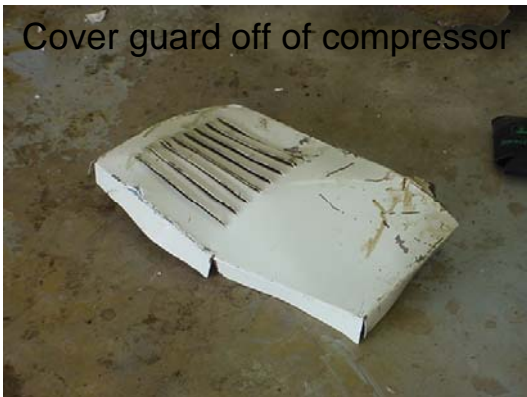
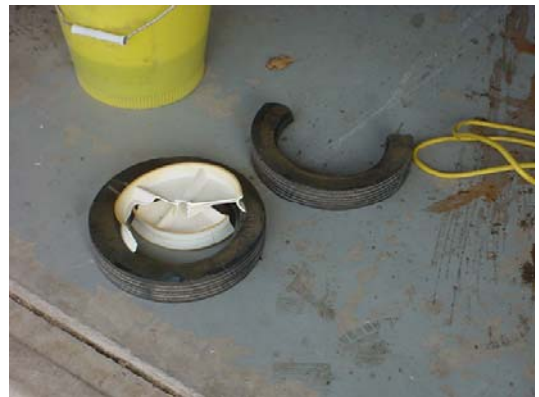
Cover guard off of compressor
