CATEGORY: Safety

Business unit:	Fort Nelson	Incident date:	February 21, 2011
-----------------------	-------------	-----------------------	-------------------

Location:	Horn River	IMS Incident Number:	I2011-00373
------------------	------------	-----------------------------	-------------

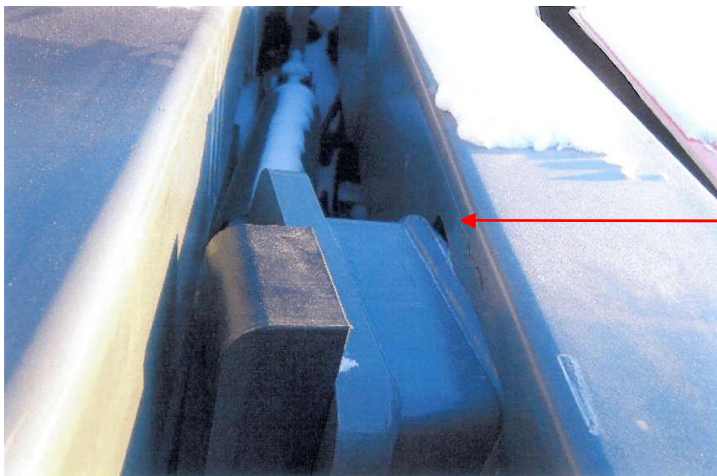
On February 12, 2011, a worker was utilizing a Skyjack Model SJ 46AJ, 45 foot diesel articulate boom lift. While at height, he noticed that the boom was exhibiting more lateral movement than was normal. Additionally, he noticed that one of the hydraulic rams was also starting to move. A second boom lift was then utilized to lower the worker to the ground. Upon examination, it was found that the welds holding one of the hydraulic cylinders in place appeared to have failed. The machine was immediately removed from service.

Failure point on unit in operation

Immediately cease use of all Skyjack Model SJ 46AJ 45 foot diesel articulate boom lifts. They must be tagged and locked out of service.

Prior to putting the boom lifts back in use, retain the services of a non-destructive testing company to carry out a detailed examination of the boom, cylinder and associated welds.

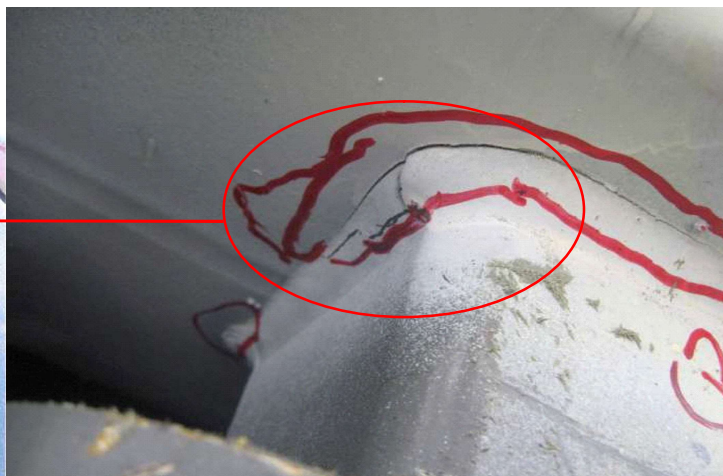
On March 17, 2011, a detailed examination was undertaken on the remaining two boom lifts by a non-destructive testing company. Both lifts were found to have weld cracking in all four corners of the main lift cylinder attachment. These two machines were immediately taken out of service.

Results of NDT on another unit showing failure point in same location
