Safety Alert

March 16, 2009

Electrical Arc Flash Near Miss

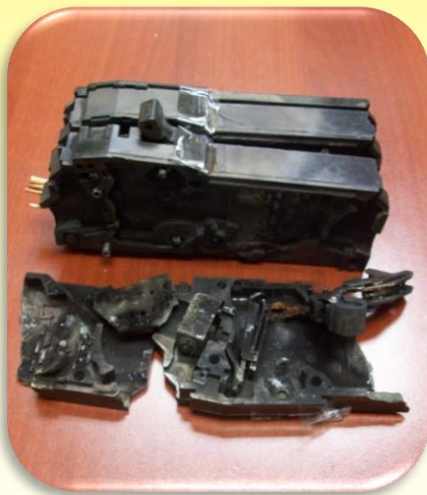
- As a result, when the power went back on line the breaker was overloaded with energy, causing another arc to occur and the breaker to exploded propelling hot gasses and molten metal out of the breaker.

Left: This is the breaker after the incident occurred.

The inside of the breaker was charred throughout.

Metal pieces had been melted and some metal had been disintegrated.

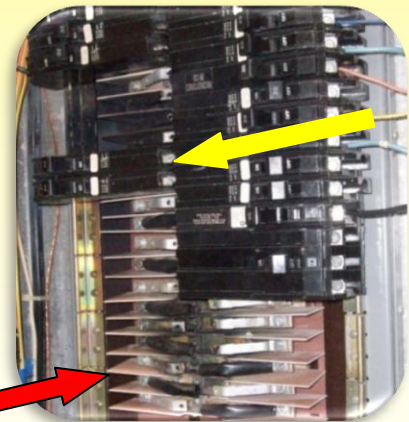
- Two events occurred in conjunction with one another leading to this incident.
 - The first event occurred when the electrical subcontractor opened the live panel and removed insulation from the wires causing the first arc to occur and the breaker to open.

Above: Damage to the panel can be seen at different areas of the panel.

Yellow arrow shows where the breaker was housed .

Red arrow shows where it is believed he was in the process of removing the rubber insulators, which caused the initial arc.

- The power to the panel shall be disabled and Lock Out / Tag Out are to be in place prior to any work inside an electrical panel.
- PSI will be done prior to the start of the task.

- Proper arc flash personal protective equipment is to be used.

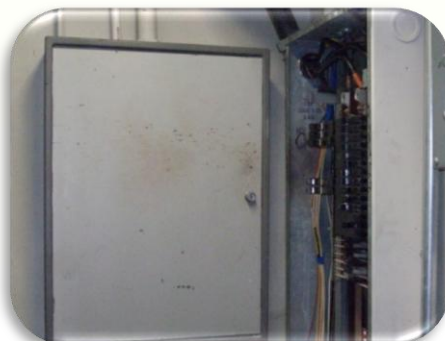
Left: Damage to an adjacent panel covering can be seen.

Notice the brown marks on the exterior panel door. This occurred when the breaker had exploded, emitting molten metal out of the breaker.

The individual involved was about 5' tall. The material grazed the front and top of his hard hat. His height is the main reason why he was not injured.
