# FPSO / 02/01/10 Fatalities (1/4)

- A fatal accident occurred on the Pazflor FPSO hull in Okpo on Saturday 02/01/10 around 09:30 am.
- 2 workers entered in a tank (LDHI starboard) to perform the alignment of the pump and asphyxiated due to the presence of argon gas in the tank.

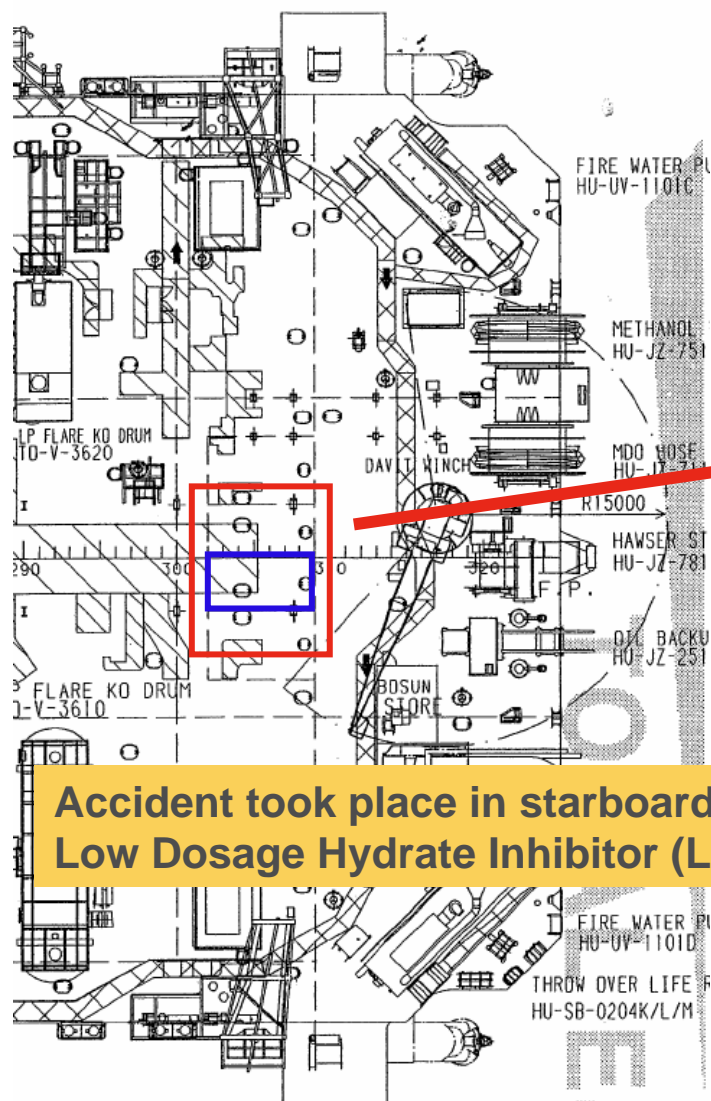
HULL DECK

**Accident took place in starboard Low Dosage Hydrate Inhibitor (LDHI)**

**A hose delivering argon and connected to the gas manifold was entering in the tank through this other hatch**

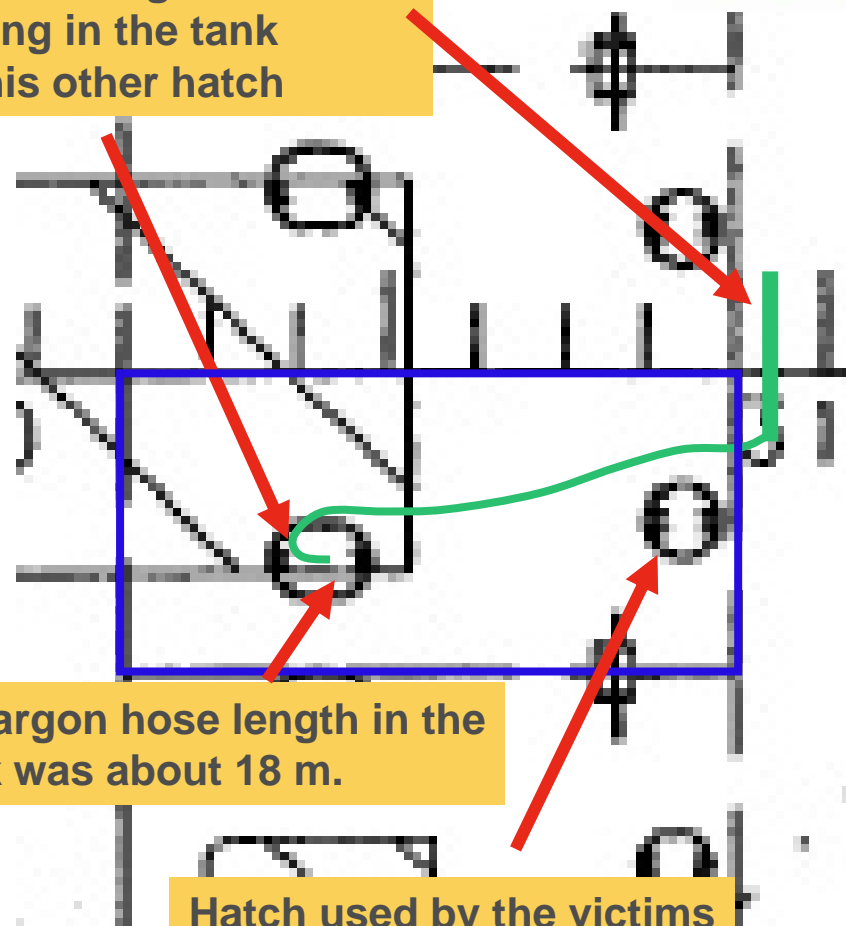
**The argon hose length in the Tank was about 18 m.**

**Hatch used by the victims to enter the tank**

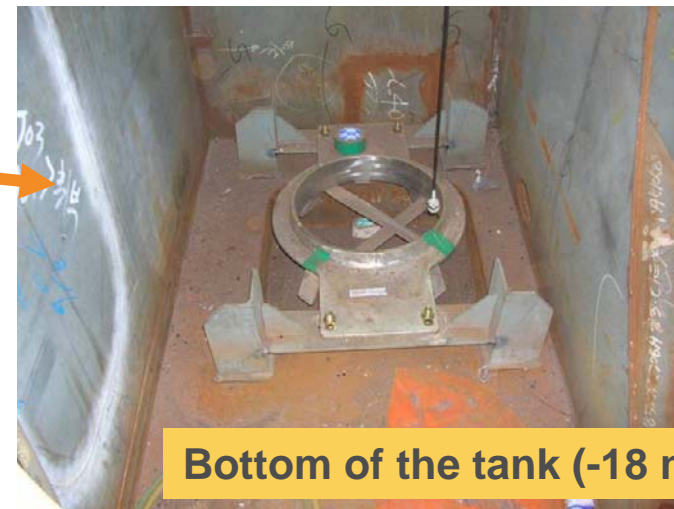
Bottom of the tank (-18 m)

**Cross section of the MeOH and LDHI tanks.  
With dimensions of 3.5 m x 7 m x 18 m, the  
LDHI ones are more like “wells” than tanks...**

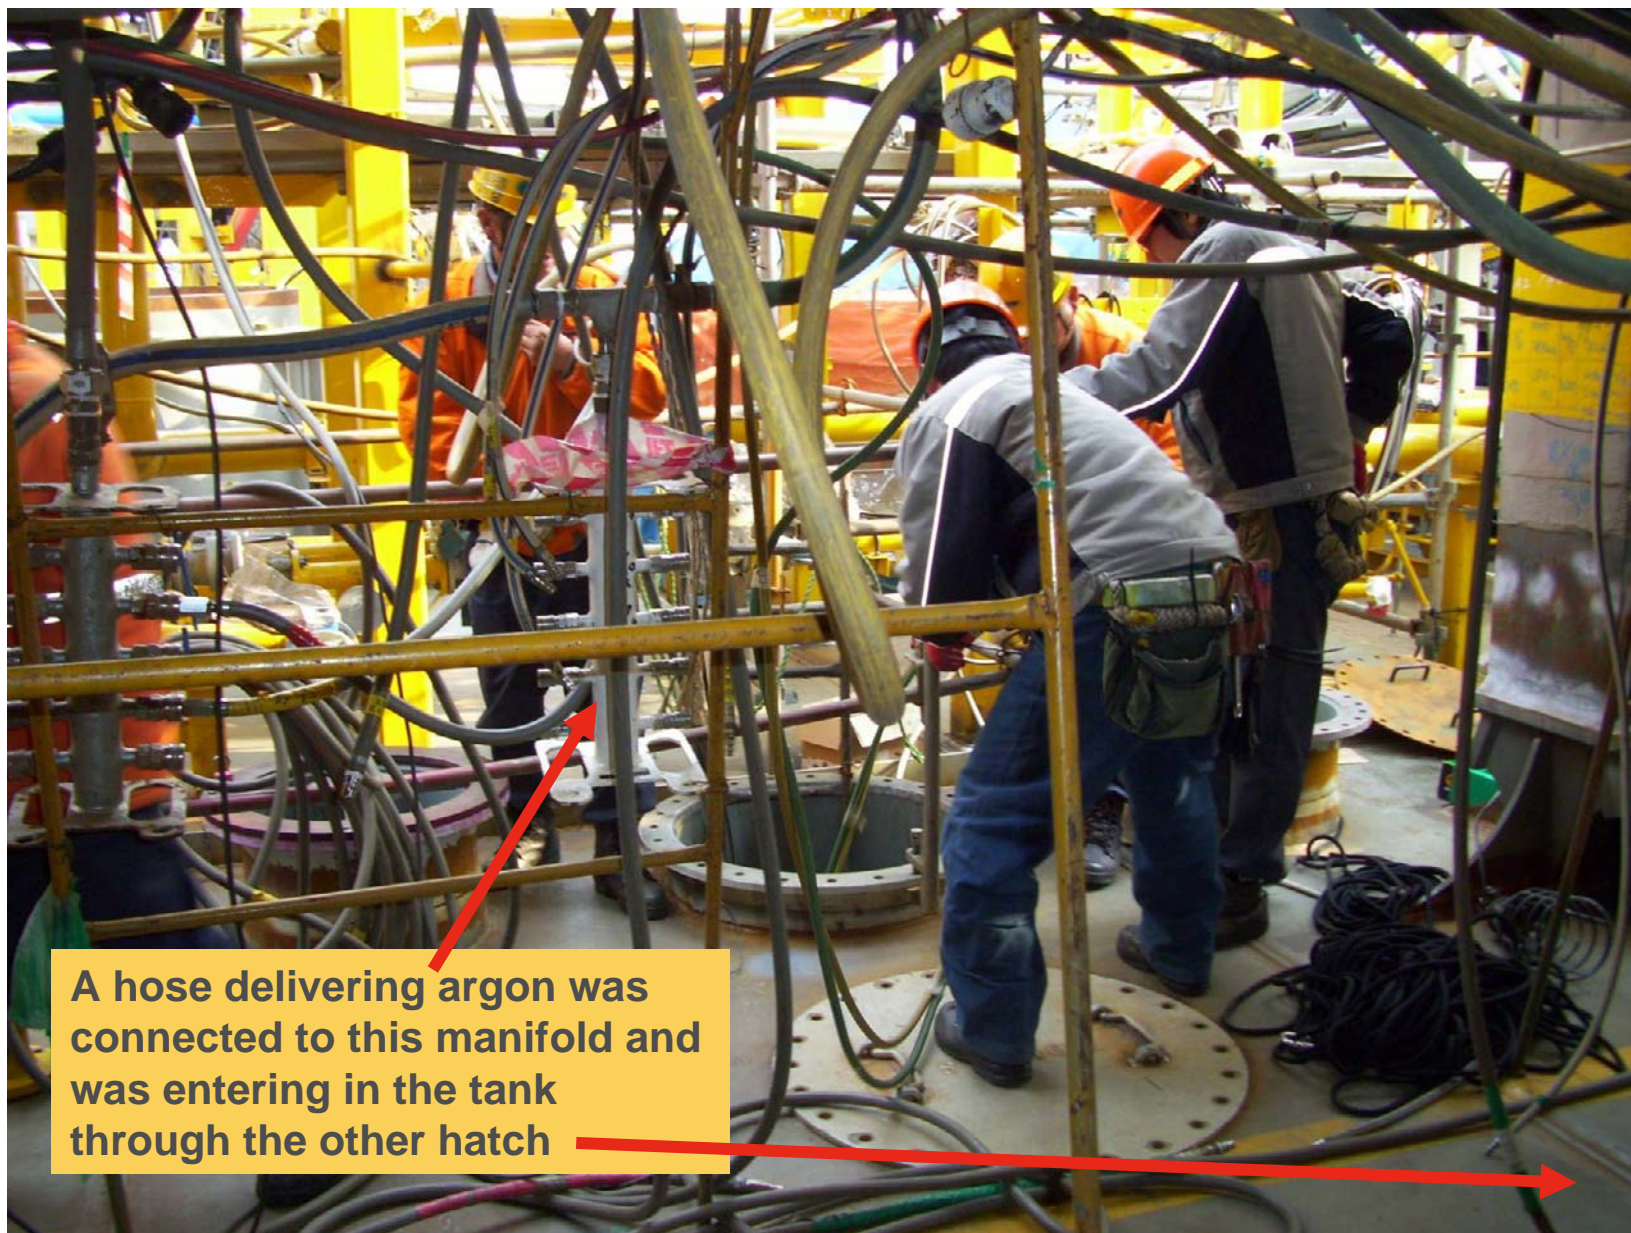
## The hatch used to enter the tank

A hose delivering argon was connected to this manifold and was entering in the tank through the other hatch

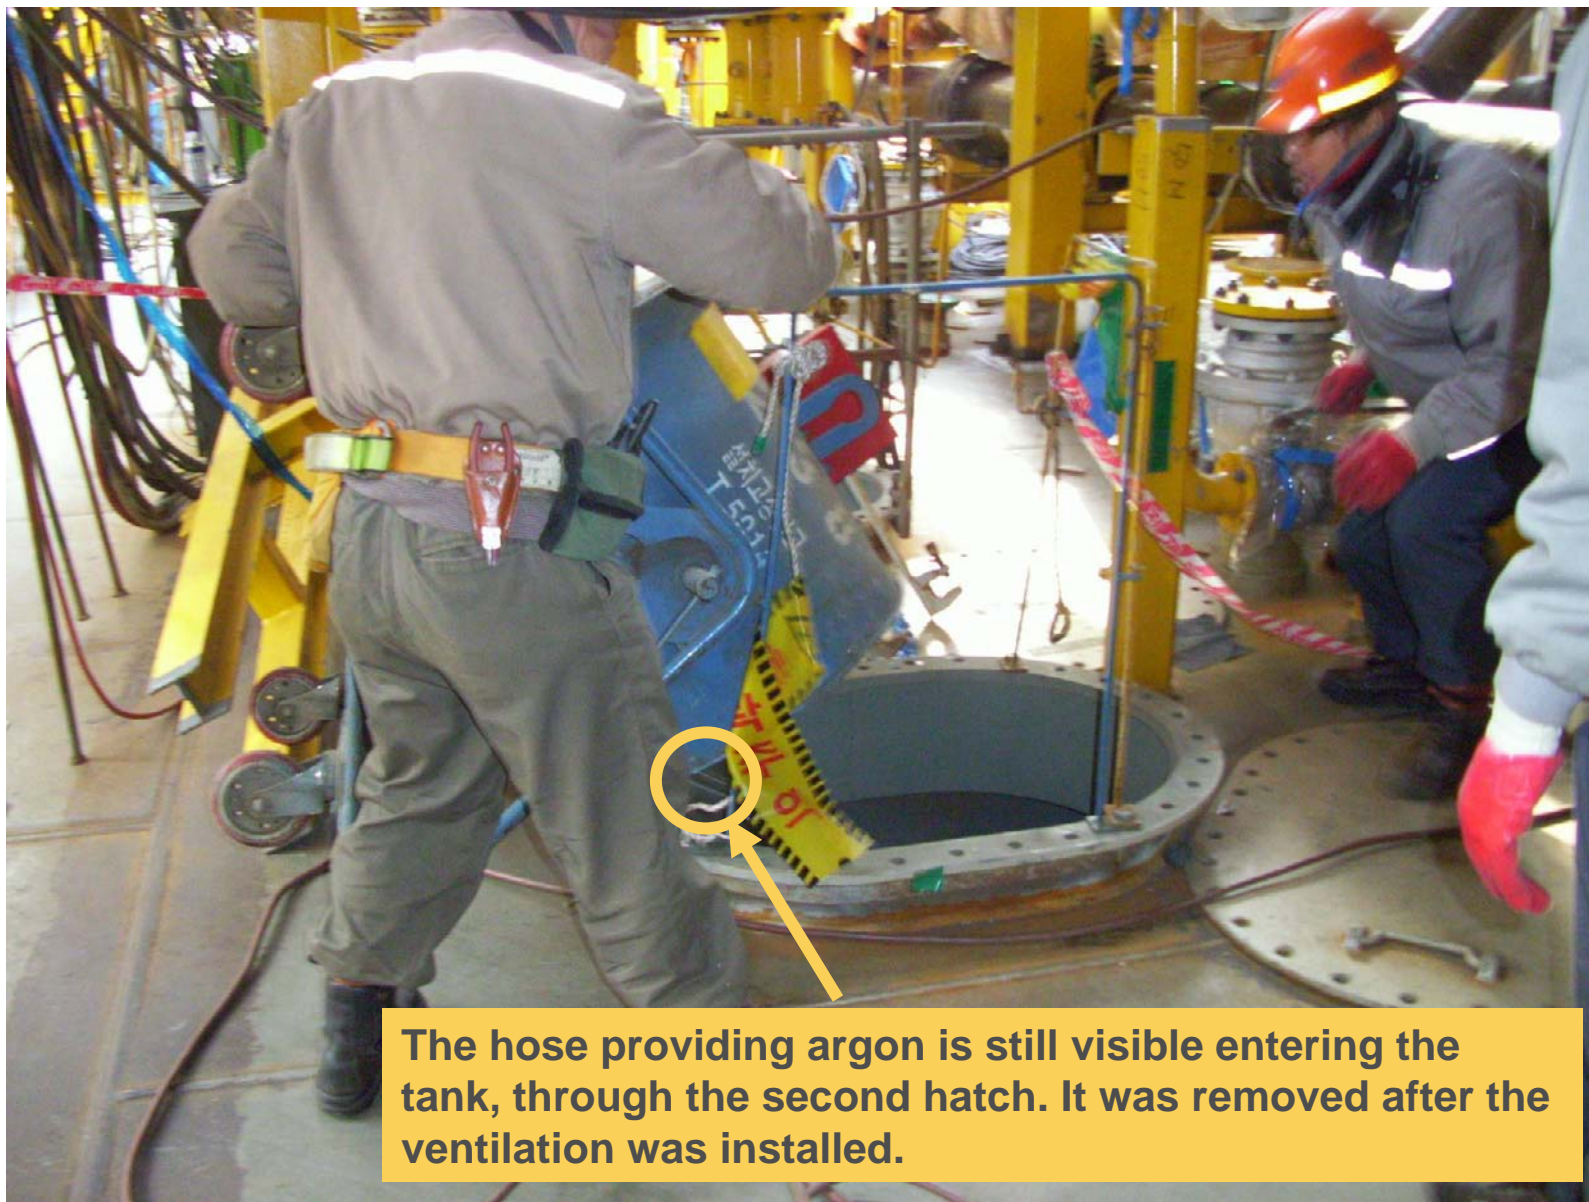
## The ventilation installed after the alarm was raised

The hose providing argon is still visible entering the tank, through the second hatch. It was removed after the ventilation was installed.

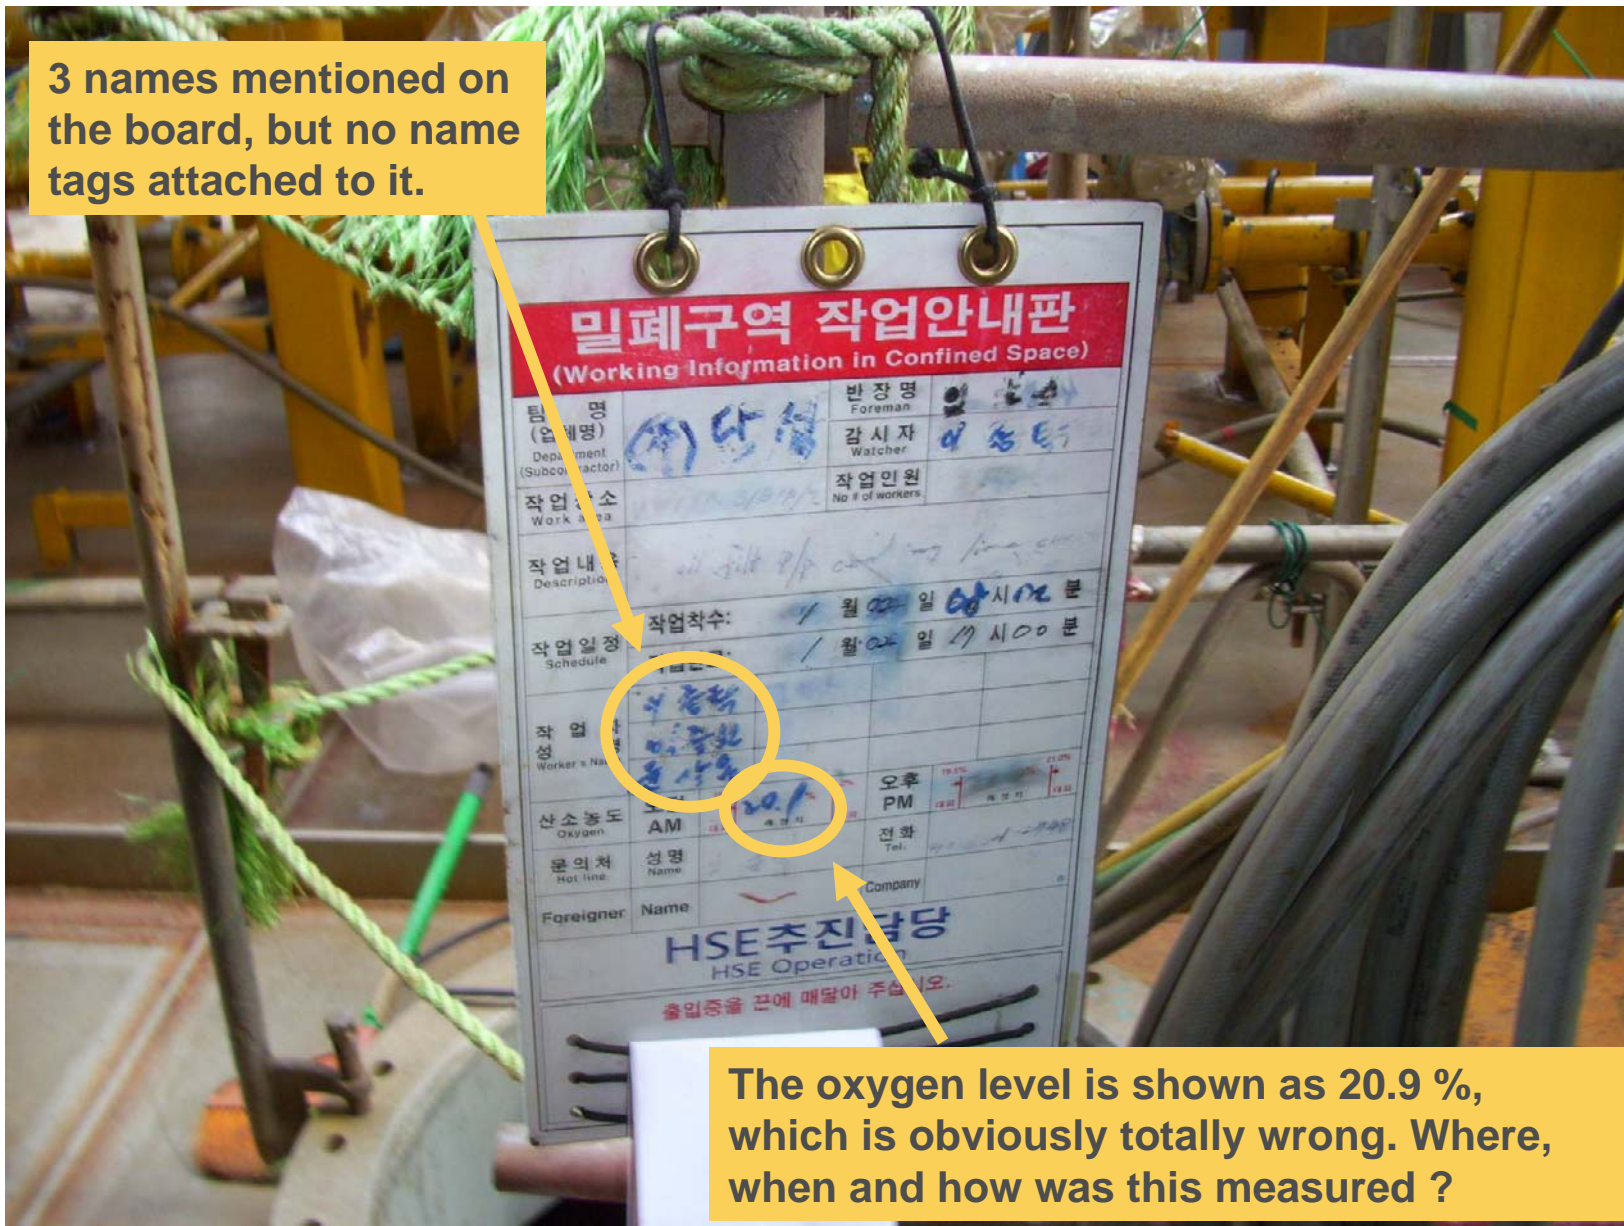
## The sign board at the entrance

- It shall be noted there was no name tags attached to the sign at the entrance of the tank.
  - The oxygen level indicated on the sign board was 20.9 %. Who wrote that figure and how / when was it measured ?

3 names mentioned on the board, but no name tags attached to it.

The oxygen level is shown as 20.9 %, which is obviously totally wrong. Where, when and how was this measured ?

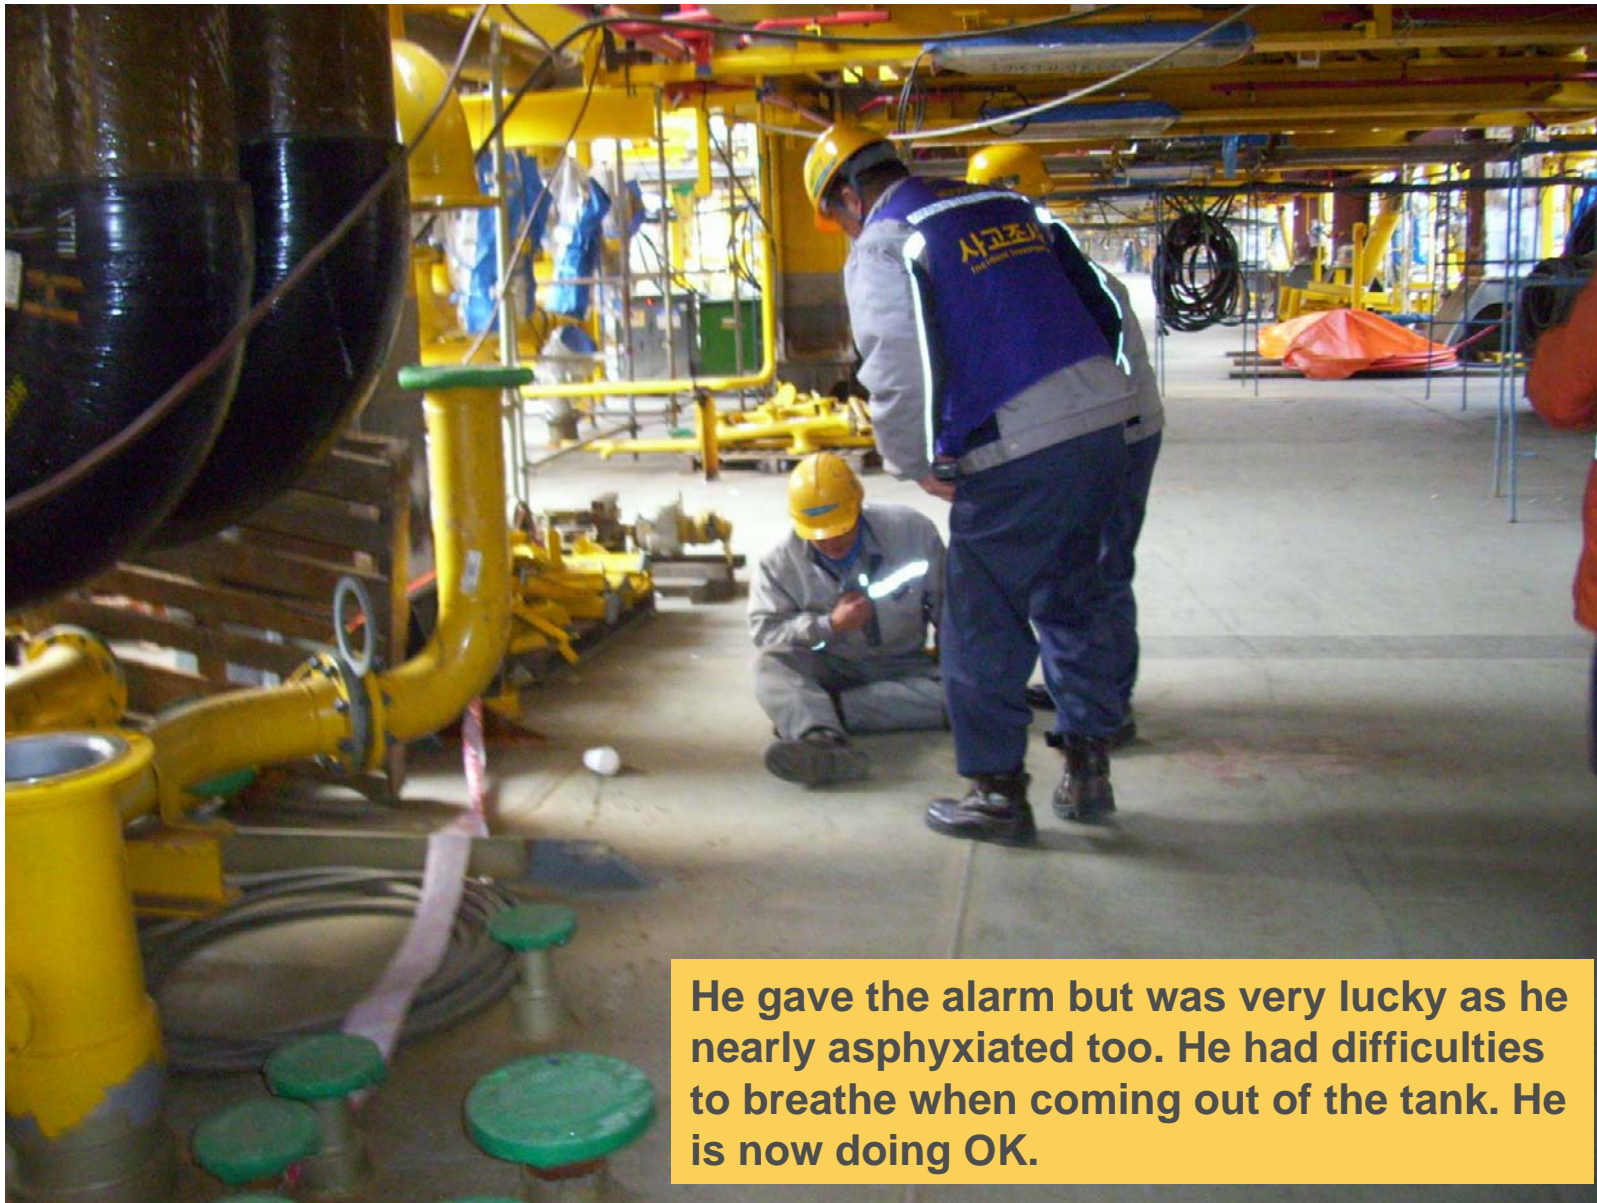
## The 3rd member of the team

He gave the alarm but was very lucky as he nearly asphyxiated too. He had difficulties to breathe when coming out of the tank. He is now doing OK.
