1. Incident Description:

Consolidated Contractors Company (CCC)
Managing Office – Safety & Controls Department
Confined Space Occupational Fatality
Lessons Learned

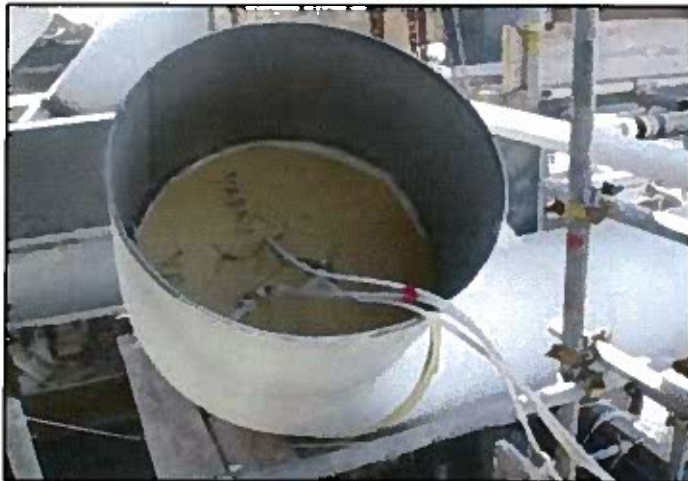
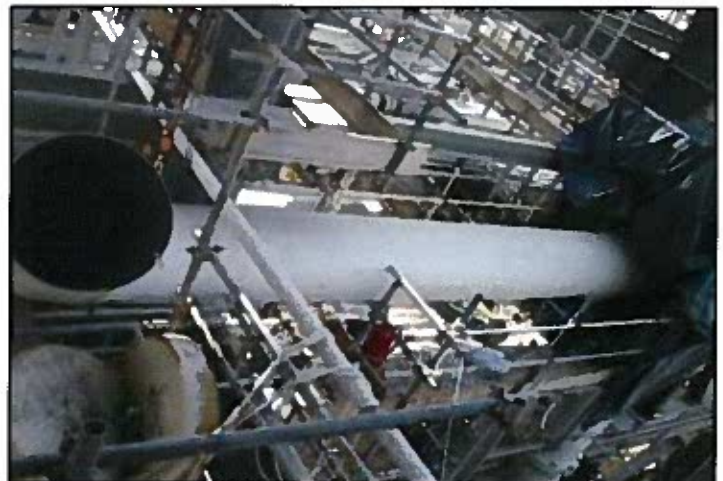
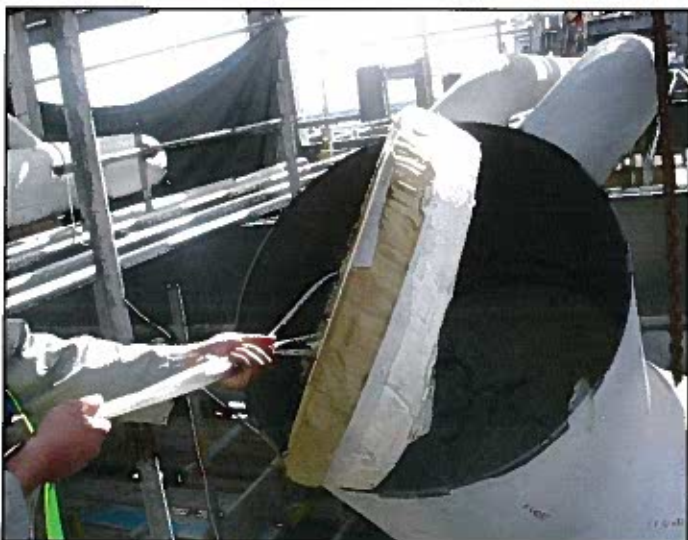
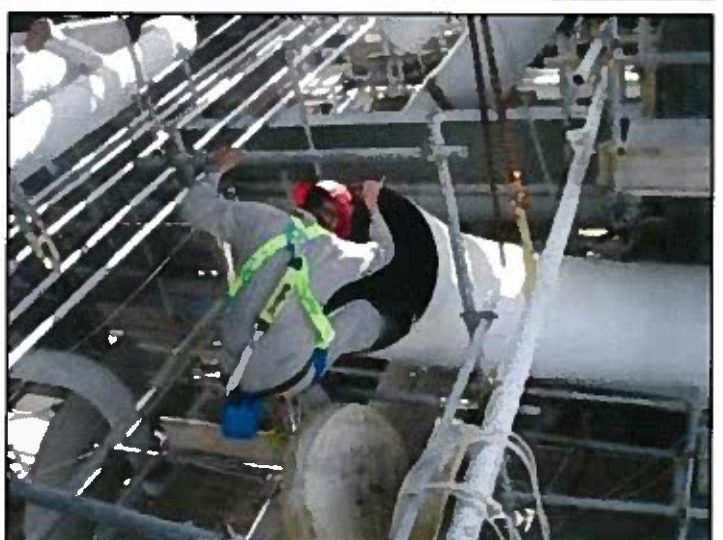
On February 6th, 2012 and in one of CCC Projects one of CCC welders entered a 30" pipe to check the quality of the welds he had just completed.

The welder (deceased) asphyxiated and lost his conscious due to the high level of Argon gas which had created an oxygen deficient environment inside the pipe.

Then another welder, upon noticing no improvement from the collapsed welder, requested the welding helper to enter the pipe and drag him out. The helper went in and had breathing difficulties and he was pulled out. Then the second welder shouted for help and another site worker went inside and he had also breathing difficulties and came out. Then again he used his H2S Cartridge mask and went in. He managed to tie a rope around the feet of the unconscious welder and came out of the pipe. Then Crew members pulled the unconscious welder out of the pipe. *He was lucky! This does nothing to protect from an oxygen deficient atmosphere.*

The unconscious welder remained unconscious and non-responsive to resuscitation and later he was pronounced dead the clinic by the medical doctor.
