# Cherry Point Diesel Reactor Incident

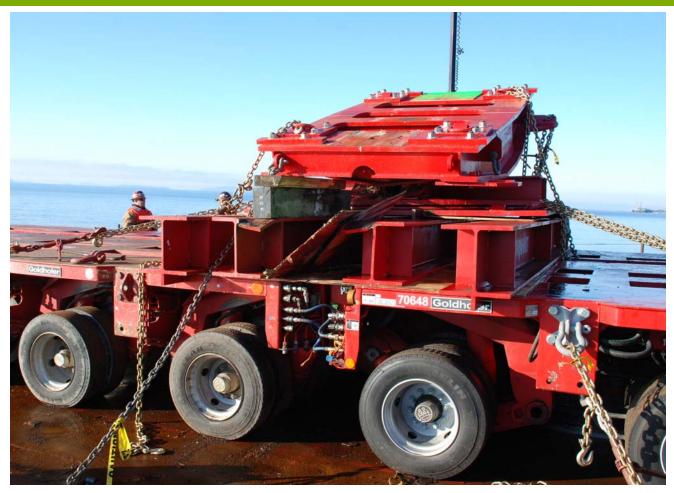
5:40 AM, December 9th

# Unknown shift in load of bolster assembly, causing it to tilt unexpectedly

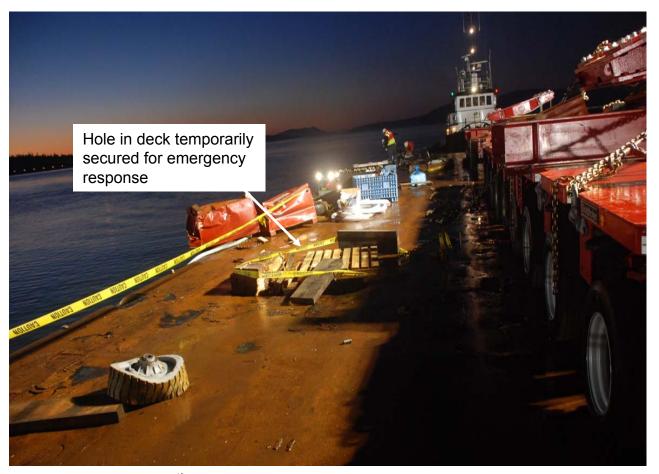
### Reactor and saddles slide off bolster assembly

-saddles likely hit and damage barge deck, then roll into ocean with reactor -believe reactor to be undamaged

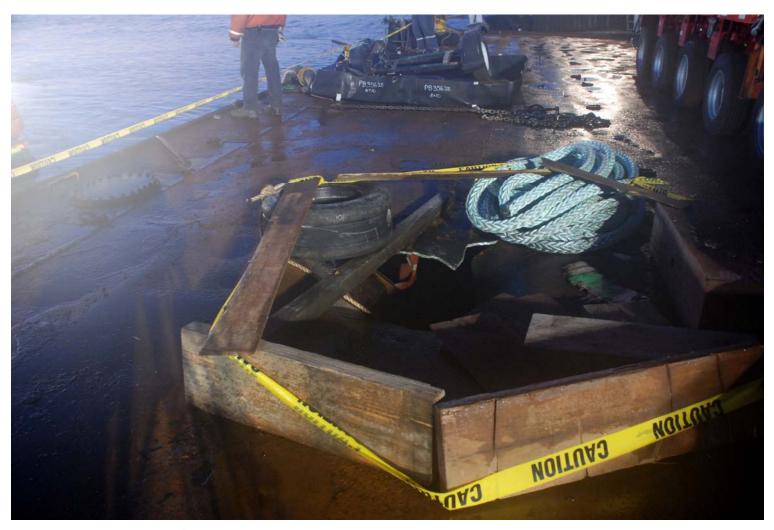
~6:30 AM, Dec. 9<sup>th</sup>

# Damage to barge deck from saddle

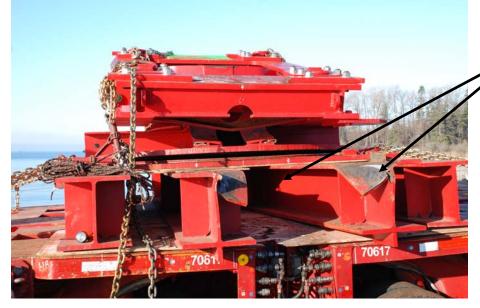
### Mechanical Damage to Bolster Assembly

Damage to I-Beam -likely caused by contact with saddles

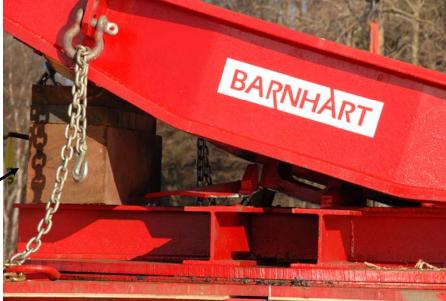
Wood Cribbing
-for barge transport only

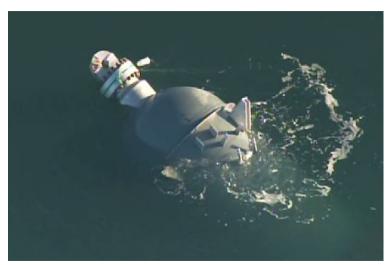
~12:00 PM, Dec. 9th

- Reactor and electric man lift submerged in ~60 ft of water
  - Reactor sitting on top of man lift
  - Reactor skirt half buried in ocean floor
    - Reactor is stable and secure

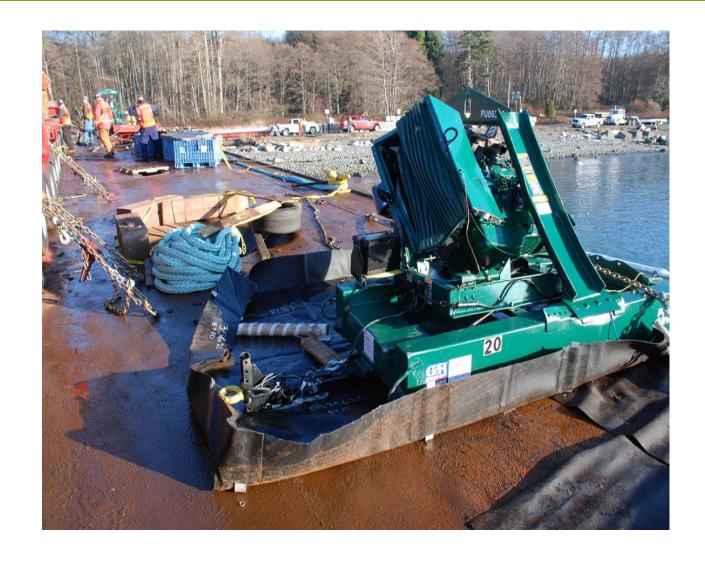
# Barge Ballast Pump damage and minor oil spill

-lube oil leak due to gearbox damage
