Incident Description: On December 30, 2008 a Loader was preparing to load a lube oil railcar. Four of the eye-bolts were loosened with an impact gun and unlatched. The 2 bolts nearest the handle were loosened but were allowed to remain in the upright position while the railcar de-pressured. One of the 2 bolts was equipped with a safety collar. After allowing the railcar to de-pressure several minutes, the Loader began to further loosen one of the remaining bolts with the impact gun and the hatch flew open. The little finger of the Loader's left hand was pinched between the hatch and the impact gun. The employee was taken to a local hospital and received medical treatment.

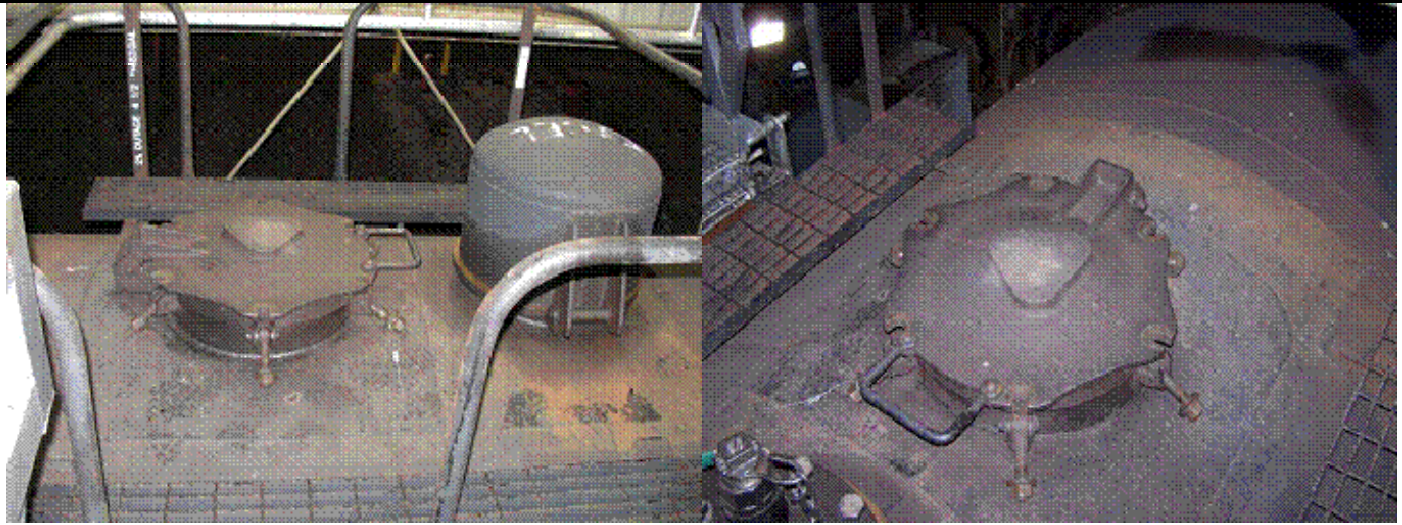
- Car arrived with ~ 10 psig air pressure – should have been near 0.
- Procedure did not address handling excess pressure
- Safety eye bolt was loosened past it's ability to function as designed
- Normalization of deviation to procedure due to variation of railcar configurations

- Communicate incident to providers/users of railcar to prevent recurrence of railcars arriving with pressure
- Revise inspection sheet to capture incoming pressure of railcars
- Provide loaders with training on hazards of stored energy
- Revise procedure to safely de-pressure railcar
- Perform at least 6 field audits to assure practice meets procedure
