# HOOK FAILURE SUMMARY REPORT

A lower 3-ton hook from a CM Series 653 Lever Hoist (come-a-long) failed at the Dynegy Baldwin worksite December 8, 2008. The failure occurred at the swivel joint area where the hook necks down to connect to the swivel. The hoist was one of 7 used to fit the cone section to Ring C-4. The applied load was in a straight line hook to hook. The hoist had been satisfactorily load tested in the Nooter Construction warehouse November 24, 2008.

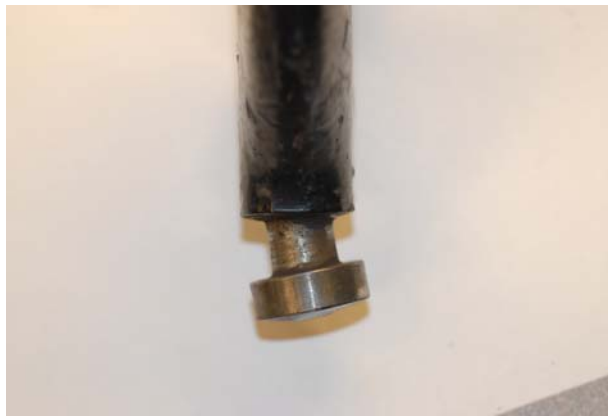
Upon investigation of other lever hoists in the Nooter Construction warehouse it was discovered that another 3-ton hook had a visual crack in the same failure location. The newly discovered hook was bent 90° to the hook (See Figure 1).

Figure 1 Cracked Hook

Detection of a bent knob is difficult as this portion of the hook is located inside a connecting swivel piece. In order for the knob to be visible the connecting piece has to be destroyed and therefore invalidate the hoist. Some level of visual detection can be made as long as the knob is bent severely like that shown in Figure 1. The swivel piece will have limited movement to one side indicating a bent knob.

The cracked hook was loaded to failure. The failure load was 40500 lbs. which is over 6 times the rated capacity. The fracture surface indicated that it was cracked approximately 17% through the diameter prior to loading. As seen in Figure 1, it too had been loaded to the side prior to loading.

The testing concluded that the failure of the hook was neither due to material deficiency nor fatigue but rather to pre-cracking prior to loading. The cracking occurred when the hook was loaded to the side. Side loading of such devices can cause injury or death either at that loading or sequential loadings.

- Inform field personnel of proper usage of lifting devices (See Section 11 “Rigging Safety” of the Nooter Construction Company Safety Manual)
- Prior to using a lever hoist the operator is to read the manual to be re-familiarized with its proper usage

- The manual has a list of operational “do’s” and “don’ts”. One of which is “...the operator shall **NOT** operate a hoist when it is restricted from forming a straight line from hook to hook in the direction of loading.”

- Prior to using a hoist in the field, an inspection of the hoist is to be performed to detect any defective areas
- Enforce the penalty of improper usage of lifting devices

- Continue test program of the hoists when the hoist is returned to the warehouse from the jobsite
- Continue to perform a visual inspection of the hoist prior to load testing

- Investigate the possibility of using strain gauge equipment to determine if equal loading can be observed on both sides of the hook and implement if it is successful
