Location: P&H MinePro Services Australasia
SHE38 – BMA Saraji

Incident Date: 10/02/2011
Safety Alert No: SA10044

EWP – INTERNAL RUST IN BOOM SECTION

Model: JLG LIFT 600AJ

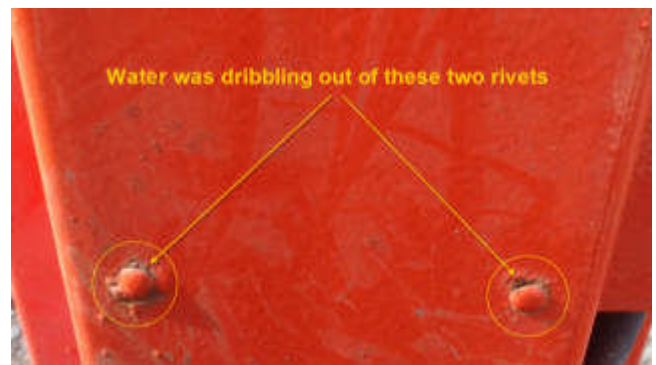
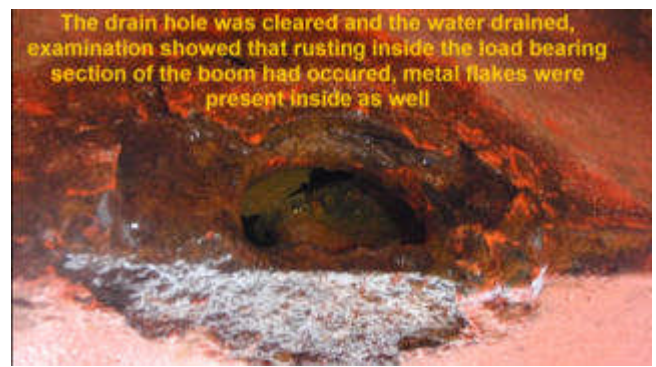
During a prestart inspection it was noticed that water was leaking out of rivets on the top boom section near the basket, upon closer inspection was found that a drain hole was block and approximately 300mm of water was retained inside the boom section.

The drain hole was unblocked and the water drained, an area of rusted metal flaked off externally near the drain hole further investigation revealed that the hole itself was out of shape due to rust and flakes of rusted metal could be seen inside the boom section.

Checking drain holes in boom sections not documented in manufacturers daily prestart check lists.

- Parked up the EWP and tagged out of service.
- Contacted the hirer who sent out a service rep to inspect the unit which was changed out for another EWP.
- Gave contact details to the service rep for feed back from the hirer regarding checks on other equipment currently in use and updating the daily prestart checklist in the hand book supplied to include drain holes.
- Raised a BMA Hazard ID for entry into BMA Saraji's first priority system.
- Included into SHE38 prestart meetings to ensure that drain holes become part of the EWP prestart checks.

Ensure that hired equipment is thoroughly checked for structural integrity when delivered, look for blistered paint on joints hiding rust, check drain holes for signs of internal rust and ask questions in relation to the history of the equipment, i.e had the equipment come from a corrosive environment etc.
