La Porte Crane Near Miss October 30, 2010

Liebherr 200 Ton Model 1160-2

Near Miss Description

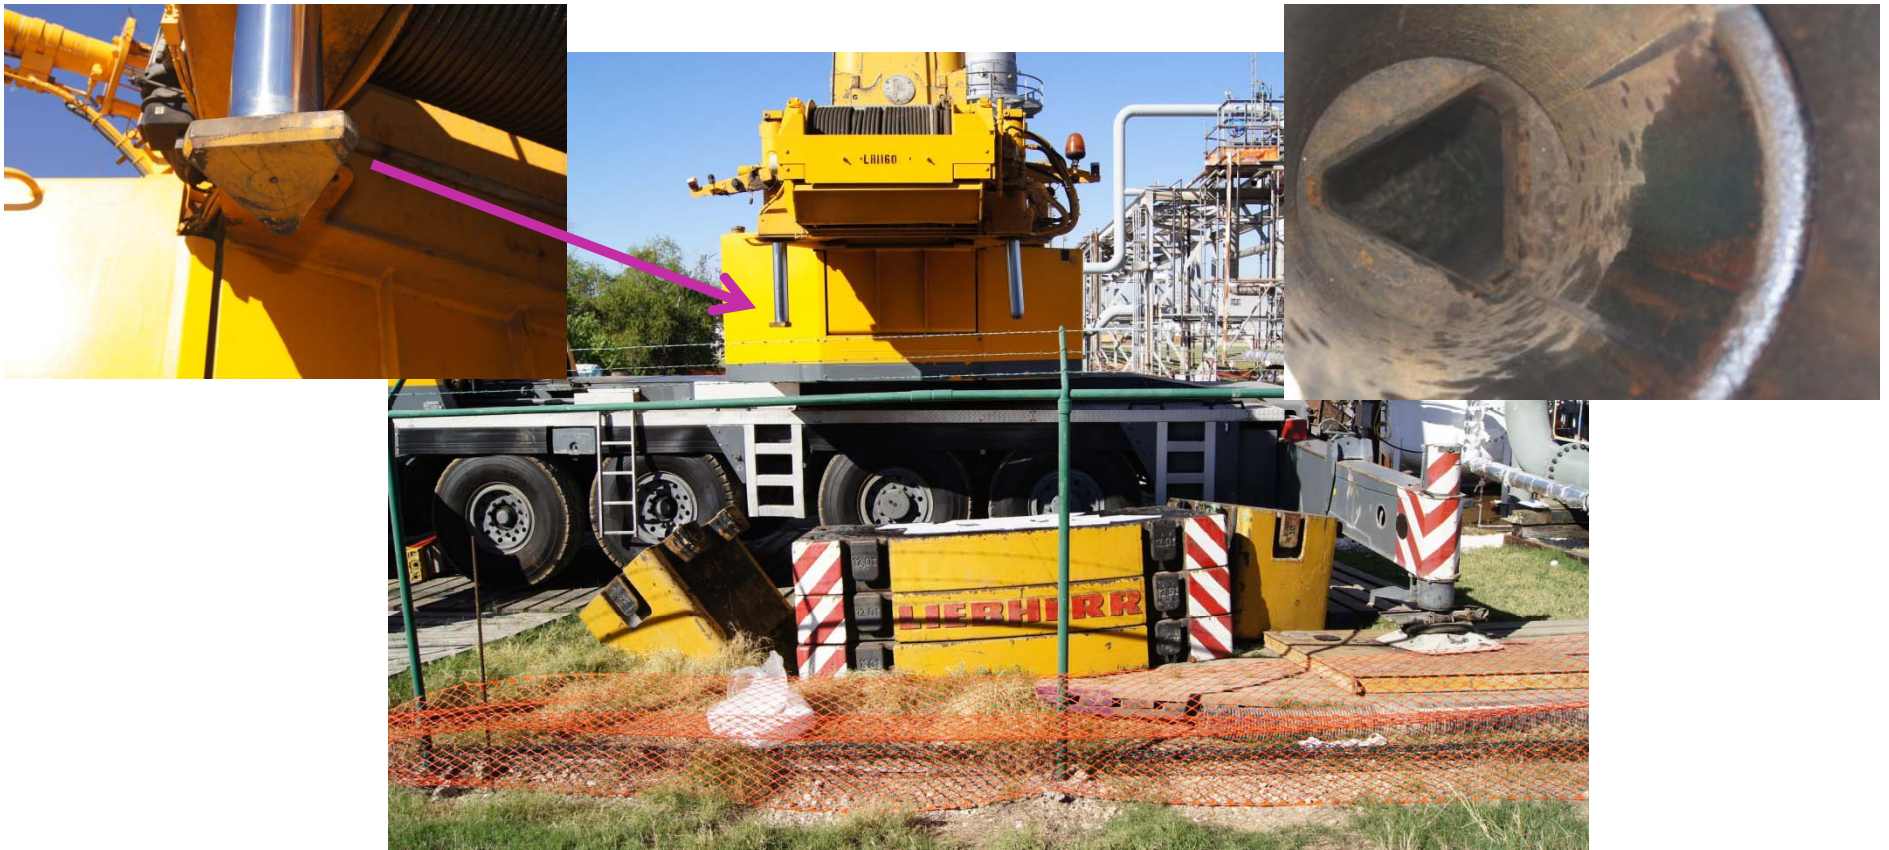
Counterweight locking mechanism

This triangular cylinder end piece extends into counterweight when cylinder ram is extended. When rotated, it locks into place in the counterweight

This view looks downward into top of hole in counterweight used to accept locking ram depicted on left side of the page

Investigation concludes that the counterweight dropped from the left locking mechanism, the entire weight of assembly then rested on the right hydraulic ram/locking assembly which bent that shaft and broke end piece/locking mechanism off

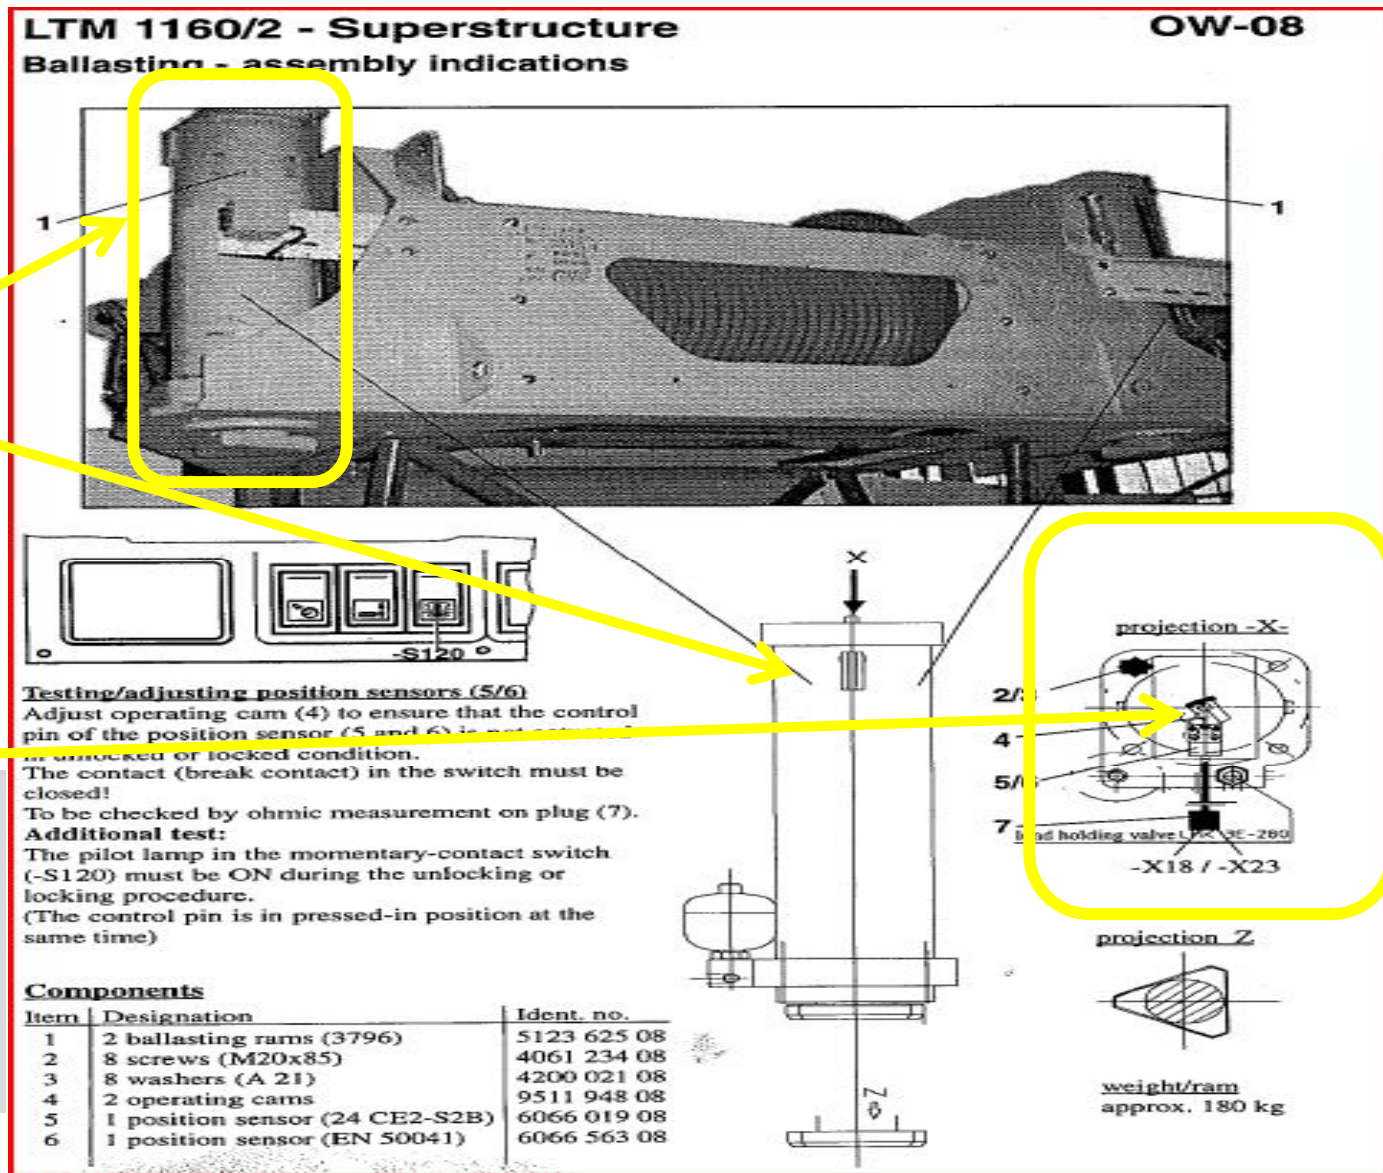
This cylinder (two on machine, one each side of counterweight) lowers and raised the cylinder ram that has triangular locking end action.

One hydraulic action actuates axially on the ram to Raise & lower counterweight.

A separate hydraulic action actuates radially on the ram to rotate the triangular locking arm that locks into counterweight.

Cams (on each of two cylinders) are attached to cylinder top to deflect positions sensor indicating lock/unlock of cylinder to counterweight.

Cams had been removed at some point in history, so positive locking or unlocking is not evident. Red light indicates when cam is not locked (if cam is installed), but if cam is missing, no light illuminates

- Add counterweight “secured” inspection to pre-use crane inspection
- Removed General Crane from approved vendor list
- Held a meeting with Turner Brothers crane company, Flares and Stacks, Austin, Total in order to discuss additional safety checks before crane use

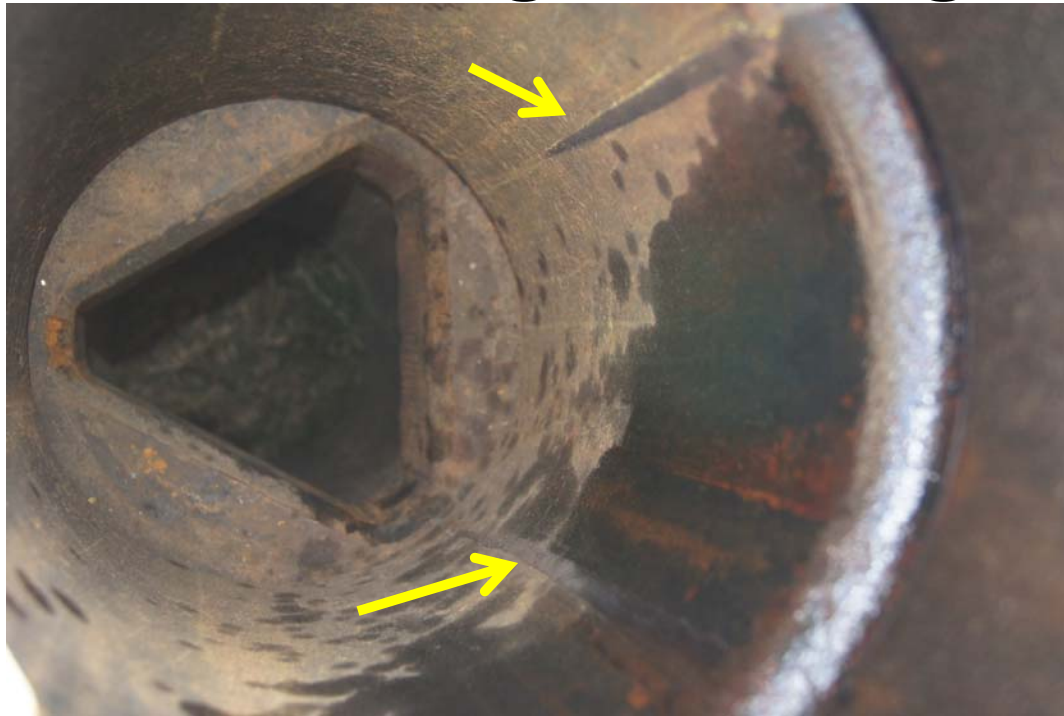
Drag marks in South end of counterweight locking chamber

This hole in the counterweight allows cylinder insert triangle to insert then rotate which locks counterweight in place.

Drag marks indicate that cylinder ram triangular insert was not fully in "locked" position such that it dragged out on the south locking mechanism inside the counterweight.

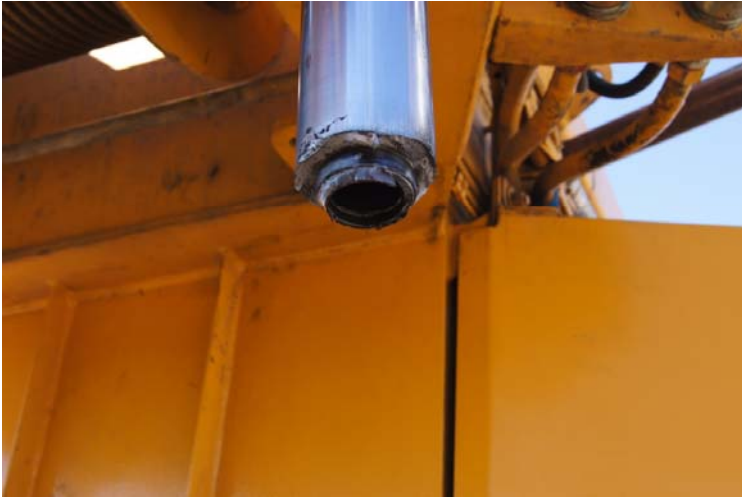
Close up view of hydraulic ram at north side of crane. End triangular locking piece has broken off

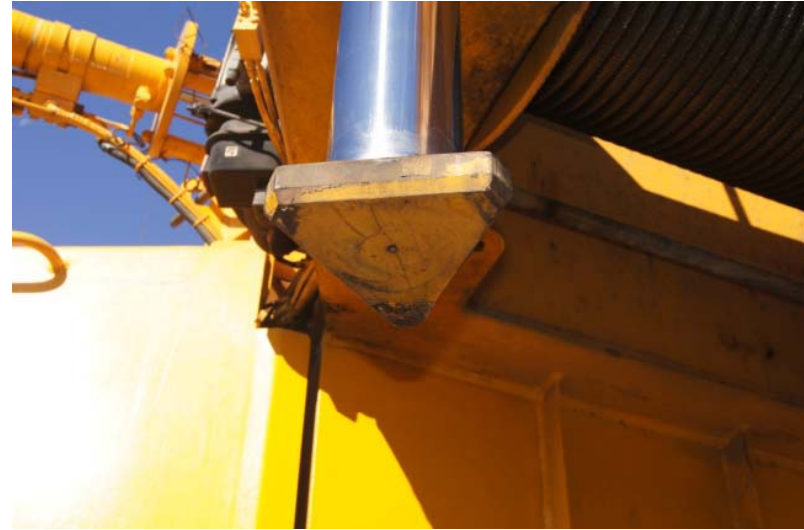
Close up view of hydraulic ram at south side of crane. End triangular locking piece intact

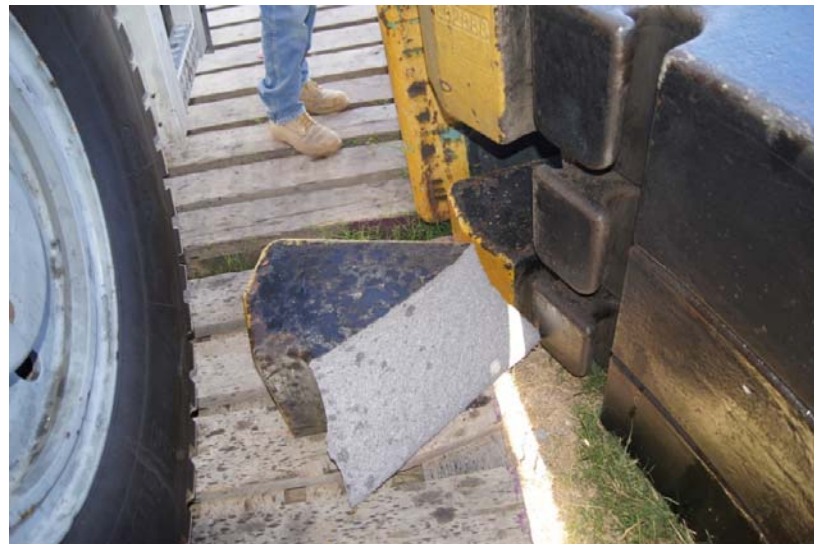
Piece of counterweight broke from main assembly during incident
