# Significant Near Miss Involving a Fiberglass Extension Ladder

## Ladder Inspections - Why they are so Important

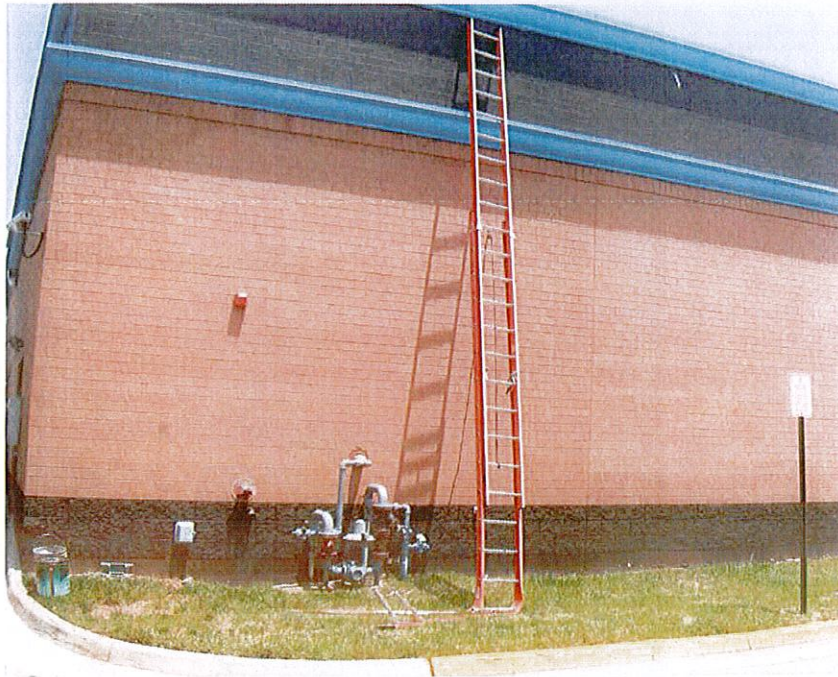
As the technician was climbing the ladder he felt the ladder start to give from underneath him. He was able to reach and hold on to the roof edge as the ladder collapsed. The second technician was able to get another ladder from their service truck, set the ladder up and get the first technician down safely without incident.

Ladder collapsed – worker was able to grab on to the leading edge of the building

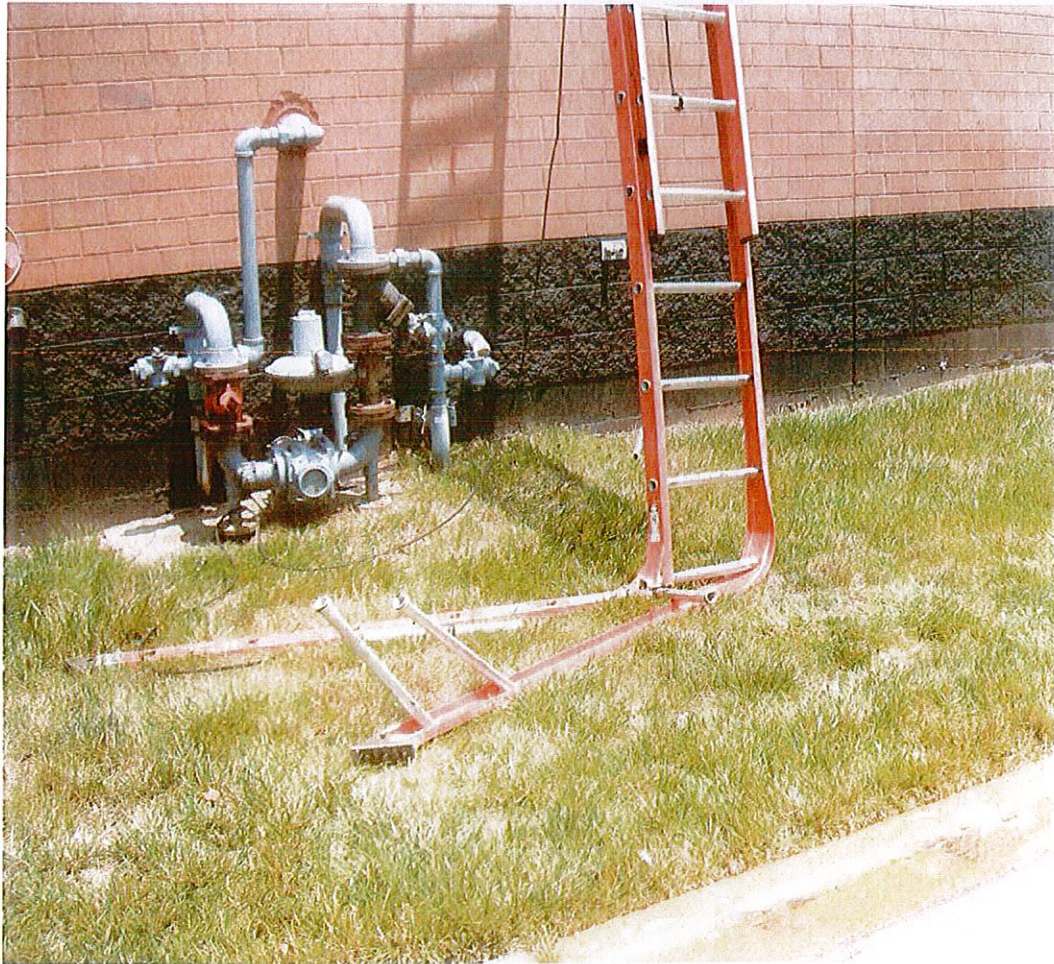
The lower section of the ladder failed

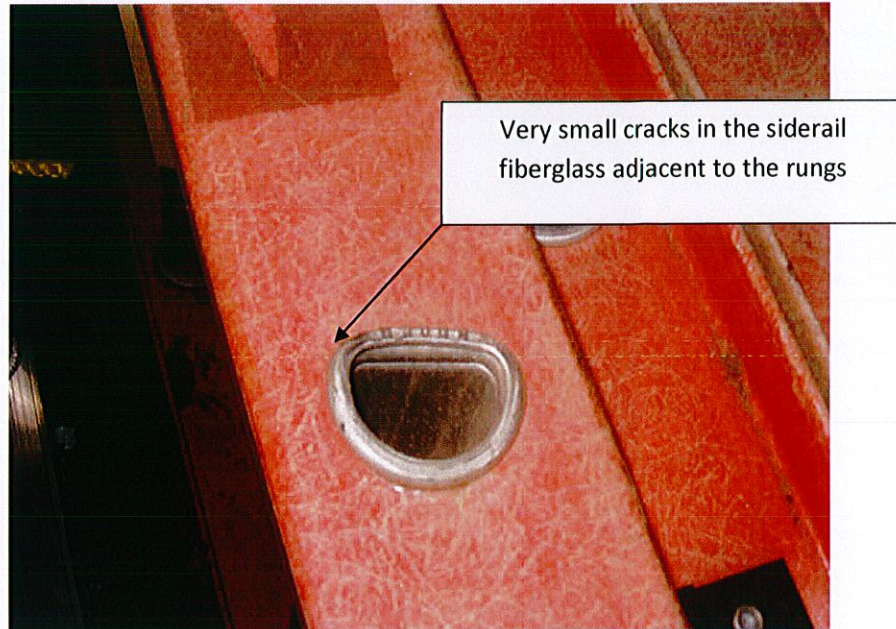
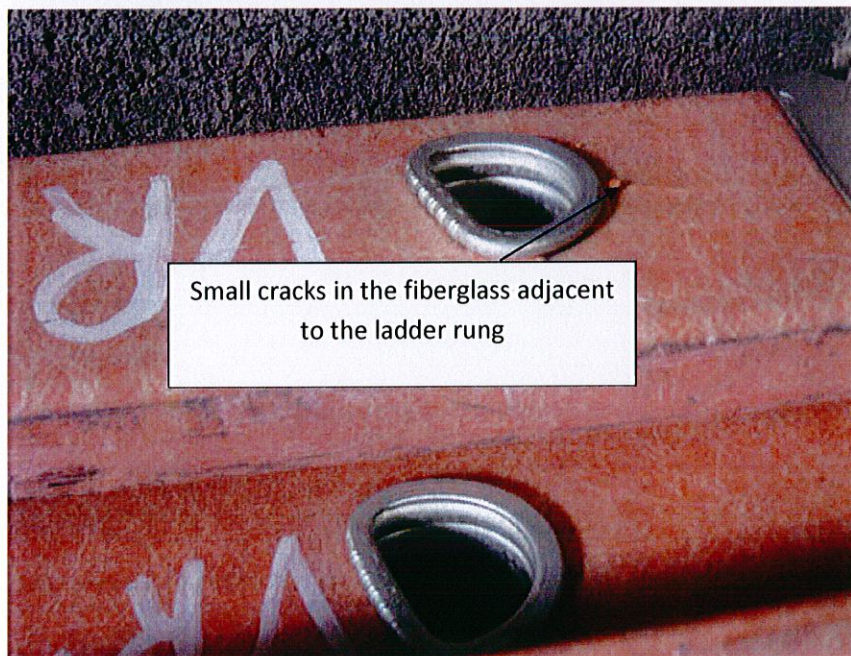
All fiberglass ladders were immediately brought in from the field and closely examined for any possible defects or damage. The company found that on approximately 20% of their fiberglass extension ladders there were very small cracks in the fiberglass on the siderails immediately next to the rungs of some ladders.

The small cracks found in the siderails of the extension ladders were not noted to be in any pattern along the siderail. The cracks and splits in the fiberglass were found to be immediately next to the rungs on the outside portion of the siderail.

Currently it is believed the fiberglass may have been damaged or fatigued during the manufacturing process when the rungs were crimped into the siderail of the ladder.

The small cracks around the rungs are not easily detected by a quick visual inspection. Workers need to 'feel' with their finger tips for any raised spots in the fiberglass and remove any debris along the side rails in the areas where the rungs are crimped to check for small cracks or splits. The cracks were not found in any pattern or specific location on all the ladders inspected. It is important to inspect each rung on both the exterior and interior side of the siderail for any signs of cracks or splits in the fiberglass.

Any fiberglass ladder with these small cracks should be removed from service.

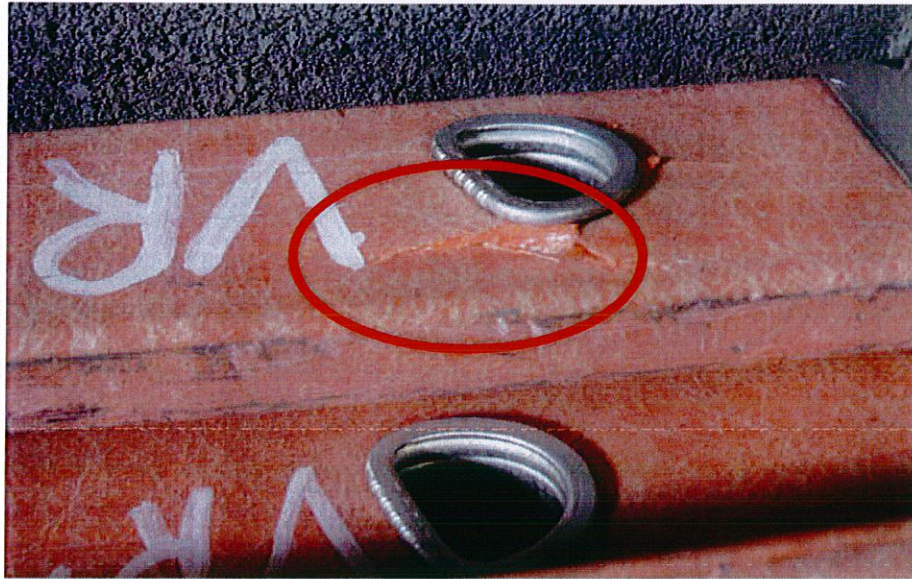
In addition to the small cracks in the fiberglass in some areas the fiberglass material had split.
