DATE OF INCIDENT: September 24, 2009

BACKGROUND

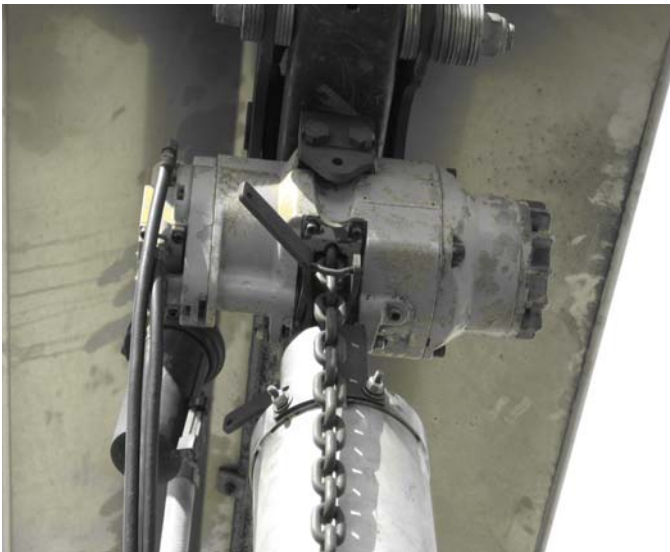
- Once in position, the contractor knelt on the basket's floor looking up into the hoist mechanism, locating the sprocket wheel of the hoist unit.
 - Working against gravity, the contractor held the chain rigid in his left hand and "bumped" the local hoist control while pushing the supported chain up into the closed housing.

- The rotating sprocket "grabbed" the first link, causing it to feed into the hoist too quickly for the contractor to react, his left thumb became lodged between the chain and hoist guide resulting in the injury.

The At-Risk Behavior in this incident is the failure to recognize a hazard in the form of a pinch point when attempting to feed the chain onto the sprocket.

- Procedures – Not Followed. Marysville’s Hazardous Energy Control procedure requires all sources of active and stored energy to be controlled or released prior to working on any process equipment. Additionally, the manufacturer’s manual reads, “It is recommended that all maintenance work on the hoist be performed on a bench in a clean, dust free work area. During the process of disassembling the hoist, observe the following: 1. Turn off air system and depressurize air lines before performing any maintenance. Disconnect air line from hoist”. NOTE: OSHA 1910.179 (l) (2) Maintenance Procedure – states that all controllers shall be at the off position and the main or emergency switch shall be open and locked in the open position.

- Hoist re-installed without the chain lead to the attempted re-installation of the chain in the field, contrary to manufacturer’s recommendations.

- 100% Energy Isolation is required for all equipment prior to the commencement of work. Deviation from established procedure requires approval.
- Completing a SPA is only a step in complete pre-job packages, subject matter experts and manufacturer's manuals must be included in all pre-task analysis to ensure all concerns reviewed prior to beginning work.
- A pre-job safety exchange (communication) soliciting input from others within a cross-functional work group sheds light on safety concerns otherwise overlooked.
- If the question "is this safe to do" had been considered, the probable answer would have been "No" and the injury would have been avoided.
