Incident Sharing

INCIDENT RESULTS IN FINGER AMPUTATIONS

Incident Date: 11 Dec 2009

Location: ExxonMobil Singapore Parallel Train Project, ExxonMobil Asia Pacific

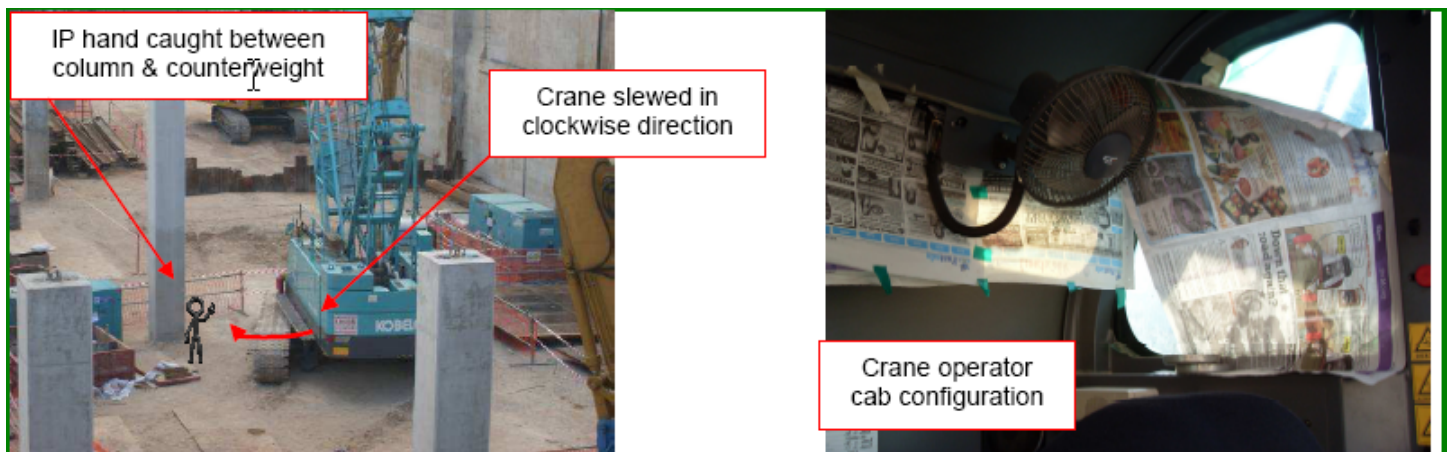
Incident Description: An 80 ton-crawler crane was re-positioned by the Lifting Supervisor and Crane Operator to lift sheet piles due to an unplanned work scope change that was not approved. As a result, the crane was moved closer to a concrete column and the Lifting Supervisor and Crane Operator turned the crane to verify the counterweight would clear the column. The two riggers/signalmen were not present to assist as the Lifting Supervisor had sent them away to collect additional slings. As the crane turned, the Lifting Supervisor was standing near the concrete column. Due to the Lifting Supervisor standing in a blind spot (and possibly because cab windows were covered by newspaper), the Crane Operator could not see the Lift Supervisor. The Lifting Supervisor raised his hand to warn the Crane Operator that the counterweight was going to strike the column and caught his left hand between the counterweight and the concrete column. Four fingers of the Lifting Supervisor's left hand were amputated as a result of the incident.

1. Crane operations conducted without qualified riggers/signalmen; crane checklists improperly completed
2. Lifting Supervisor placed himself in crane's visual blind spot, and Crane Operator turned the crane without full external visibility (blind spot + windows partially covered with newspaper)
3. Pre-task preparation did not address 'unplanned' work change; Approved work plan was not followed
4. Permit To Work (PTW) system not detailed enough regarding specific work location, tasks and controls
5. Use of a crane with high speed turning (4.0 RPM) that was not designed for congested work areas

1. Controls must exist to ensure compliance with crane lifting procedures and effective PTW / Work Planning processes
2. PTW and Lift Management System deficiencies were not identified by audit processes or by field supervision
3. When the work scope changes, the plan, equipment & work environment must also be re-evaluated to ensure adequate mitigations are implemented before work start (i.e. review of PTW, Work Method Statement, procedures, etc.)
4. Two previous observations and interventions on crane high turn speed were not formally recorded and did not identify or correct a critical equipment issue (i.e. crane operator behavior vs. equipment turn speed design)
5. An unreported asset damage incident (counterweight scratches) occurred previously such that potential SHE learnings were not identified or shared
