Type of Incident: Line of Fire causing injury to hand

Incident Date: 7/18/11

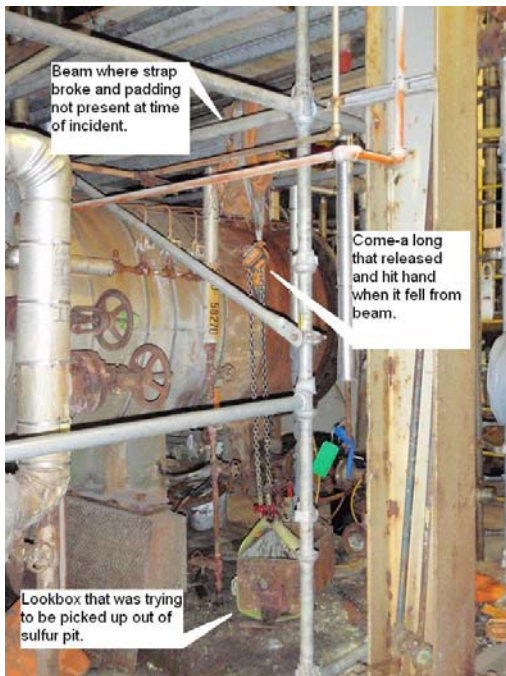
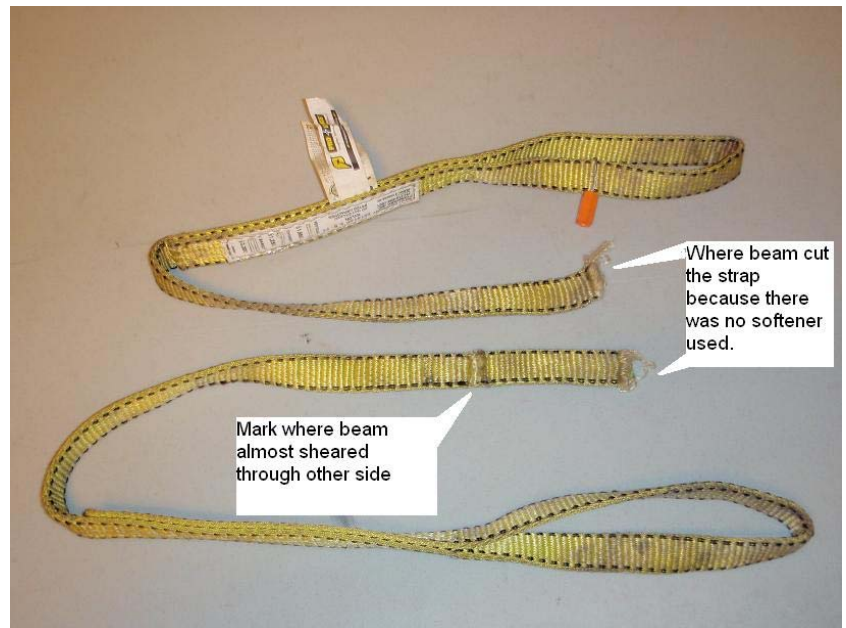
A 1" strap was placed over an "I" beam (without any type of softeners) to aid in lifting look out box from top of sulfur pit. Lookout box pipe was embedded in concrete. The lookout box did not budge and more force was applied to come-along. The resulting force of the come along cut the strap due to sharp corners of the beam. The strap cut through causing come-along to fall on worker's hand

- JSA did not contain enough information to pre plan task
- Softeners were not used to protect sharp corners of beam
- Pipe was in a sleeve which was attached to the box; detail was overlooked
- Too much force was used with no give to pipe

- More detail including inspection of area should be given for JSA
- Ensure material being demo'd is able to move freely with out excessive force on come-along
- Rigging should be protected against sharp edges
- Sleeve should have been cut first to remove the box, then sleeve could have been removed separately
