Safety Flash

RECENT NEAR MISS WITH NITROGEN HOSE

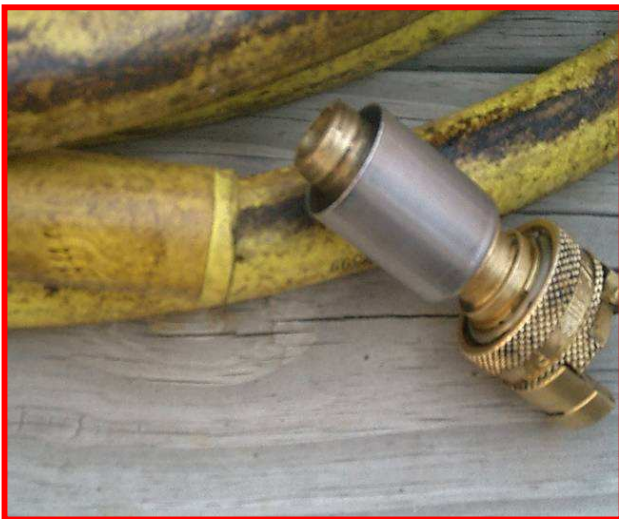
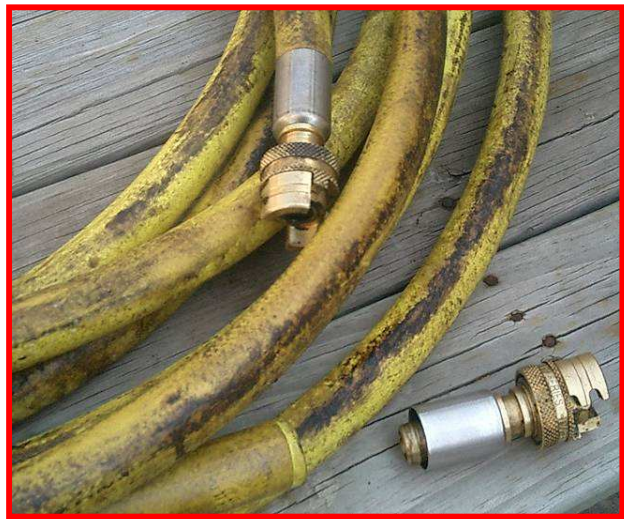
On 03/02/10, CDCC personnel were clearing E-715A for mechanical work. While nitrogen purging the tube side of the exchanger to an established H₂S regulated area, the crimped fitting on the end of the nitrogen hose became separated from the hose. A whip check was utilized on the hose which prevented possible injury to personnel. CDCC technicians did an outstanding job by completing a well written JHA, following established procedures and having a check valve installed at the exchanger bleeder, which prevented crude oil from being released to the atmosphere. This incident is a prime example of why we have established procedures and why we should follow them. Any short cut taken while performing this task, i.e. no whip check, no check valve, etc., could have resulted in injury. We should always visually inspect all hoses for excessive wear, damage, and expiration date prior to each use.

Triplex inspected the ferrule and found a small imperfection in the form of a protrusion of metal on the inside of the ferrule. Triplex checked the equipment used to push the fitting and the ferrule onto the hose and found it to be in good working order. They also checked the FP-140 Finn Power machine used to crimp the ferrule onto the hose securing the fitting into the hose and found it to be in good working order. Triplex conducted several checks with different sizes and types of hoses measuring the crimp diameter of each. Each time a hose has a fitting crimped onto the hose the ferrule crimp diameter is measured for accuracy, consistency and repeatability. This is standard practice. Triplex follows the fitting manufacturer's crimp recommendations on the crimp diameter for each hose size, type, end fitting and ferrule.

It appears that the ferrule on the fitting in question did not get pushed up all the way onto the end of the hose. It appears to have stopped at the point of where Triplex found the imperfection on the inside of the ferrule. Therefore, it was not completely seated onto the end of the hose. Once they discovered this Triplex took the following corrective actions.

1. Triplex inspected the balance of the ferrules in their inventory.
2. Triplex, jointly with the manufacturer's approval, implemented a tighter tolerance on the crimp diameter of the ferrule which secures the end fitting to the hose.

3. Triplex conducted 100% hydrostatic testing of all the Nitrogen hose assemblies in their inventory with crimped fittings that are pre-fabricated for ExxonMobil.

4. Triplex added the following to their existing procedures for rubber hose fabrication.
 - a. Using the ferrule length, mark the hose in four spots behind the end of the ferrule on the hose providing a point of reference to check and verify that the hose is securely pushed all the way onto the fitting and into the ferrule prior to and after it has been crimped.

- b. As a secondary check, manually push the fitting into the hose and ferrule onto the hose up against a wood or metal stop to further check and insure that the fitting is all the way up onto the hose as far as it could go prior to crimping.
