2011 Alky Turnaround

Overpressure Failure of 42" Slip Blind at
C-404 Suction Line

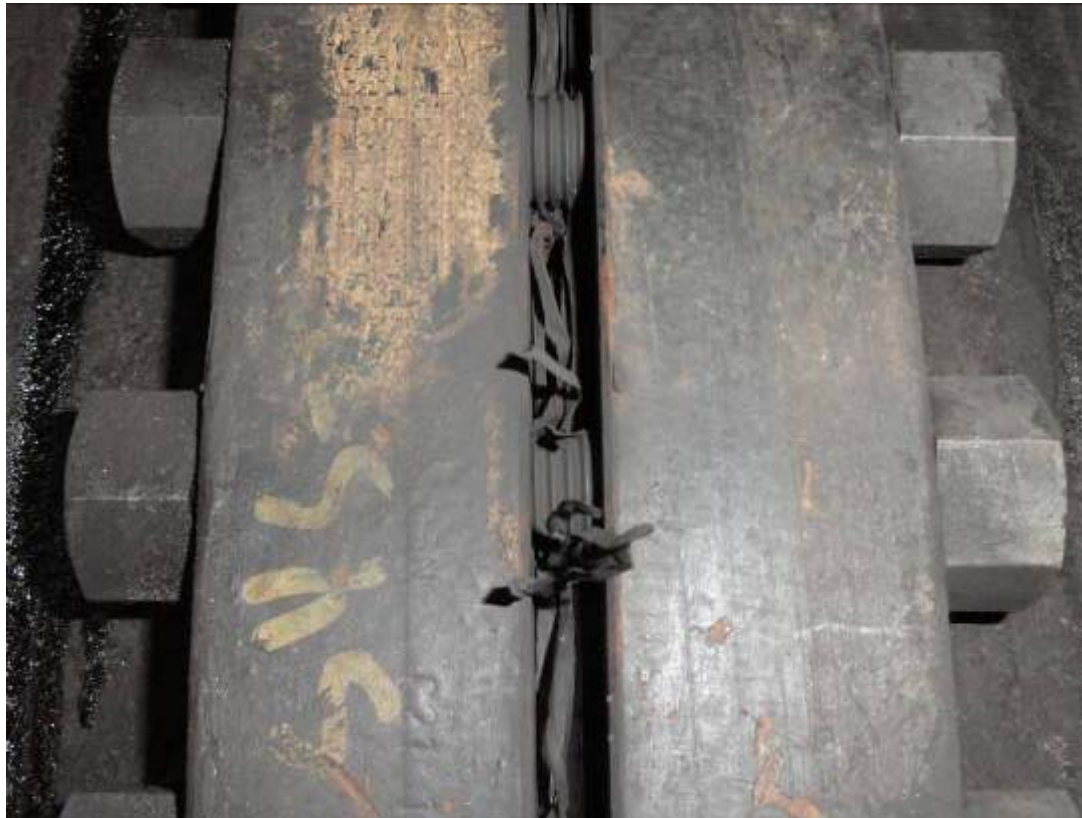
View of flange where slip blind was installed. Gasket winding material trapped in bolts. Most winding material pulled into pipe with blind & blown downstream to compressor.

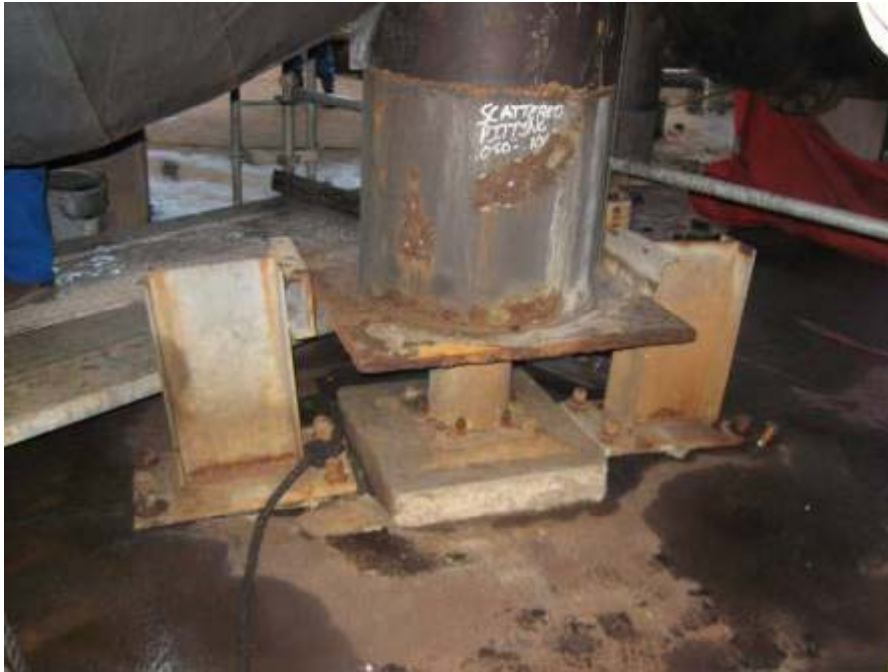
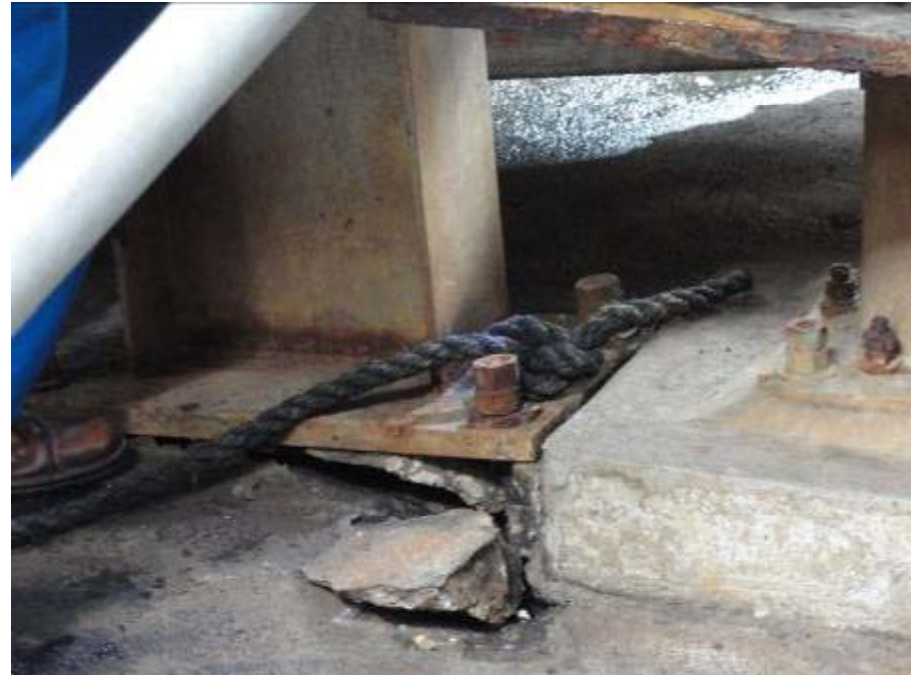
Pipe support and guides for 42" pipe, immediately downstream from slip blind location. Anchor bolts partially pulled out of concrete. Indicates that pipe moved ~2" north and south during incident.

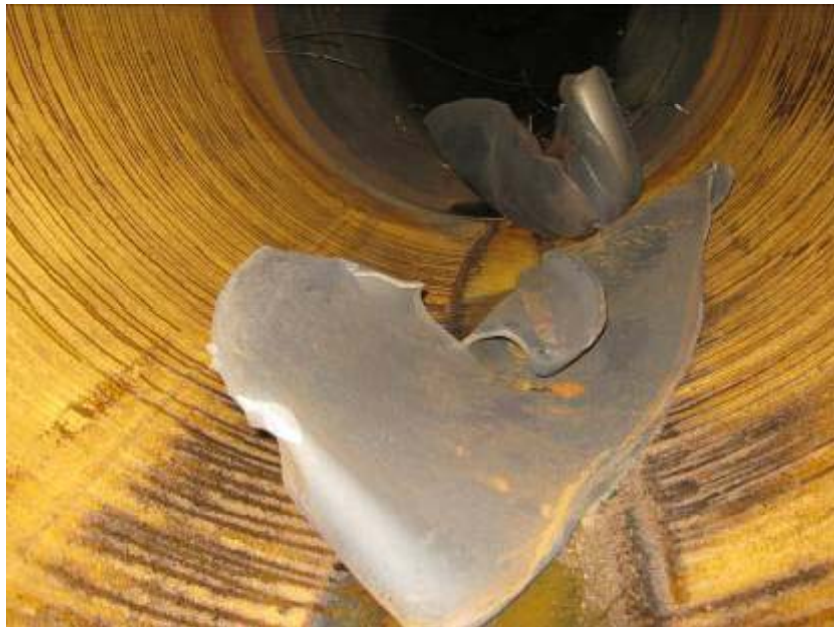
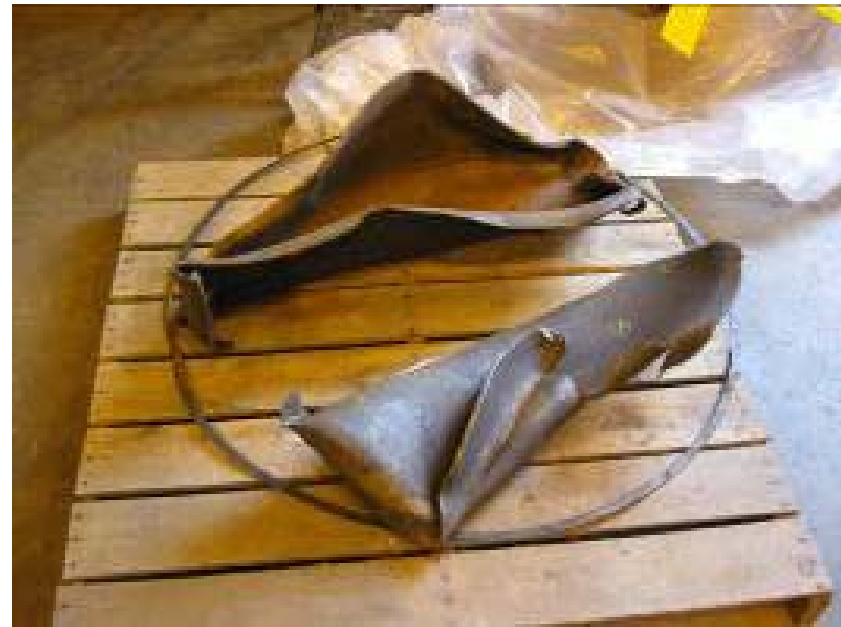
42" Slip Blind after failure. Blind was torn into two pieces, both of which were found near the flange where installed. Damage to plate from initial failure and impact with pipe and compressor inlet. Gasket outer ring also shown with pieces after removal from pipe.

- **Slip blinds are not rated to withstand the full pressure of the piping in which they are inserted.**

- **Slip blinds require adequate bleed.** Slip blinds are not intended to be used to isolate energy sources unless there are sufficient bleed points to prevent pressure from building. When introducing a pressure source to an area protected by a slip blind make sure the bleeds are sufficient. If local procedures do not provide the information needed to make an informed decision then check with Process Engineering.
- **Size Matters!** As piping and equipment size increases, the potential to generate large amounts of contained energy increases when any type of compressible gas/vapor is introduced. The bigger the line size the greater the hazard potential.
- **Verify the source.** When using temporary hoses, verify the source. This is especially true when normal utility drop stations are not available.

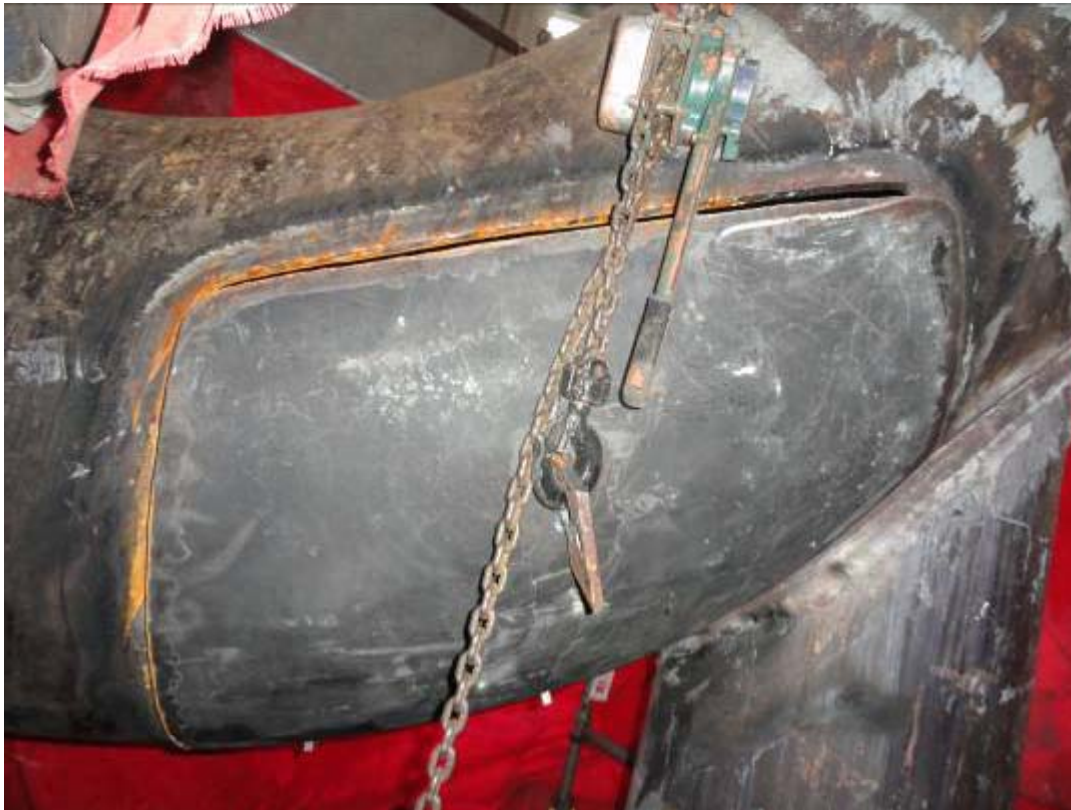
42" Elbow was dented/bulged from slip blind failure. Damaged area cut out and replaced.

- C-404
 - Thrust bearing damaged on inactive side (significant babbit damage).
 - Seals damaged & contaminated with pipe scale/grit from suction piping.
 - Compressor disassembled for complete overhaul
- Pipe
 - 42" Elbow immediately downstream from slip blind damaged (bulged from displacement or impact). Being repaired.
 - Pipe shifted in pipe rack and damaged guides/supports/insulation.
- Overall TA timeline extended by ~2 weeks.

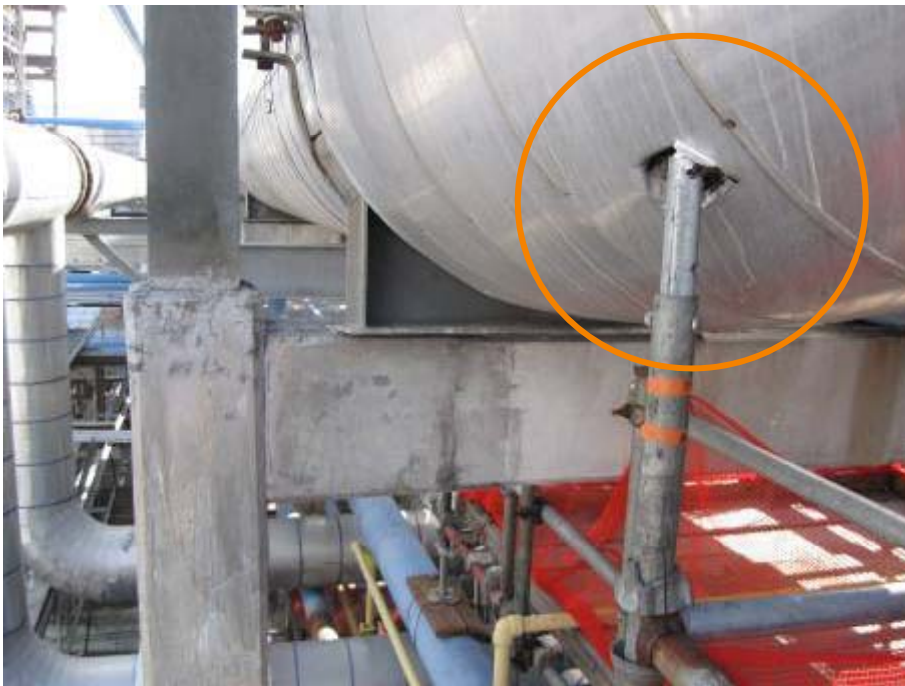
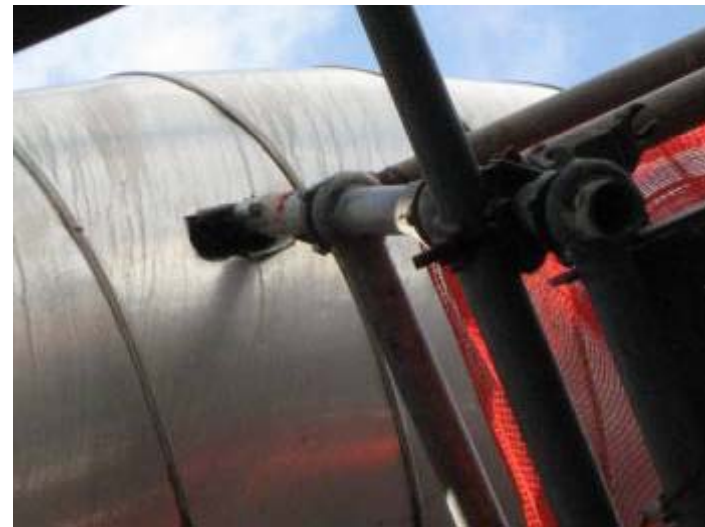
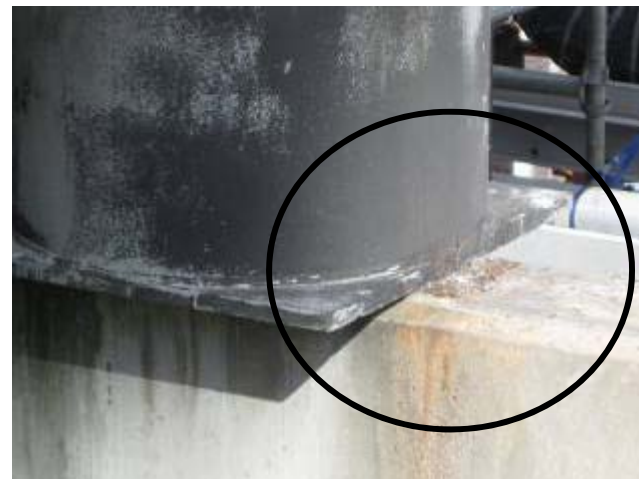
Pipe shifted in pipe rack, contacting scaffolds and puncturing jacketing. Support shoes also shifted.

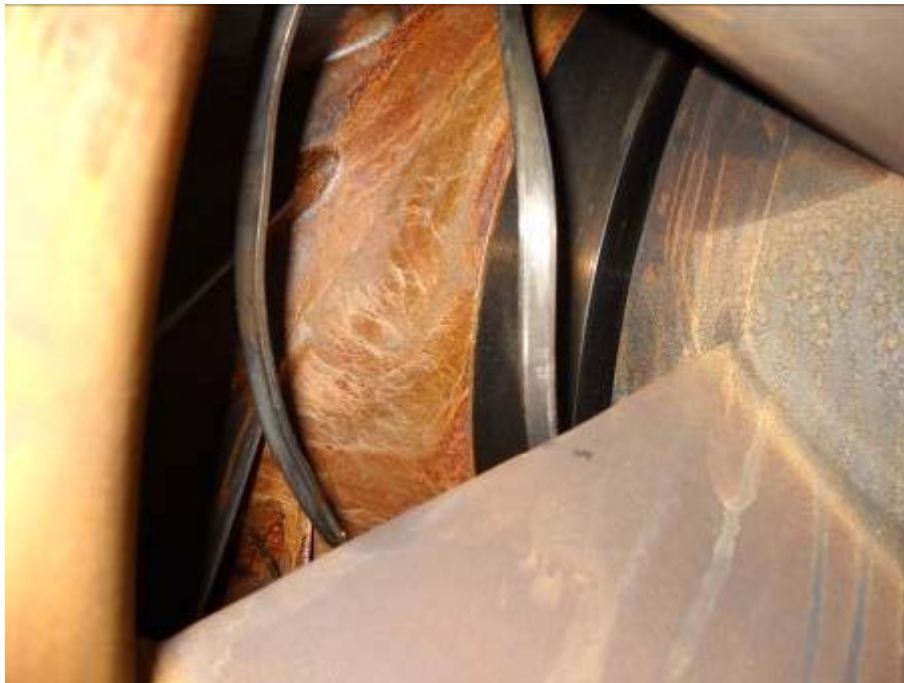
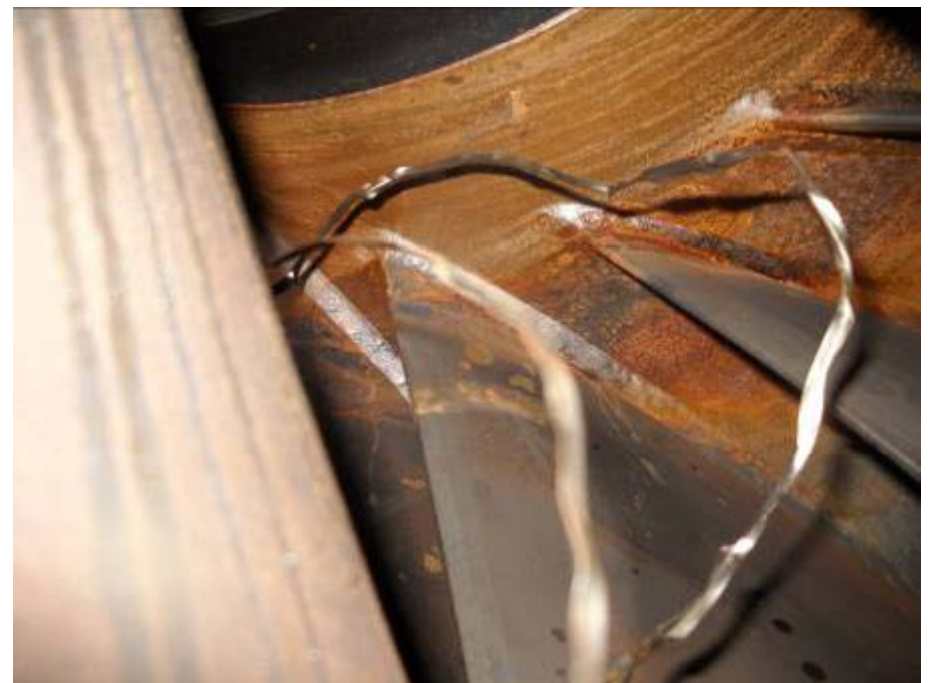
42" Gasket inner ring stuck in 1st stage impeller
