## Monday Safety Topic – Near Miss & ALERT

### Near Miss – Boom Chain on Powered Industrial Truck

## ***SAFETY ALERT***

**UNEXPECTED TELESCOPIC FORKLIFT DROPPED LOAD DUE TO CHAIN FAILURE: Highlights need to verify maintenance & inspections**

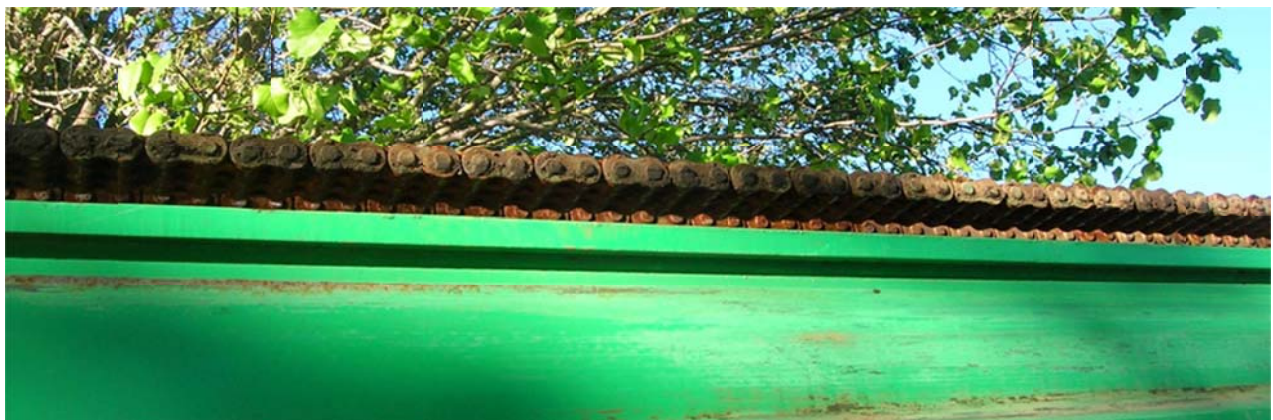
**View of Non-lubricated Chain from Ground**

On the following pages are photos of the dry chains discovered during our jobsite inspections as well as the NAVFAC Alert published by the US Navy. Please work with your subcontractors and take a moment to **inspect the Boom Chains on PIT's working on our projects**. If you determine the Boom Chain is not lubricated, **at any point along the chain or between the links**, have the user take it out of service and have that unit inspected immediately.. The Boom Chain is located along the top of the boom and can often be inspected from the ground. The NAVAC Alert provides a photo of what a lubricated chain should look like. It is an obvious condition for anyone to spot.

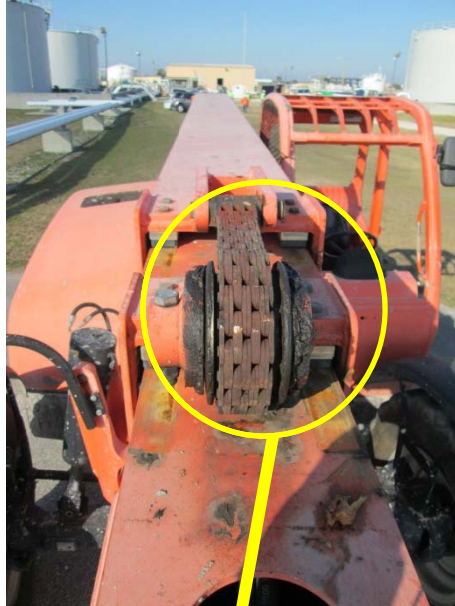
**LULL with Non-lubricated Chain**

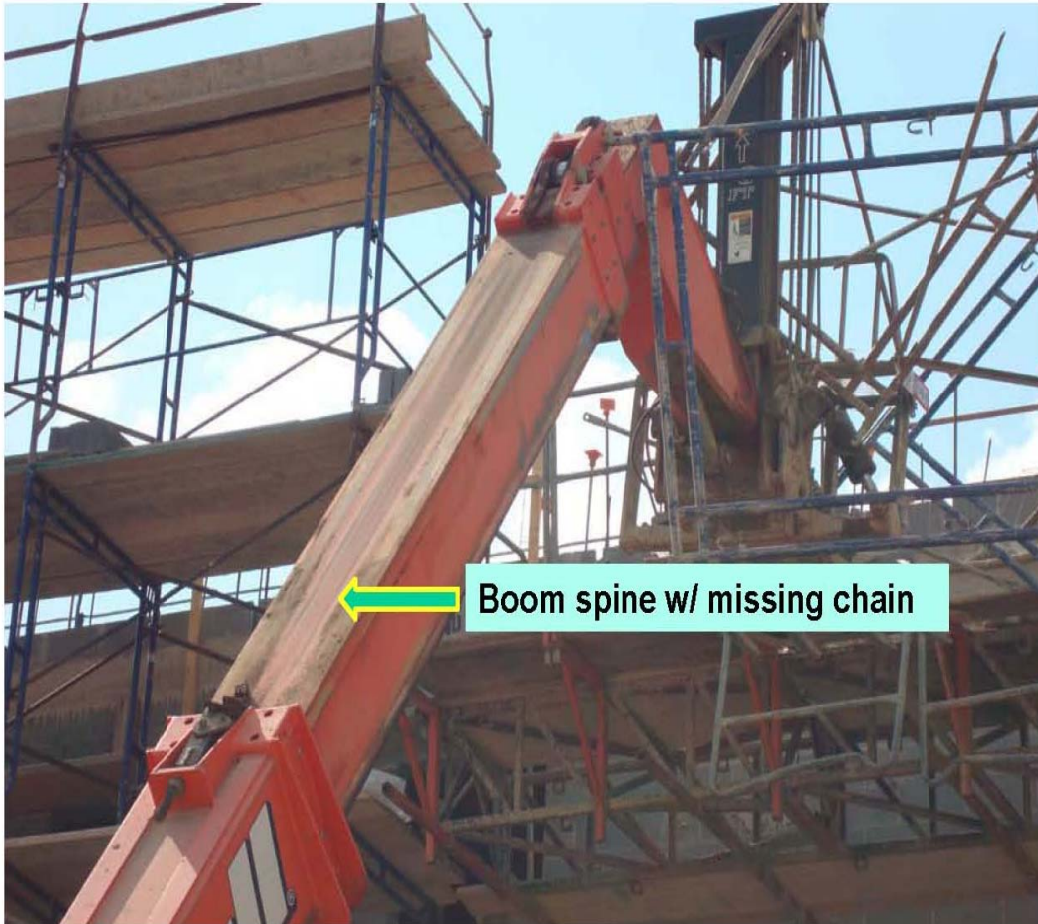
Photo shows missing chain on boom spine after a chain failure. Boom section is designed with a chain that travels the length of the boom.

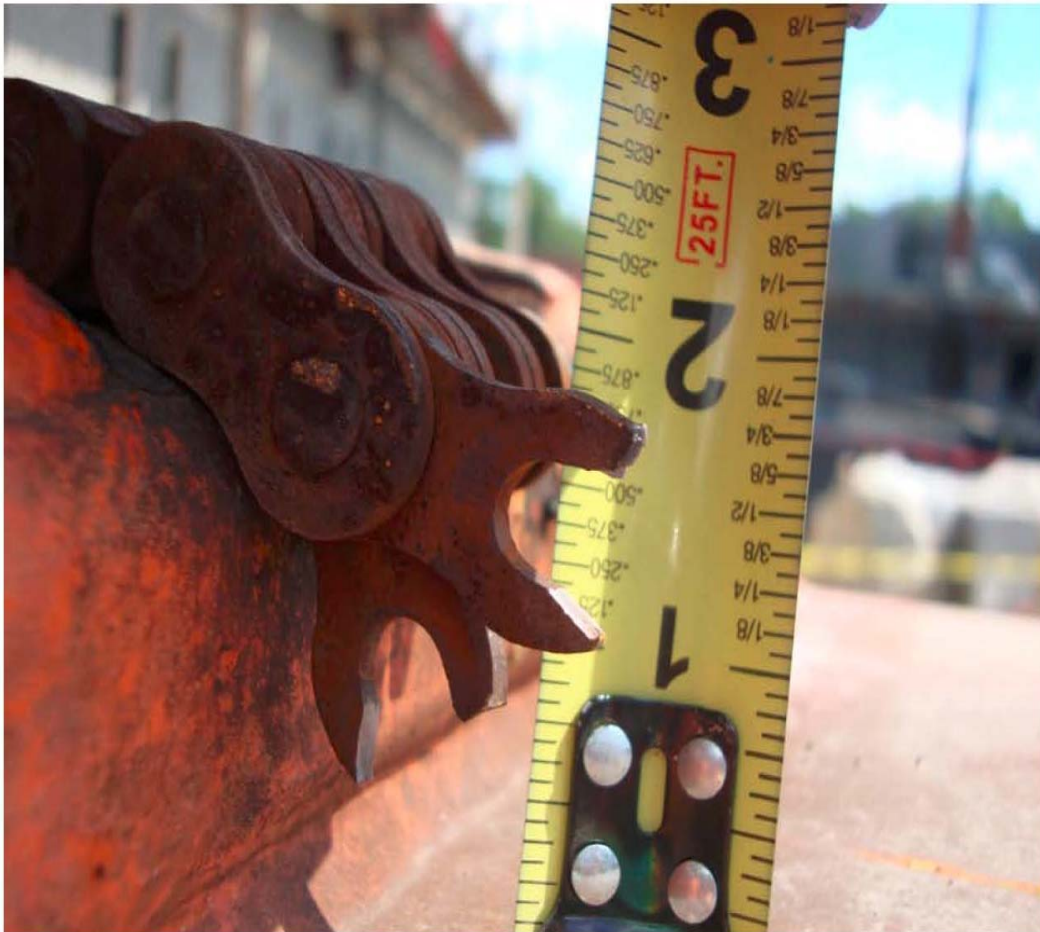
Photo shows broken chain sections occurring on two separate links

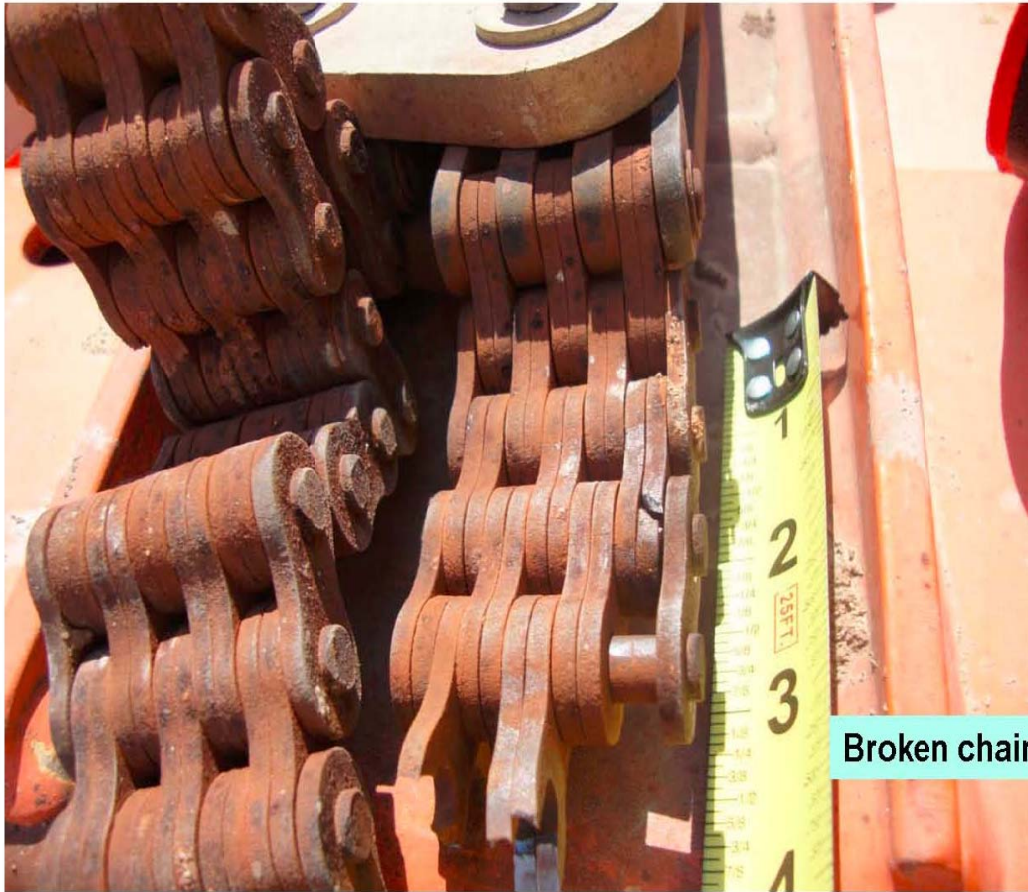
Broken chain links

Lack of lubrication increases likelihood of water intrusion leading to corrosion (rust). The additional stress can result in fractures and wear.

Several other fractures visible along chain beyond break points. Chain observed with rust and no lubricant.

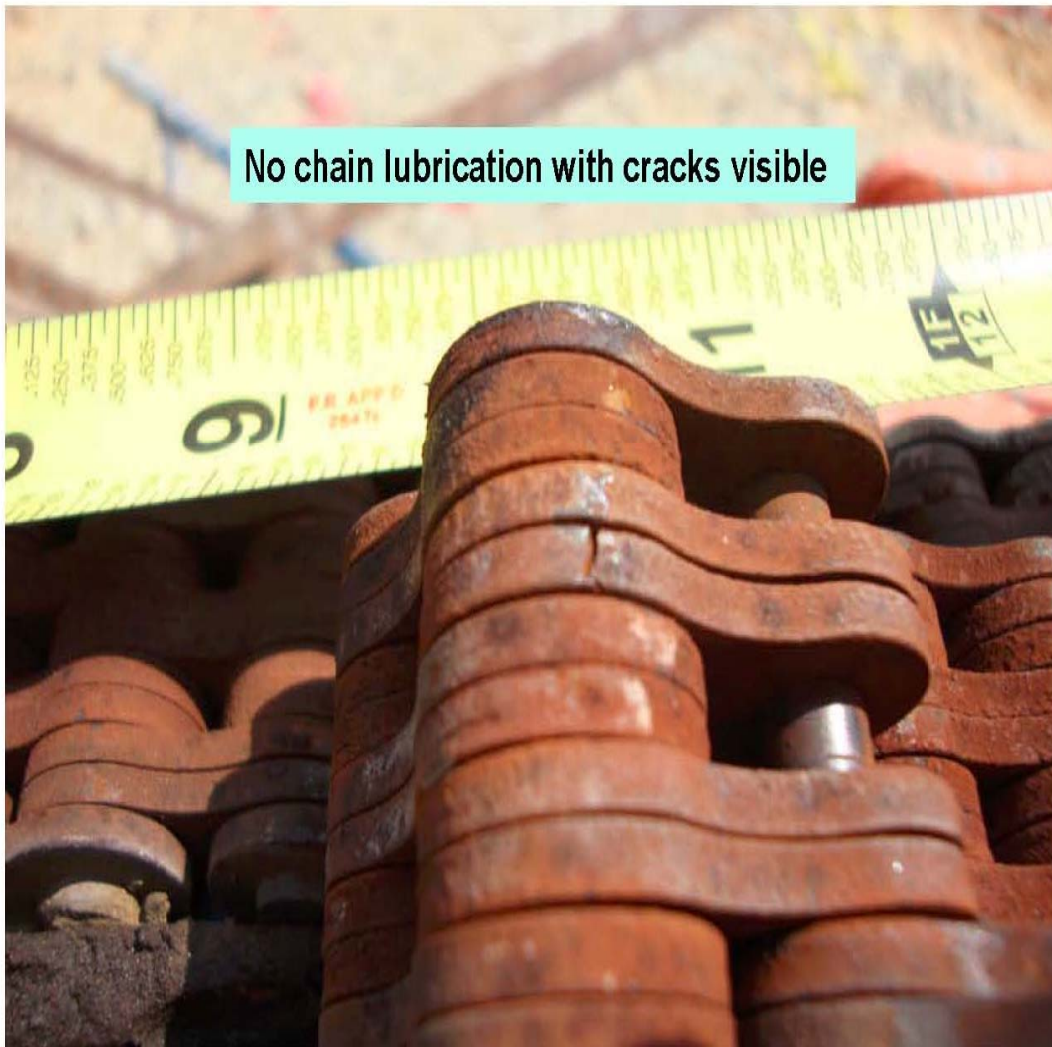
No chain lubrication with cracks visible

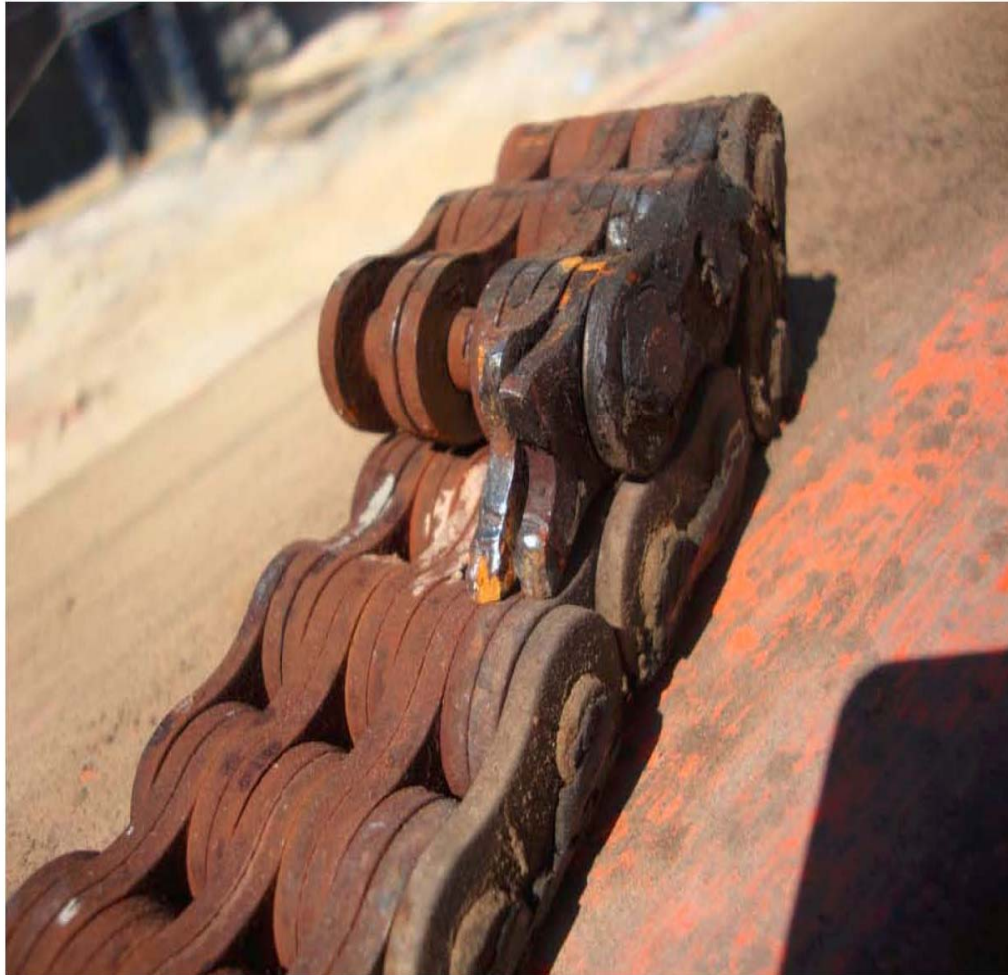
Photo of links where a break occurred. Notice that one link has a section with rust and one without and that one link shows previous in service wear at the breaking point

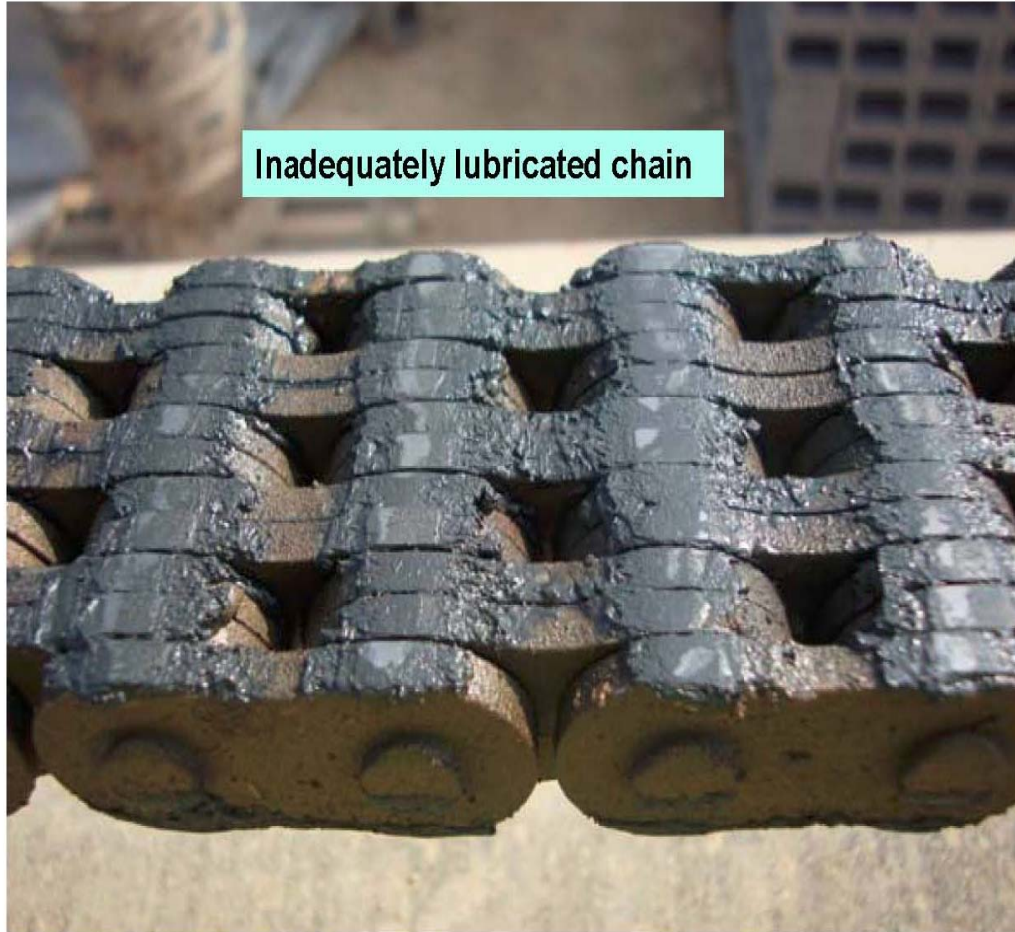
Deficiency: This photo demonstrates an example where some chain lubrication has been applied mostly on the surface, but not enough to penetrate movement contact points.

Inadequately lubricated chain
