## **Lessons Learned Form**

### **Industrial/Process Holcim Project Missouri**

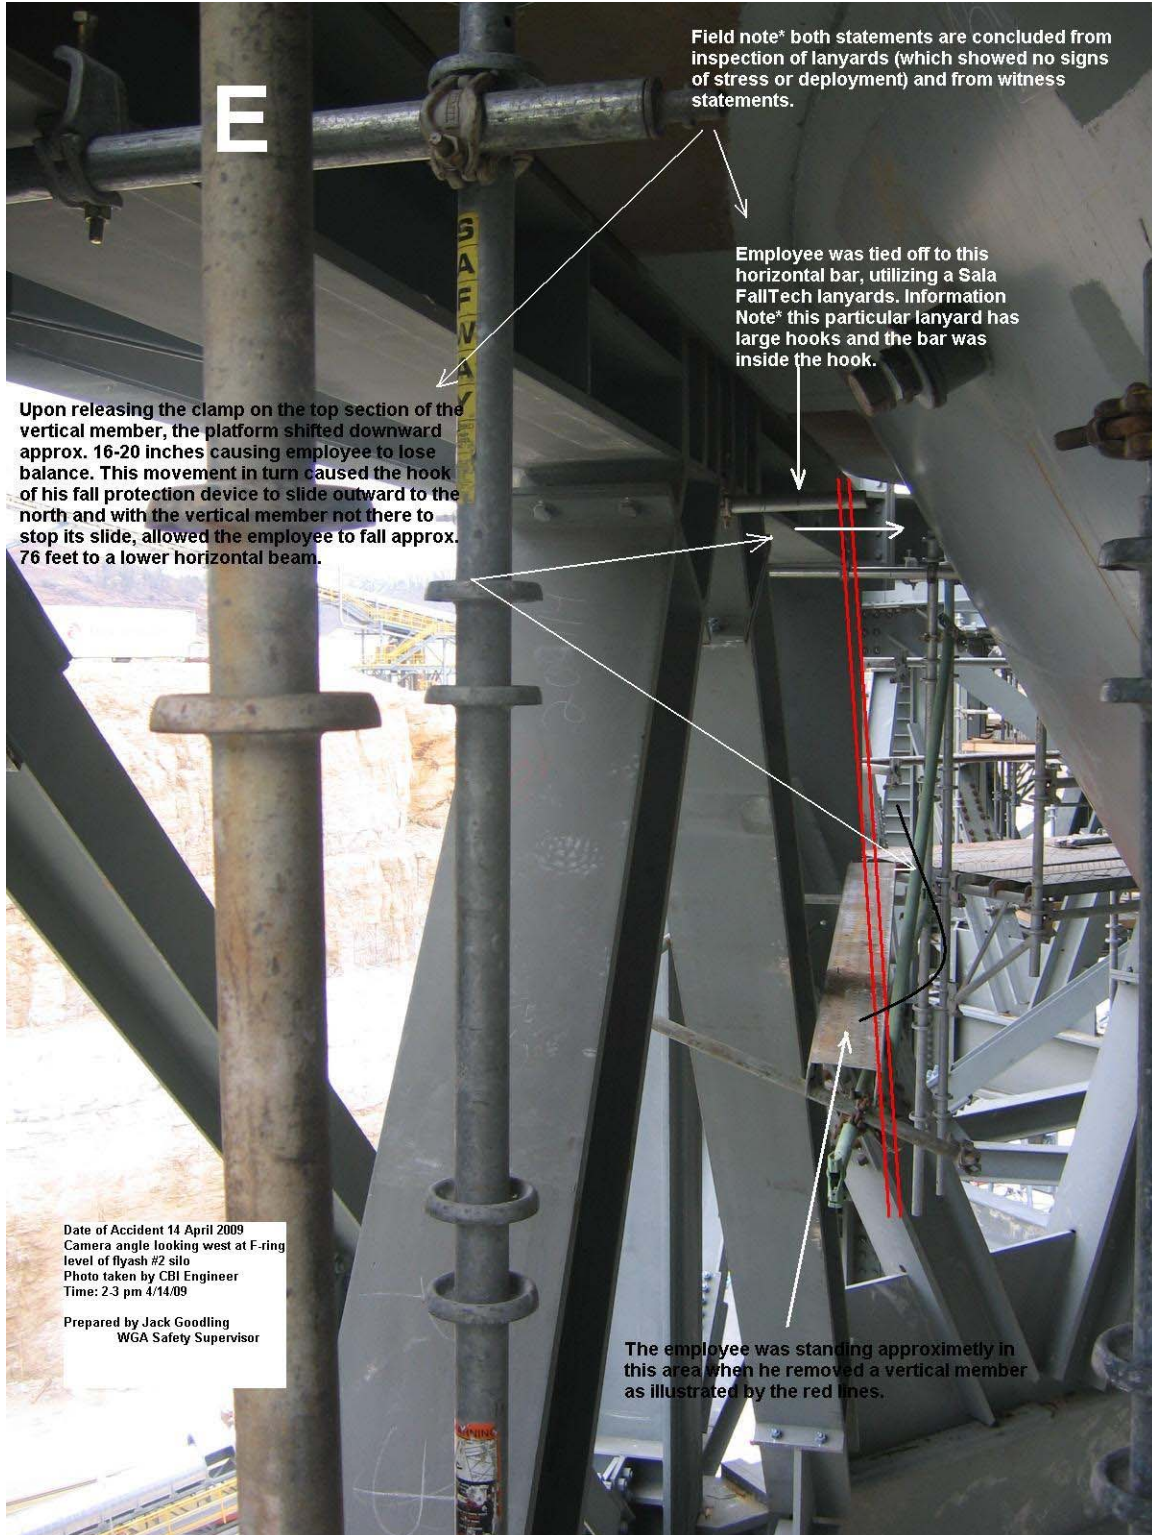
Field note\* both statements are concluded from inspection of lanyards (which showed no signs of stress or deployment) and from witness statements.

Employee was tied off to this horizontal bar, utilizing a Sala FallTech lanyards. Information Note\* this particular lanyard has large hooks and the bar was inside the hook.

Upon releasing the clamp on the top section of the vertical member, the platform shifted downward approx. 16-20 inches causing employee to lose balance. This movement in turn caused the hook of his fall protection device to slide outward to the north and with the vertical member not there to stop its slide, allowed the employee to fall approx. 76 feet to a lower horizontal beam.

Date of Accident 14 April 2009  
Camera angle looking west at F-ring level of flyash #2 silo  
Photo taken by CBI Engineer  
Time: 2:3 pm 4/14/09

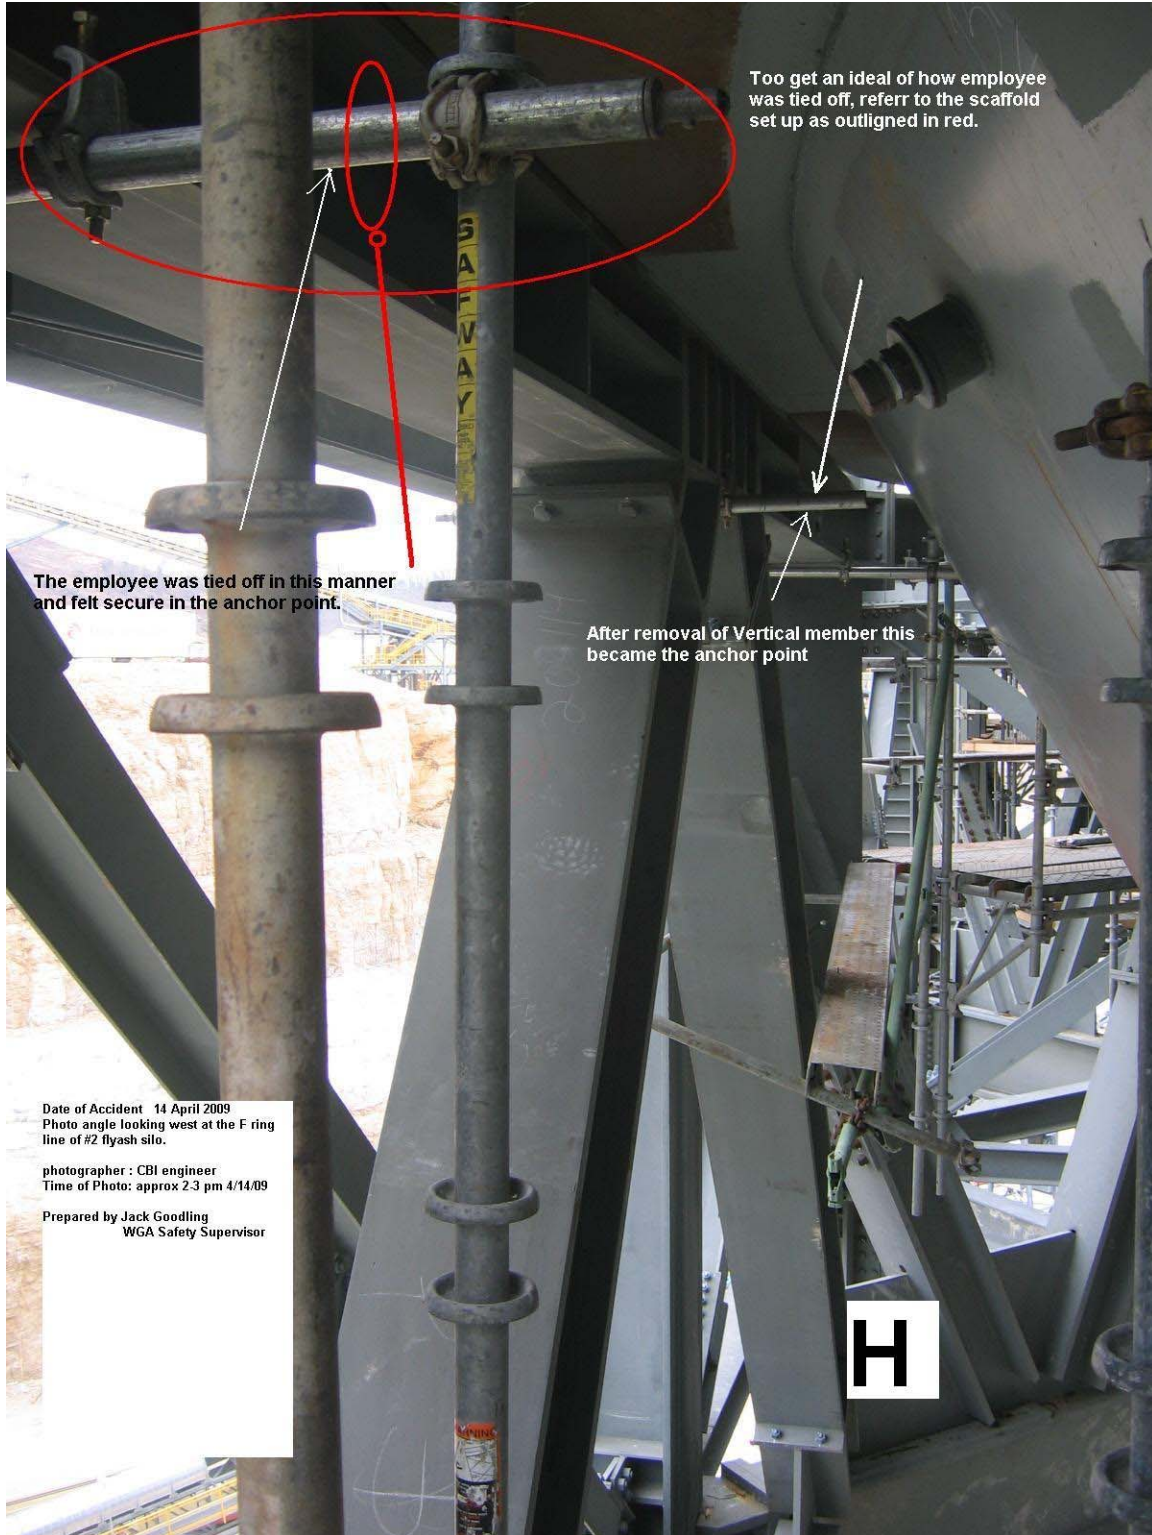
The employee was standing approximately in this area when he removed a vertical member as illustrated by the red lines.

To get an idea of how employee was tied off, refer to the scaffold set up as outlined in red.

The employee was tied off in this manner and felt secure in the anchor point.

After removal of Vertical member this became the anchor point

Date of Accident 14 April 2009  
Photo angle looking west at the F ring line of #2 flyash silo.
