Turkmenistan Crane Collapse

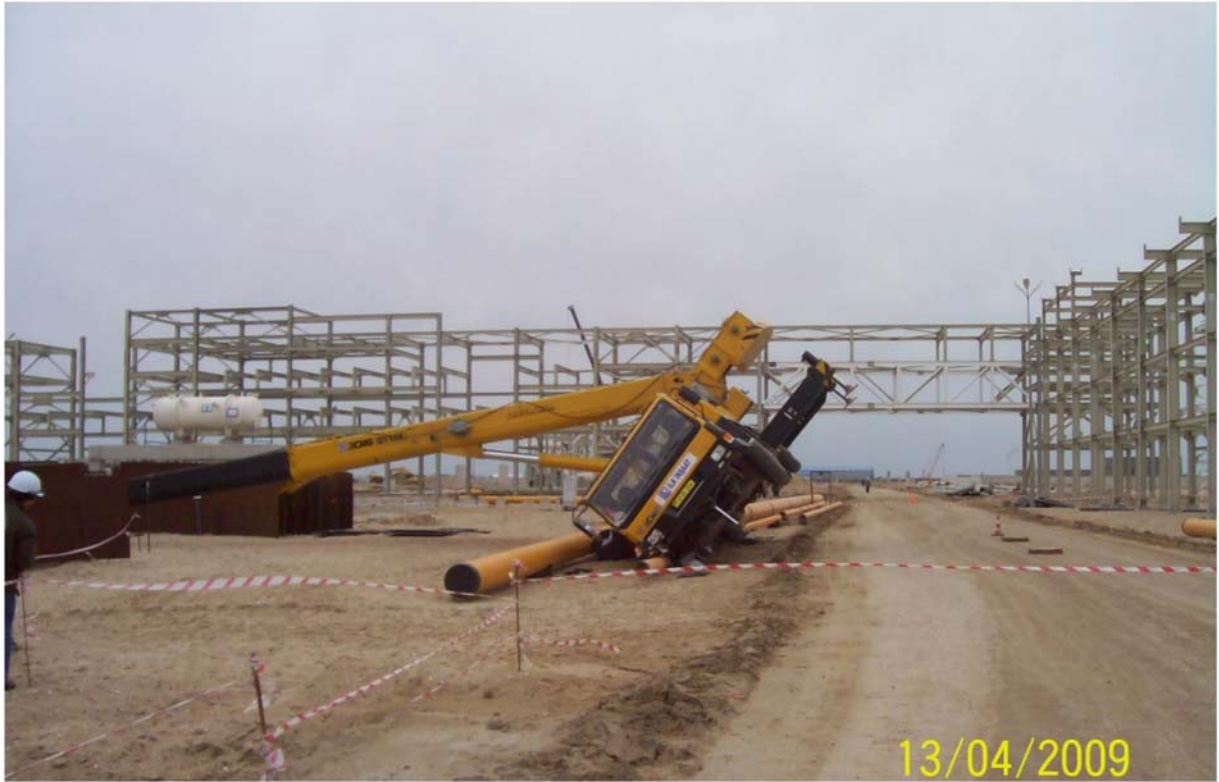
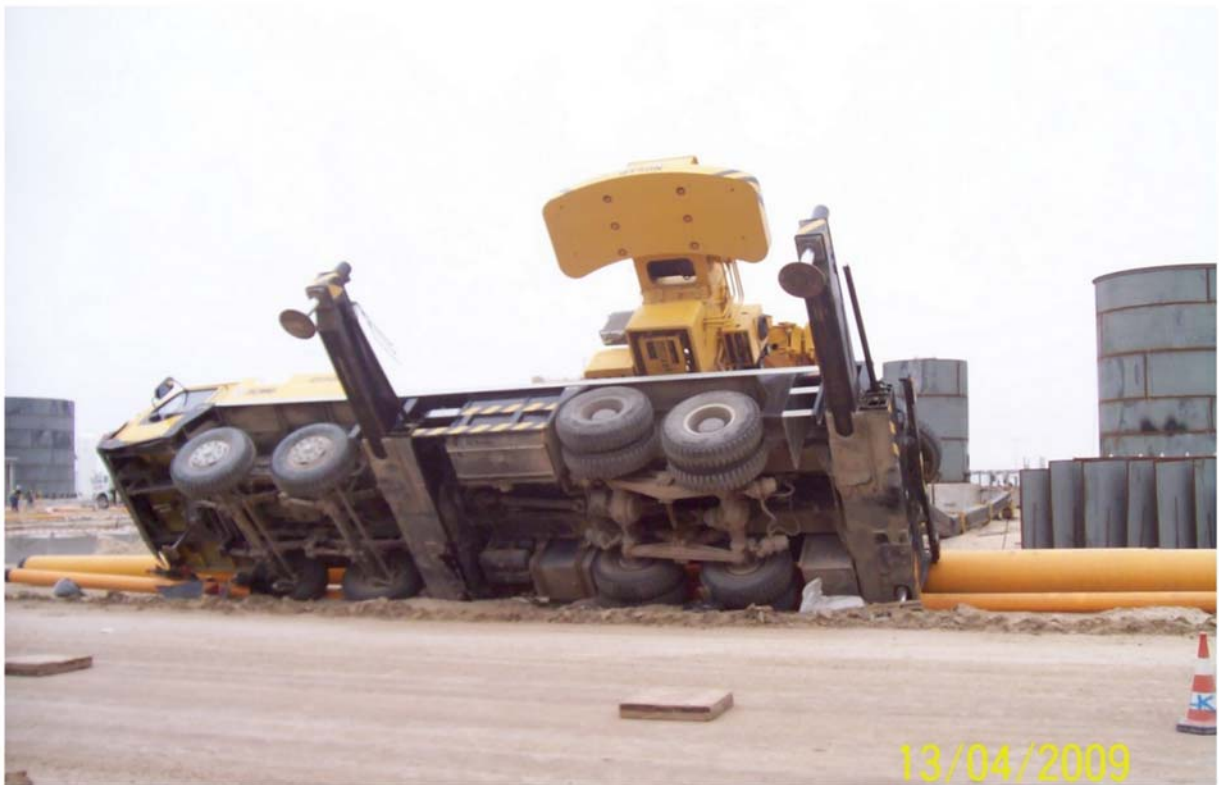
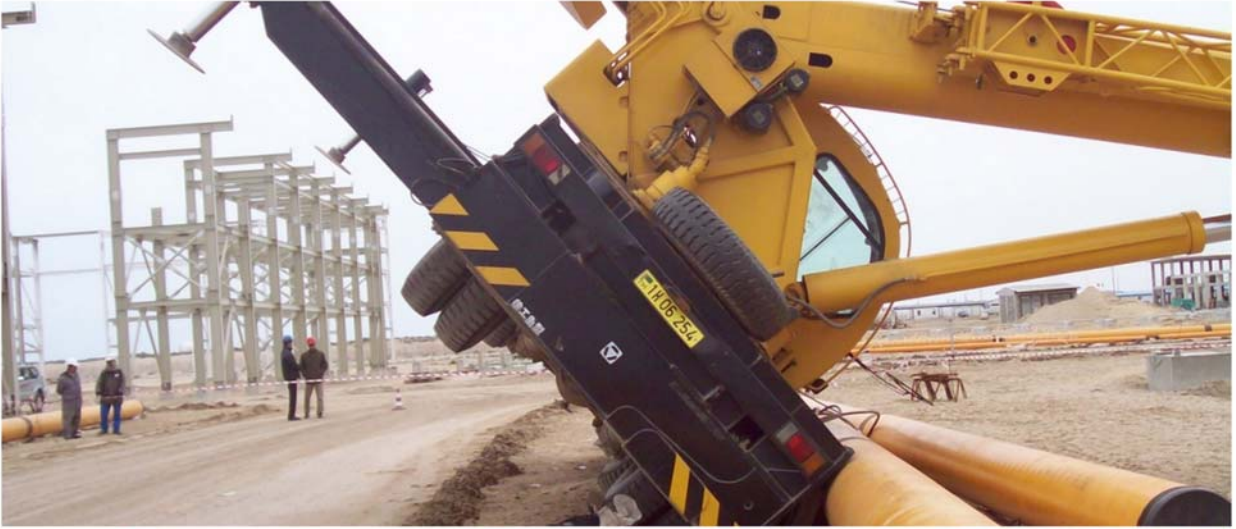
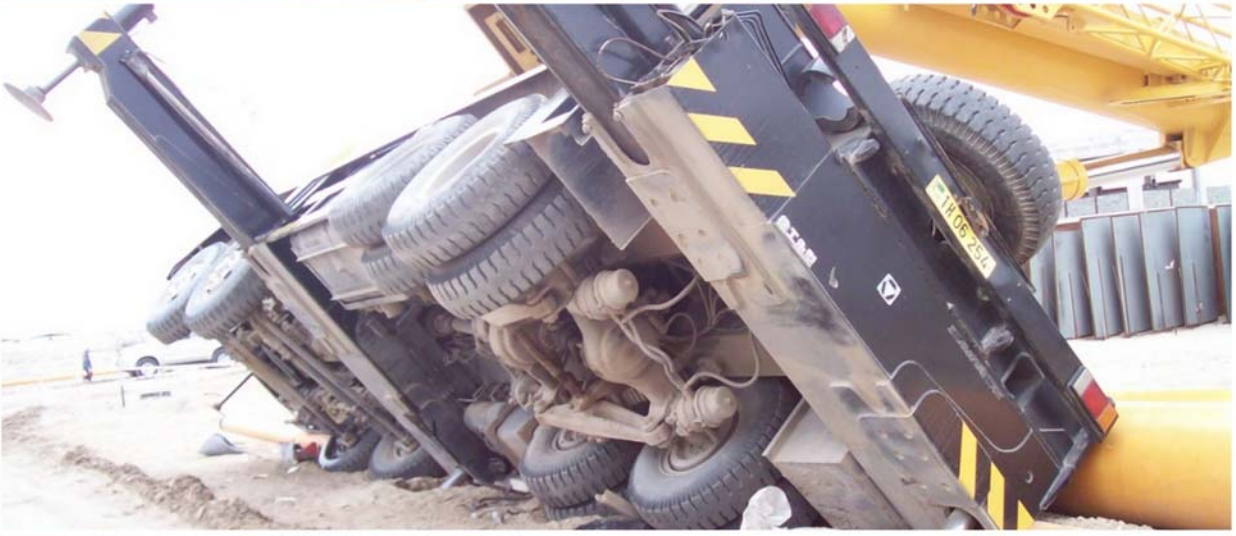
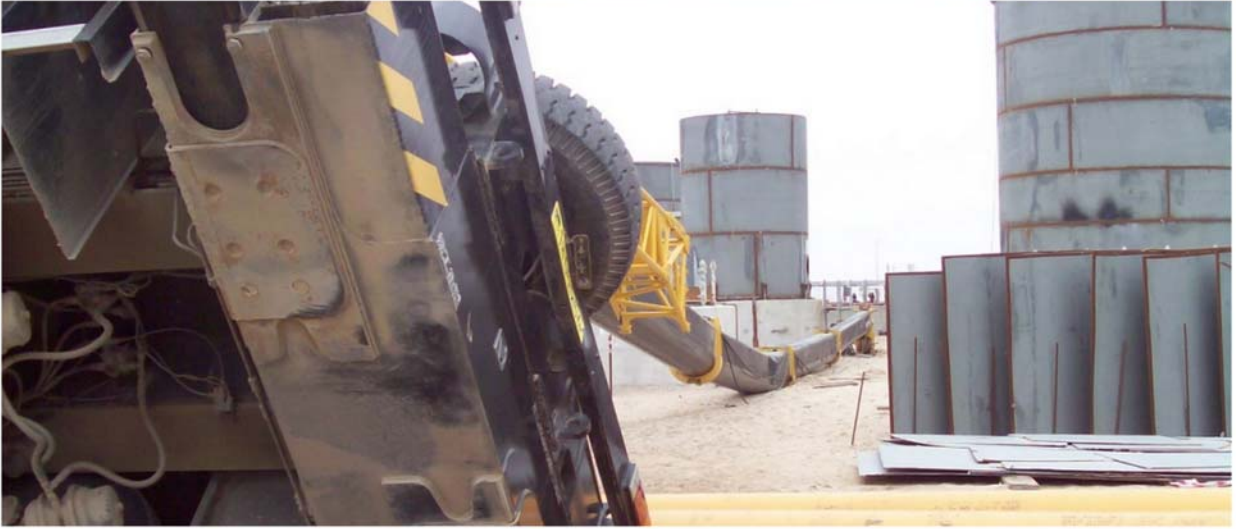
Looking closely at pictures, pads appear to be too small, therefore, poor pre-lift risk assessment performed.

The attached photo is crane accident that was happened in TURKMENISTAN on April 13, 2009. In the report, it mentioned that the outrigger were full extended and the stability of the crane be affected by soft ground. But as seen from picture, I do not think so. The right side of outrigger was not full extended yet (may cause of collapsing) and the boom was full extended (may cause of overloading and collapsing).

From the incident report, "At about 1530 hours, a 50 ton crane toppled while lifting a bearing plate at this location. The crane was lifting a load from the storage area to designated installation area. The outrigger was fully extended and the condition of the crane was found satisfactory. The stability of the crane was affected by the soft ground. No injury was found to the crane operator and other personnel during this activity."
