**Contract Employee Fatality at Tank A-146**

Location: <b>Wood River Refinery</b>	Date of Issue: <b>July 11, 2011</b>
Contact: <b>Cully Farhar</b>	Risk Rank: <b>IV</b>
Type of Incident: <b>Fatality (Recordability Undetermined – Awaiting Further Information)</b>

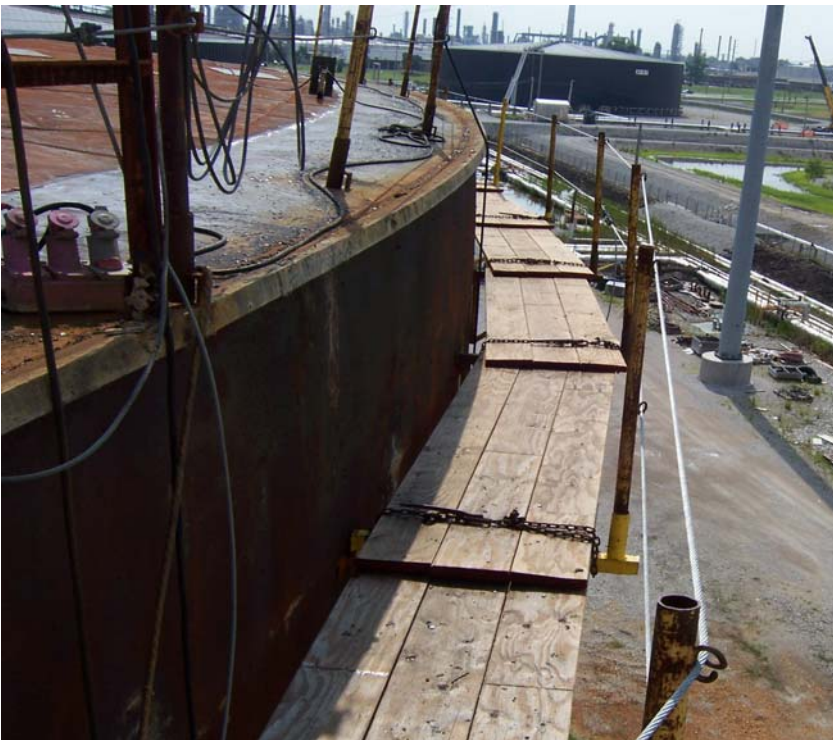
**Photos:**

On Tuesday, July 5<sup>th</sup> a contract boilermaker was involved in a fatal accident while working on an asphalt tank (Tank A-146) at the Wood River Refinery. The asphalt tank was out-of-service and clean for repairs and inspection. The work was being performed from a welded bracket-type “tank-builders” scaffold (see picture). The contract employee was welding steel plate at the roof seam of the tank. Early indications, based on an eye witness account are that after working for less than an hour, the contractor called out and was moving toward a co-worker when he dropped to the scaffold deck and was observed to be unresponsive as he rolled off the scaffold. The scaffold was built per documented procedures and “green tagged” by the contractor. Neither the facility’s procedures, the contractor’s procedures nor OSHA provisions have a requirement to use fall protection while working from the scaffold because top and mid cable rails were provided.

- Whether a physical ailment or symptoms contributed to the incident is currently unconfirmed and will be better understood pending a Coroner’s report.
- The scaffolding meets OSHA regulatory requirements.

In an abundance of caution and until such time as internal ConocoPhillips and OSHA investigations are complete and until any pertinent refining standards are reviewed and/or revised, the Wood River Refinery will require 100% tie off while working on tank-builders scaffolds, including the one present at Tank A-146. The Refinery is also requiring supervisory JSA reviews before beginning any new work at elevation.
