BR MECHANICAL DIVISION SAFETY ALERT

Location: BRCP/Mechanical/Polymers Unit Maintenance/GFLA-5 Cooling Tower

Classification: Contractor Recordable Lost-Time Injury

April 23rd, 2010

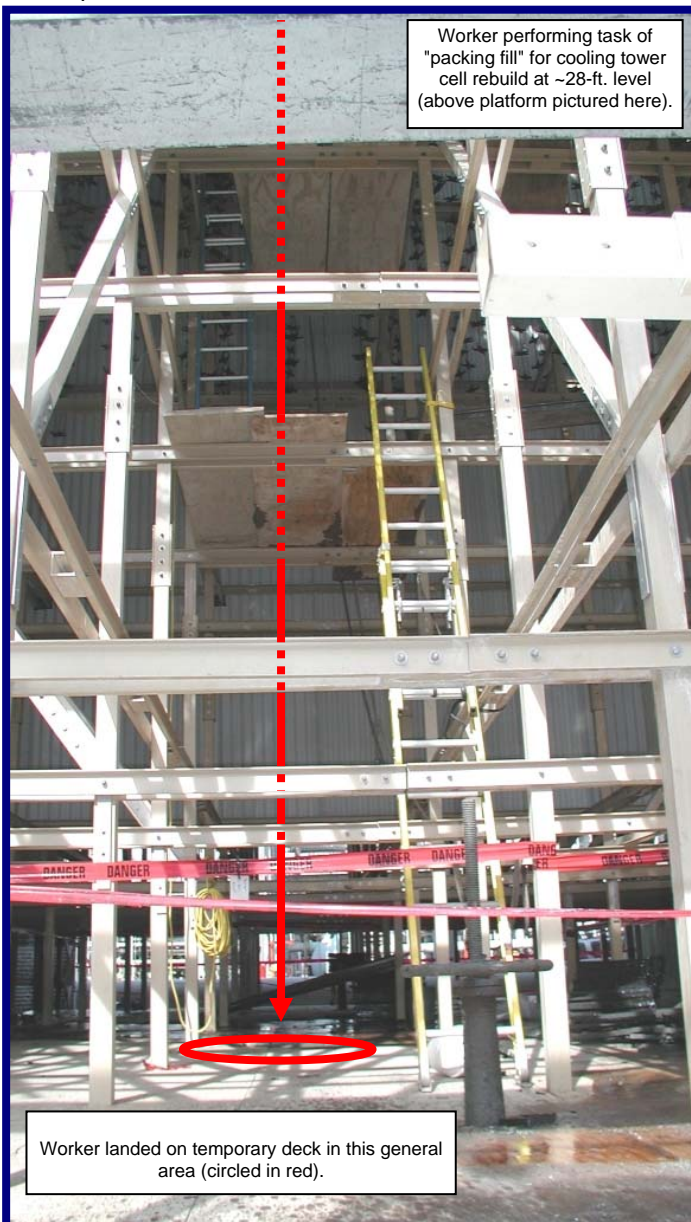
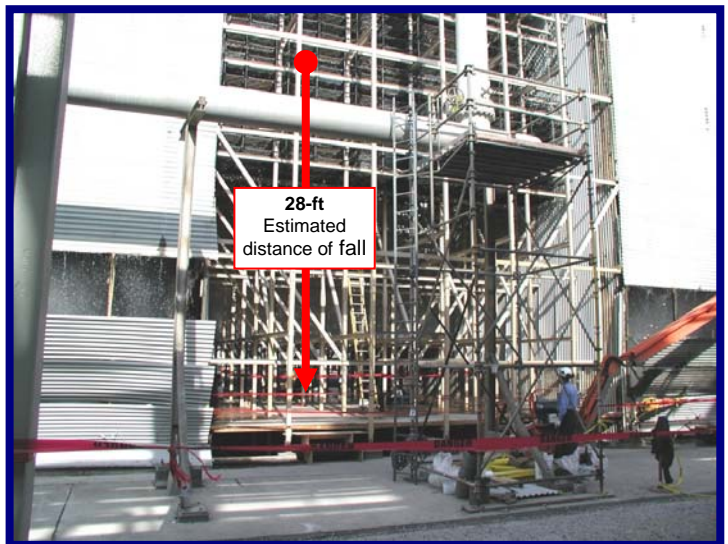
Description: On 4/12/10, at 5:40 PM, a cooling tower maintenance contractor experienced a fall of approximately 28-feet inside cell #3 of the GFLA-5 cooling tower. The worker sustained serious but non-life threatening injuries and is expected to make a full recovery. The incident is currently under investigation to understand the details of the event, determine the exact cause and prevent recurrence. More information will be shared once the investigation is complete.

- Safety Standard 439 calls for mandatory 100% tie-off in situations where fall protection is required. This means, while working in situations where a fall harness/SRL is required, there should never be a point where an individual is not tied off -- even for a second.

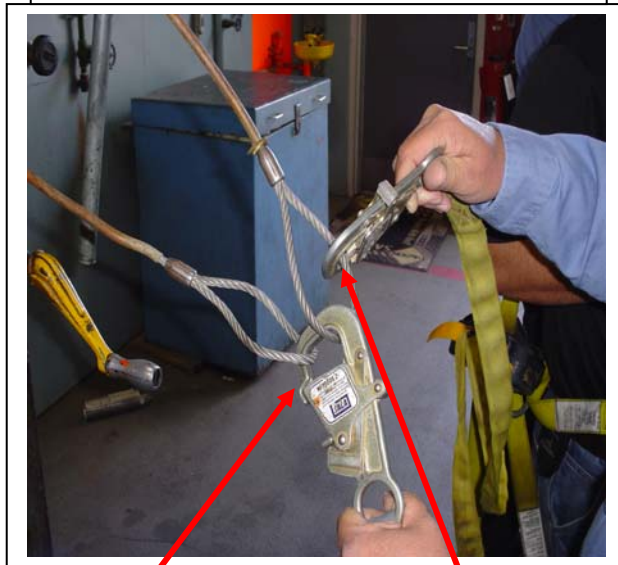
Improper Tie-off, potential hazard

- While working at elevation in the cooling tower, the injured technician was tied off utilizing his fall harness and self retracting lanyard (SRL), with the snap hooks attached to a cable extension sling placed around a cooling tower component beam.
- One snap-hook (lower in photo, below left) from his SRL was engaged through both eyelets of the cable extension to provide his fall arrest anchorage.
- The second snap-hook (higher in photo, below left) was engaged on a single eyelet of the extension to aid in keeping the loop of the lanyard from interfering with material handling while performing his work task.
- As the technician moved to communicate with a co-worker, he errantly disengaged the snap-hook that was attached to both eyelets, eliminating his fall anchorage.
- During his movement he stepped on an unsecured material storage platform.

- Connection through both eyelets = 100% fall protection
- This snap-hook was errantly disengaged, negating fall anchorage

Snap-hook and lanyard improperly stowed to eyelet, presenting opportunity for error and disengagement from fall anchorage

- When utilizing a fall extension device such as the wire rope pictured, do not attach both snap hooks. This can lead to accidental disengagement from a fall anchorage point as described above.
- If presented with similar circumstances and you are unsure as how to proceed, notify your Supervisor and/or Safety Facilitator immediately.

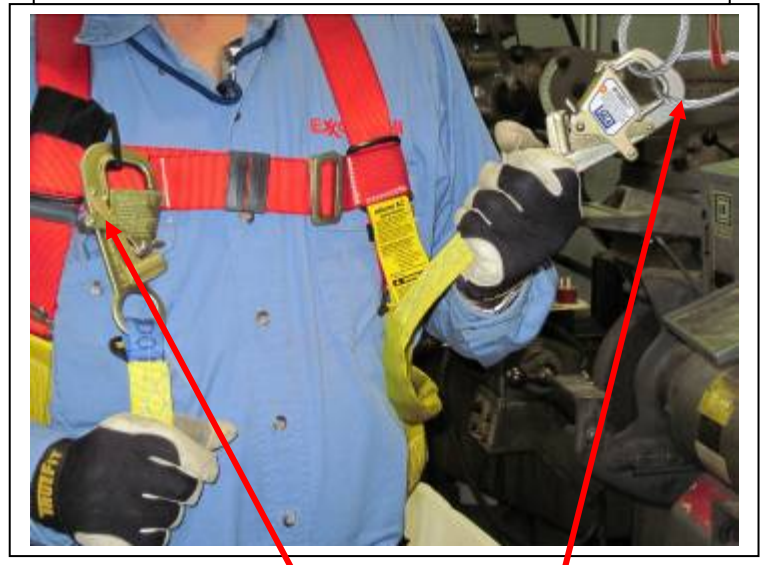
Proper Tie-off, hazard mitigated

Snap-hook and lanyard properly stowed to harness or stowed to independent anchor point.

Snap-hook properly engaged through both eyelets of cable extension provides fall-arrest anchorage.
