Major Projects Safety Incident Alert

Incident Type	Medical Aid	Incident Date	March 8, 2011
Project	Line 6B Replacement	Location	Michigan, USA
Distribution	Internal (US / CAN)	Safety Alert Number	MPSIA 00030-2011

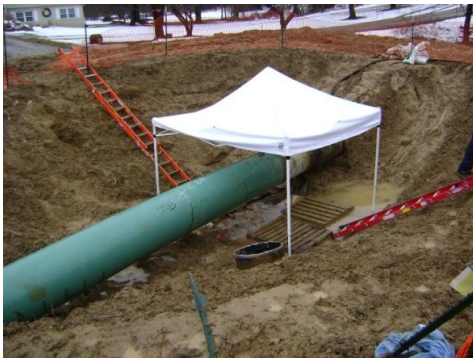
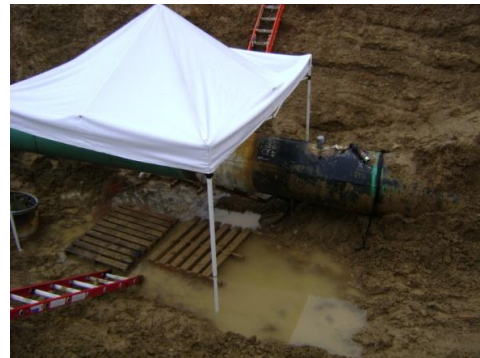
The Straw Boss continued monitoring air quality in the pipe. Low-oxygen readings persisted. However, the Straw Boss proceeded to enter the pipe to prepare to install the mud-plug. A short time later the Laborer saw the Straw Boss become limp and unresponsive and attempted to remove him from the pipe. The Laborer also became dizzy. A nearby Welder and a Pipe Services Representative saw what was happening and entered the site to assist. The Foreman and Inspector had now returned to the site. The Inspector called 911 while the Foreman and Laborer administered CPR. The Straw Boss and Laborer were transported to a medical facility for observation. Both were later released from the medical facility and returned to work with no restriction.

- Worker did not understand the risk associated with low oxygen atmospheres.
- In an attempt to save time, the Straw Boss disregarded confined space entry procedures and verbal instructions given by the Foreman and entered the pipe.

- Review Work Practice associated with installation of mud-plugs in oxygen-deficient atmospheres.
- Ensure Confined Space Entry ("CSE") training and gas detection equipment is provided for inspection staff issuing permits for CSE work.
- Install a physical barrier to prevent access to confined spaces until the atmosphere is proven tenable by entry supervisor. The physical barrier should not be removed until a Permit is issued.
