Green Alert / Incident Summary

{New Metabo Near Miss}

Date of Incident: 5/02/2011

Incident Location: Duck Creek Power Station

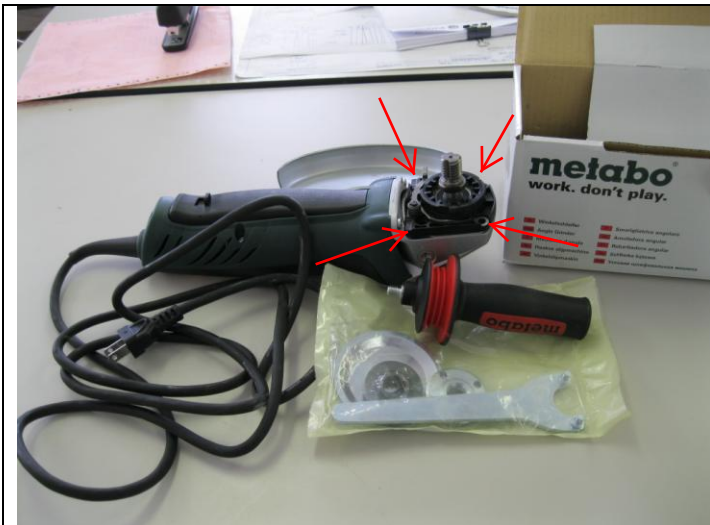
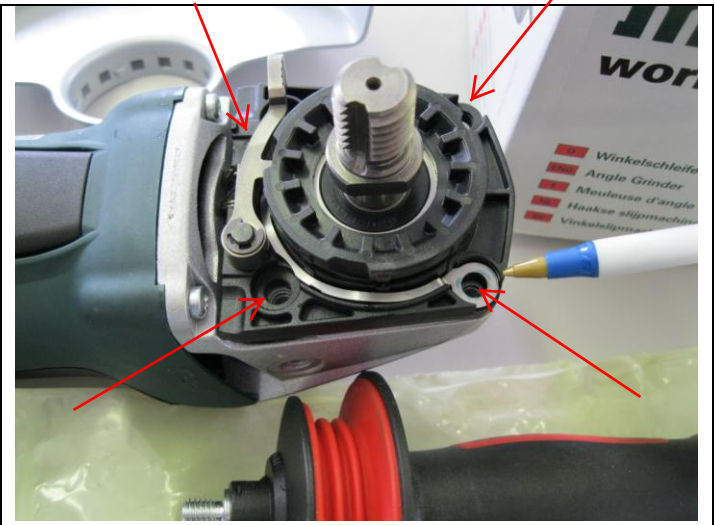
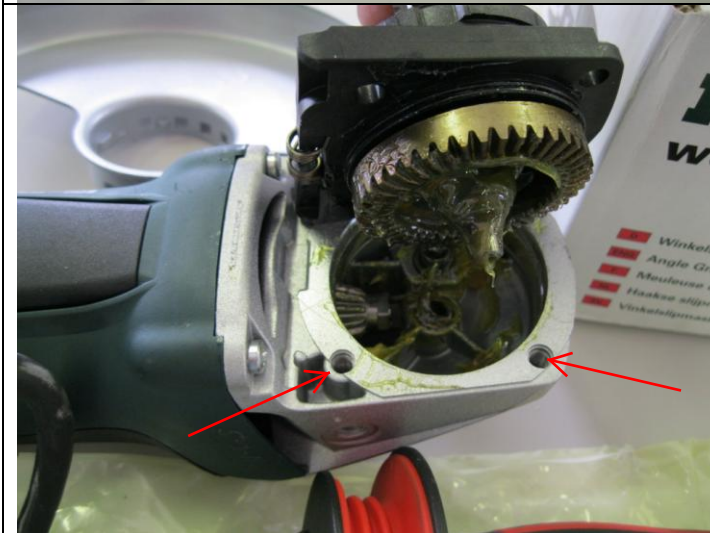
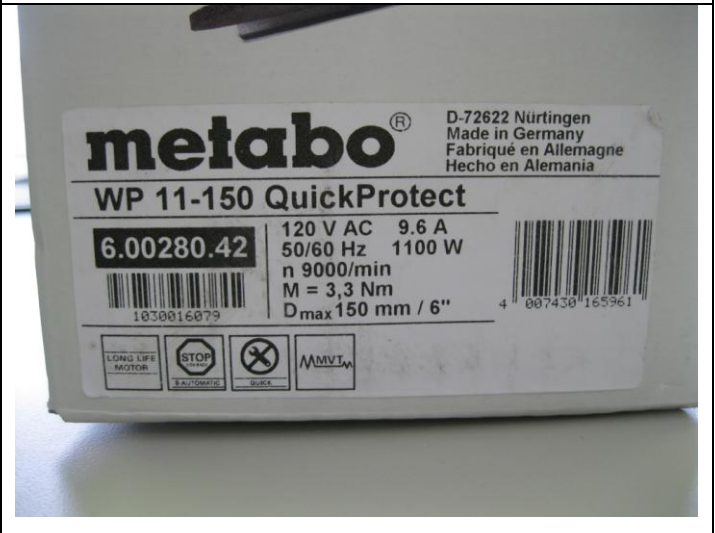
The Incident: When a contractor superintendent was in the process of setting up a new Metabo angle grinder for his employees to use, the grinder head came apart as he was installing the guard due to the four bolts that were missing from factory. Please see pictures on second page.

1. New Metabo out of the box was missing four bolts that were to secure the grinder head.

1. Reemphasize to our employees and contractors to always inspect equipment/tools prior to use even if new.
2. Employees should not rely on equipment to be ready for use upon receipt. Always inspect equipment for missing parts and hardware prior to assembly and use.
