All Foremen and leads;

David "Tony Lewis, Wyatt Safety

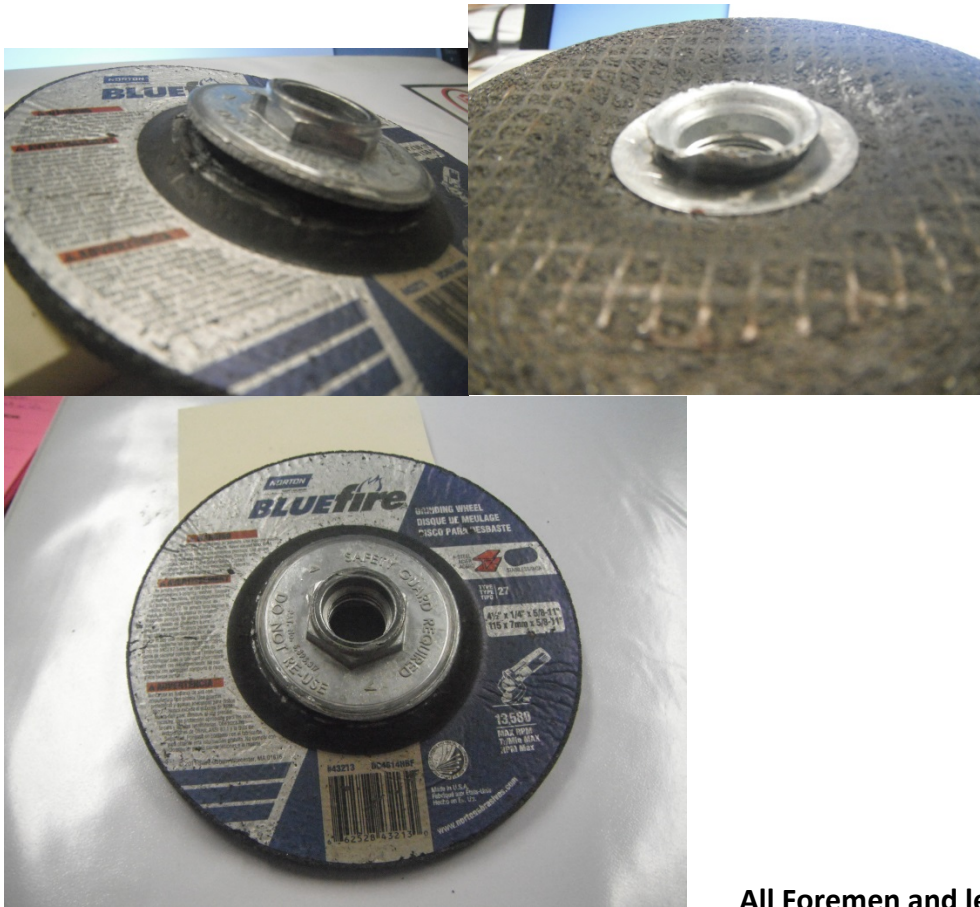
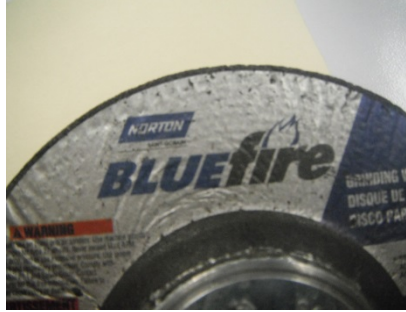
Have your crews inspect all 4" grinding disks before use, the disk in question is the (Norton) Bluefire.4' grinding disk. During night shift, a pipe welder discovered this during operation. As the images show, the center ring (depressed) came apart while grinding. This had the potential of the abrasive portion breaking up and projecting fragments and injuring the worker and others in proximity. An immediate inspection and test (Mfg suggested) was conducted on all in stock disks and none were found to be defective. Your attention and vigilance is expected and most appreciated.
