Rigging Structural Members

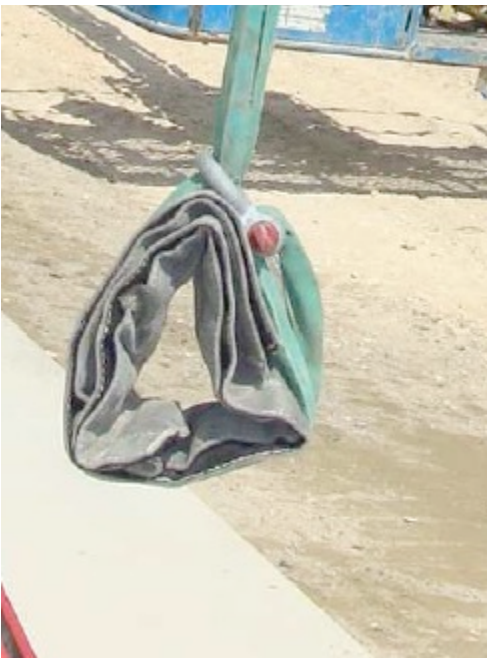
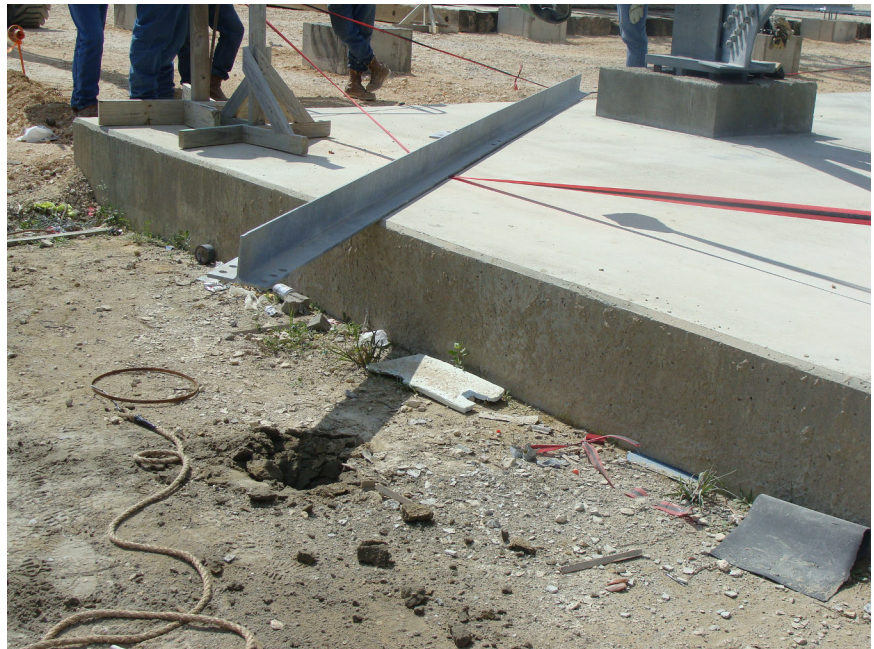
Ironworkers were in the process of connecting a 22 foot, 6 inch diagonal support brace. As the crew got into position, they noticed the beam would have to be repositioned to complete the task. The decision was made to send the beam back down to grade to be re-rigged. As the beam was descending, the load shifted slightly, resulting in the softener around the beam contacting a fixed horizontal beam. As a result of the contact, the softener and rigging lost tension from the beam, allowing the beam to slide out of the rigging and subsequently fall 50 feet to grade level.

- Ensure the material being rigged is secure within the rigging prior to lifting.
- Ensure softeners are not too big or bulky around the material, reducing the hold of the rigging.
- Use positive methods of securing rigging around, or to material whenever possible.
- Double wrap and/or otherwise rig the material to prevent sliding.
