## FIRE AND EXPLOSION AT EDCO

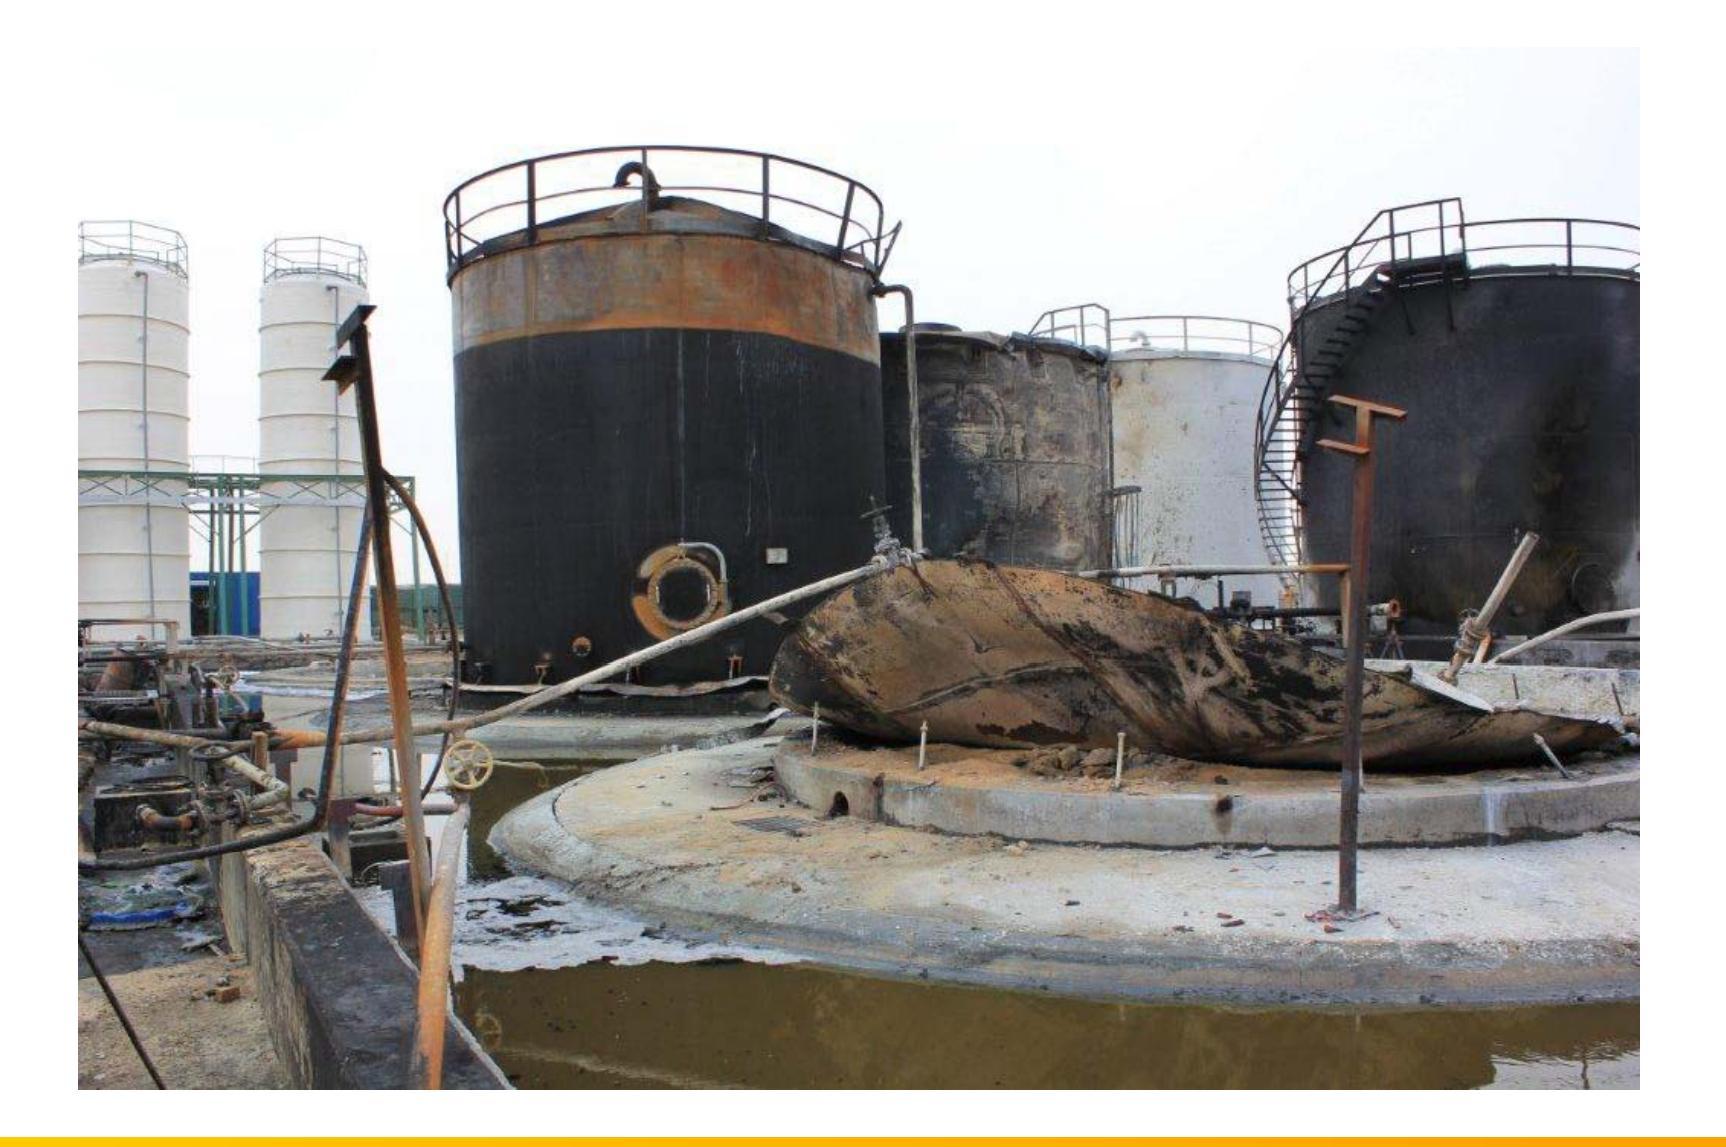
Base of the tank, which was an explosion where he flew a distance of about 100 meters from this site

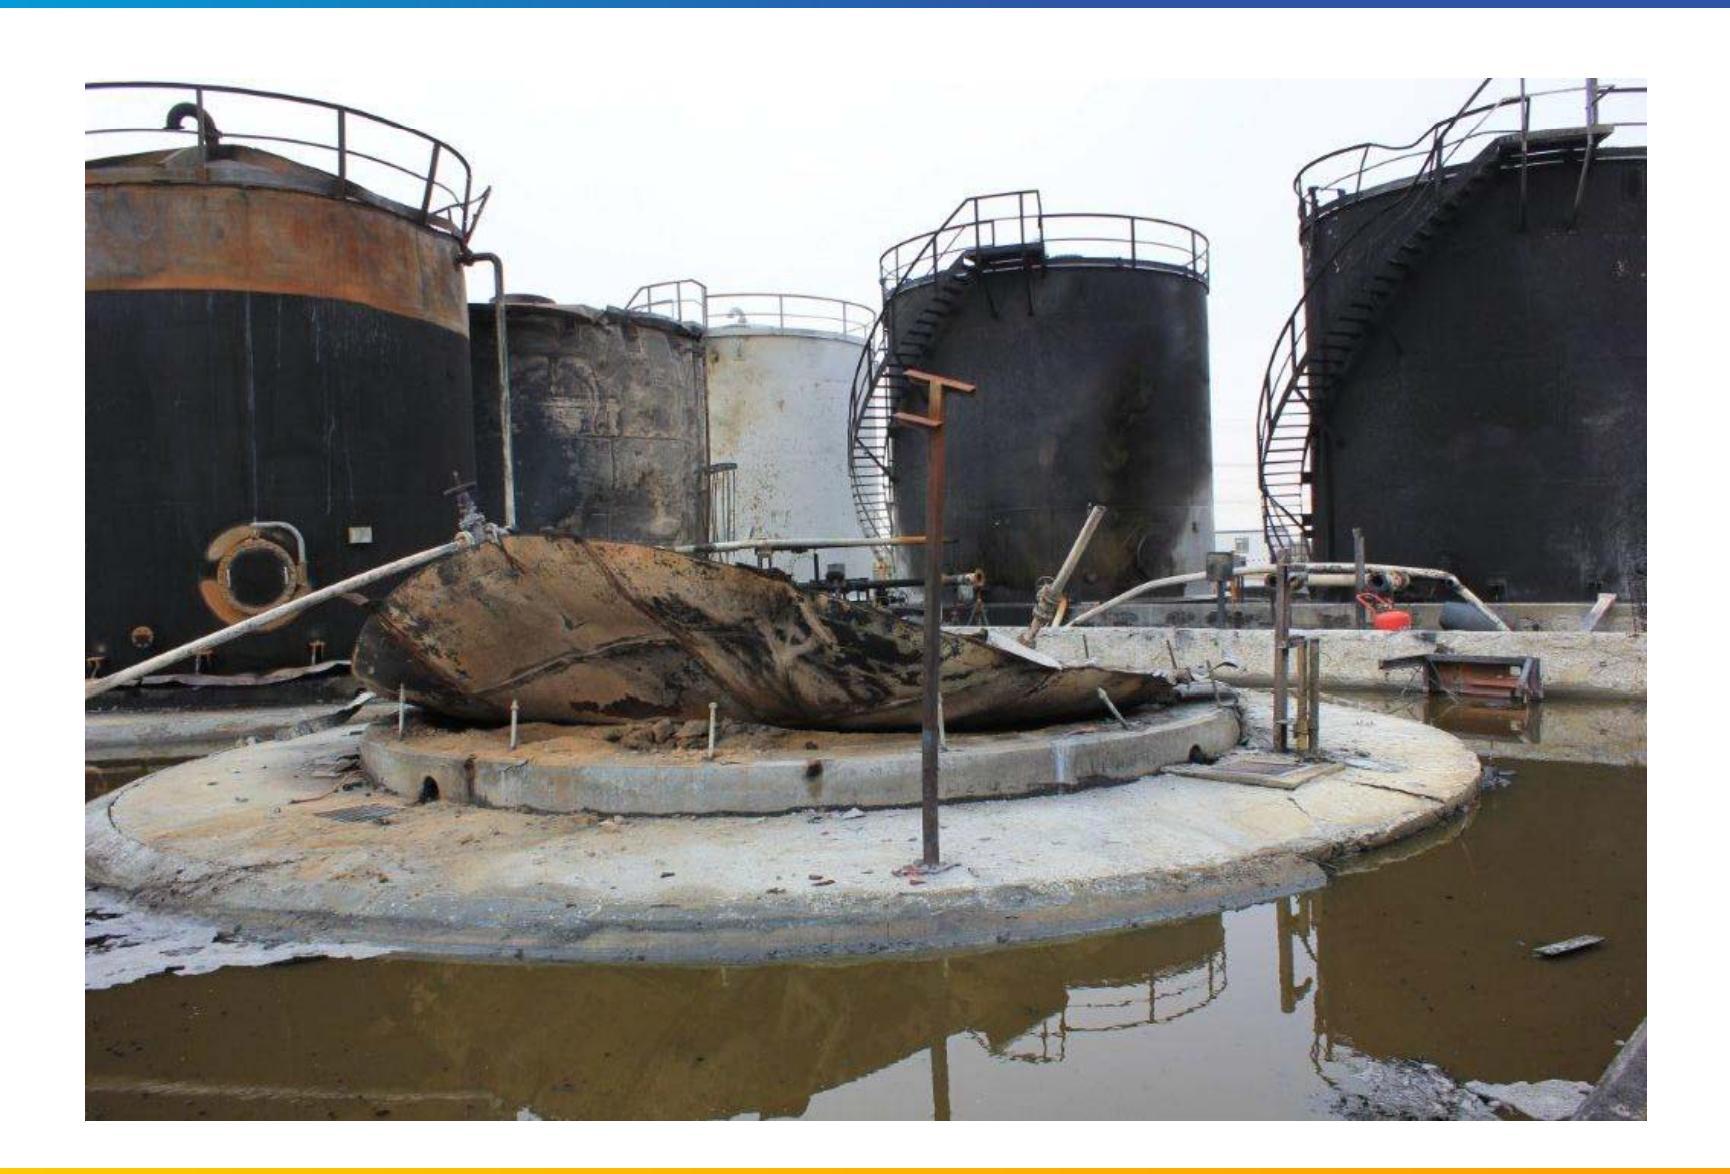
Base of the tank, which was an explosion where he flew a distance of about 100 meters from this site

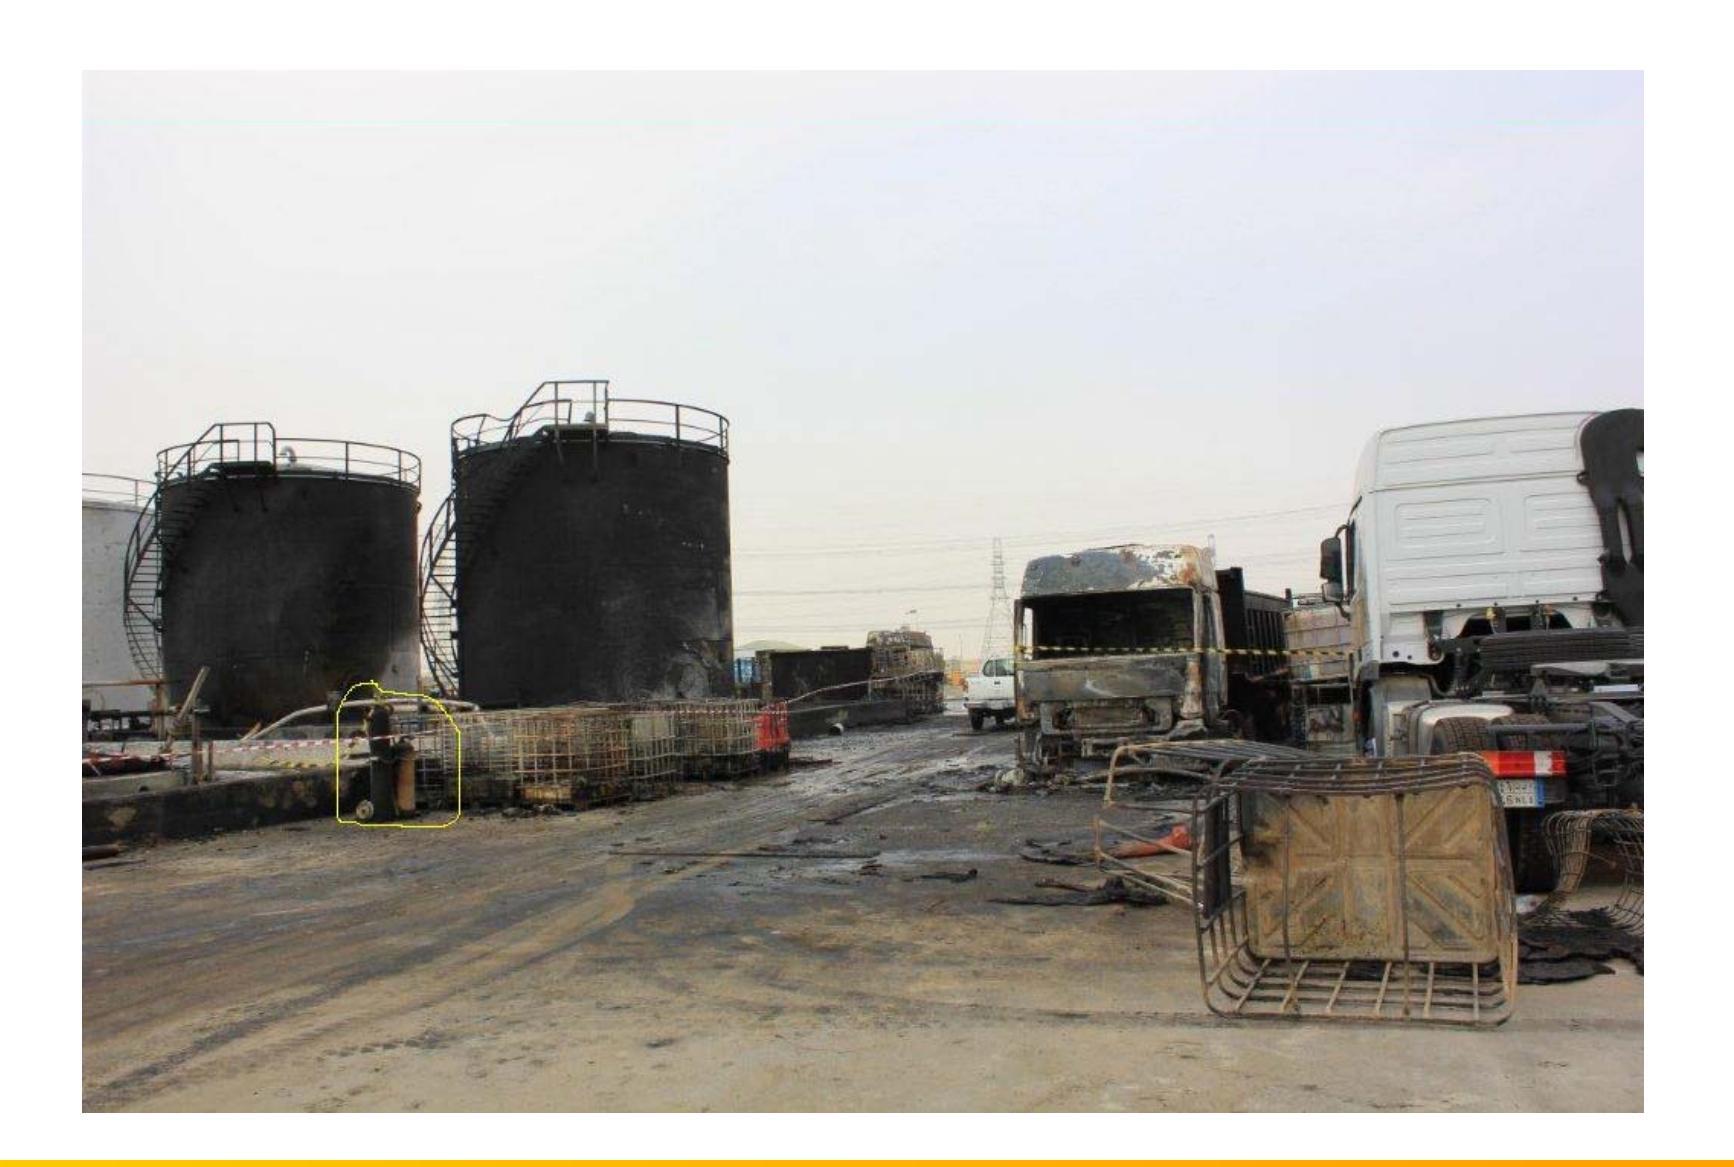
Here it is clear to us the main cause of fire as is evident in the yellow frame image a welding cylinder acetylene

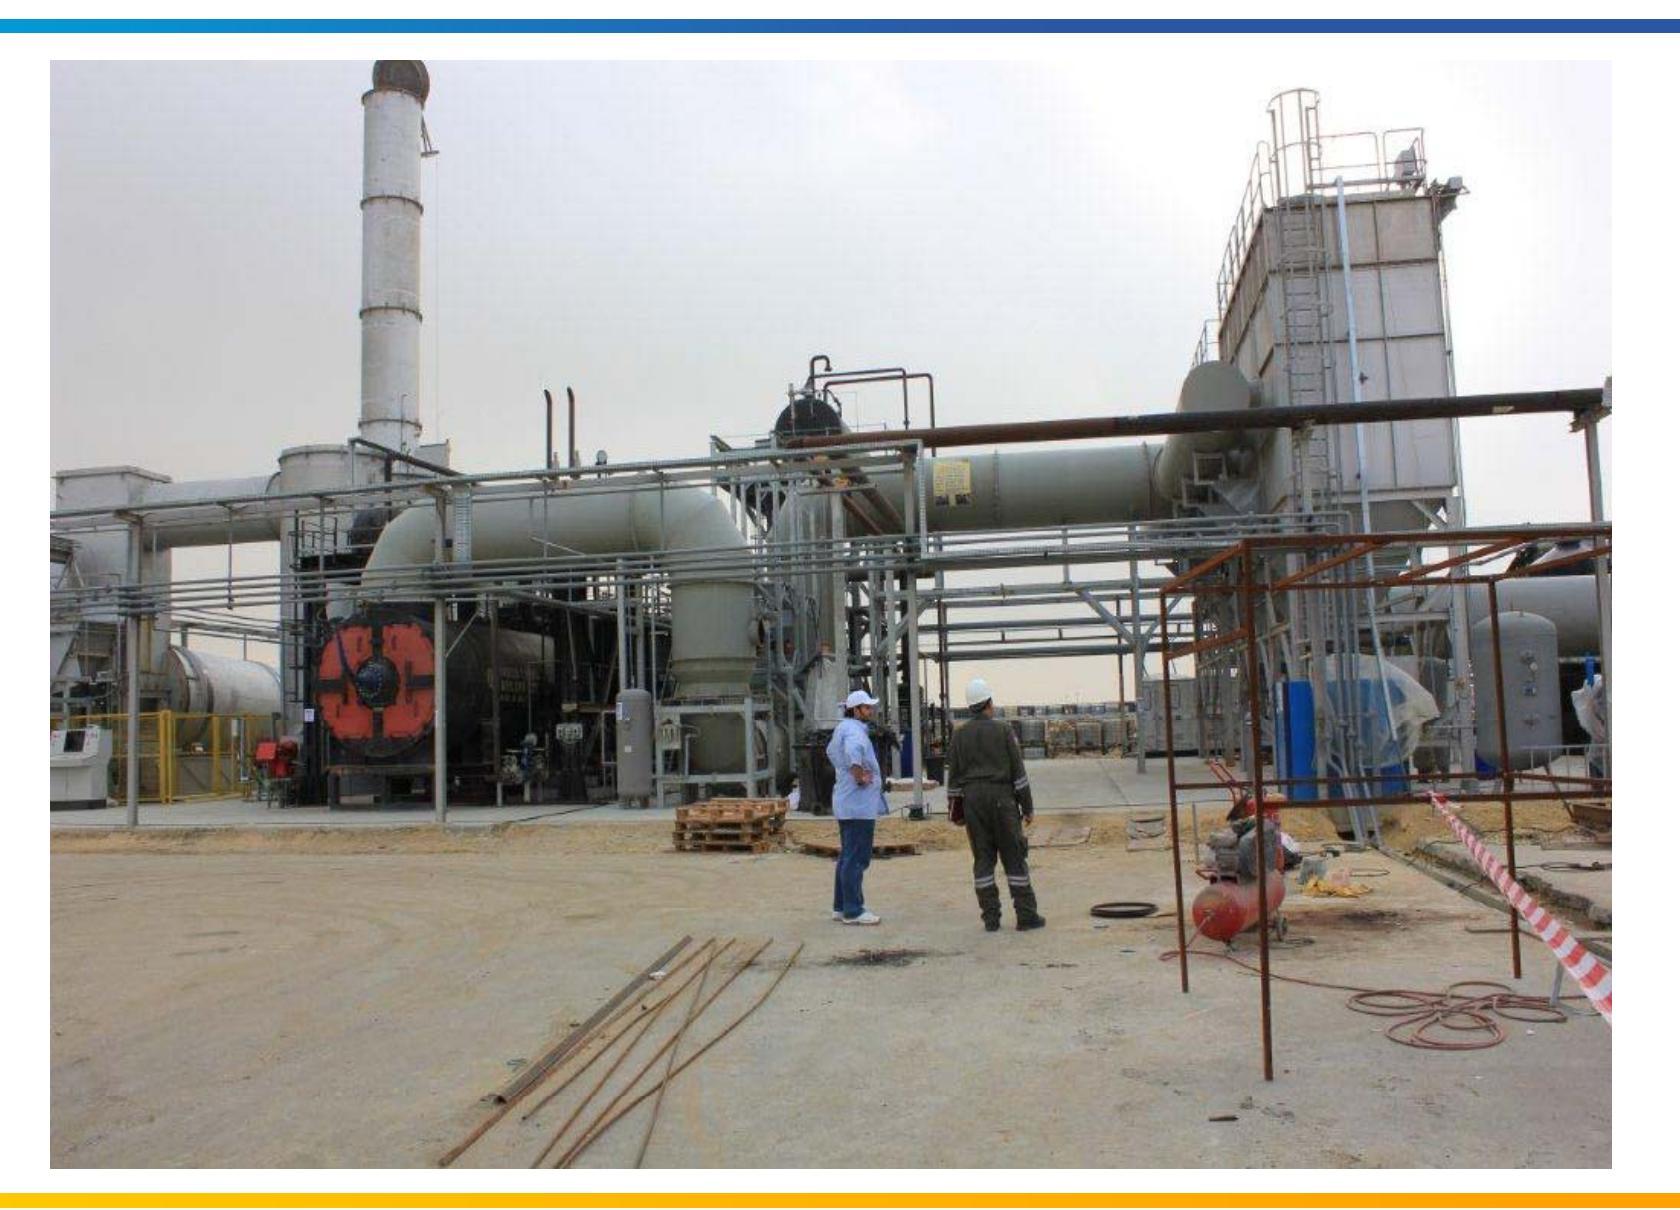
We see here a picture the plant where it is clear to us that it was not affected by this, it indicates that the tank did not hit any part of the process plant, thereof and The means that the tank was flying in a vertical rise of at least 15 meters
