## **Compatibility of UST Systems with Biofuels**

**Final Report  
June 2013**

**Alternative Fuels Workgroup  
Tanks Subcommittee**

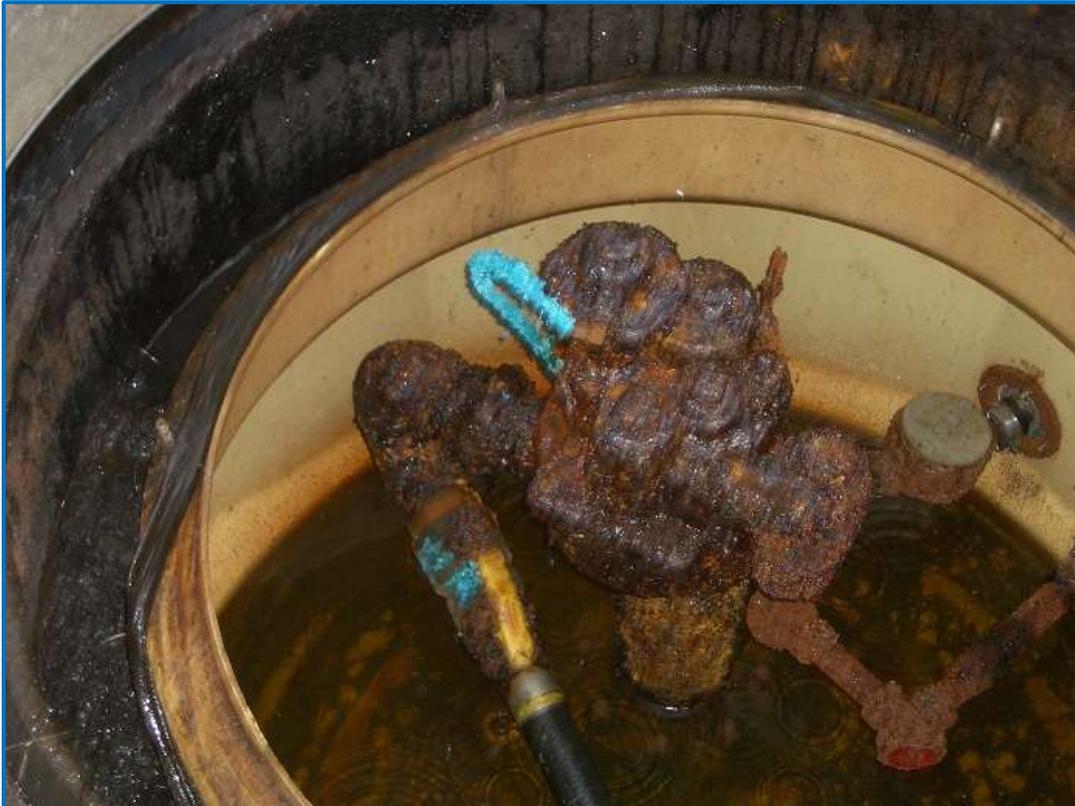
Cover Photo: The picture shows corrosion and acetate crystal formation commonly found in Submersible Turbine Pump (STP) sumps for systems storing gasoline-ethanol blends.

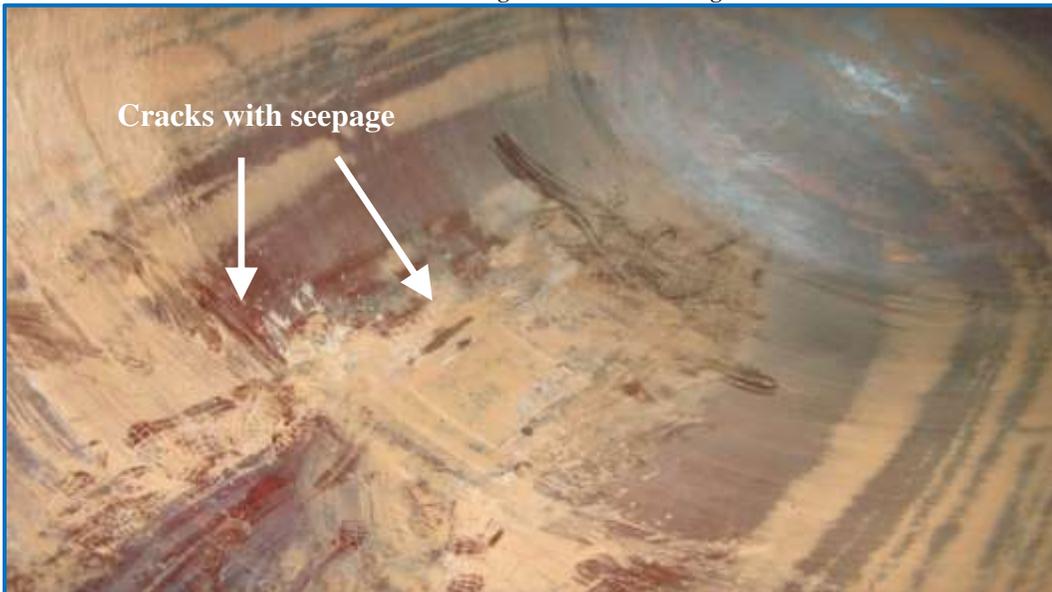
### Supporting Pictures: *Damaged Internal Lining*

Premium Unleaded gasoline tank installed in 1987 (note: E10 was used as a “winter blend” in AZ fuel starting in approx. 1988). In October 2011 the owner noticed an inventory issue and called their contractor. Automatic tank gauge (ATG) results did not indicate a leak; however, the inspector went through inventory records and found several hundred gallons of fuel missing. The contractor conducted a tank tightness test that failed.

The contractor called the inspector and the tank was emptied to mitigate any further release. The contractor contacted the manufacturer. A 10' x 10' hole was cut into the cement and the manufacturer entered the tank on November 1, 2011. The manufacturer discovered several cracks on the bottom of the tank. Arizona Department of Environmental Quality (DEQ) was notified that the tank is to be re-lined.

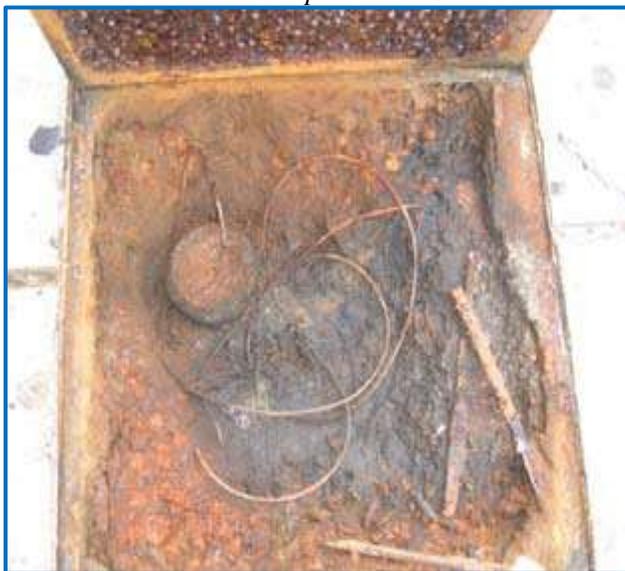
*Corroded Incompatible ATG Probe*

In 2005, prior to the introduction of the “Alternative Fuel Checklist”, this site converted a tank to E85 without the knowledge of the SC UST Program. An inspector performing a routine inspection discovered that the upgrade had taken place. In 2007, the inspector returned for the annual inspection and noticed that several months of ATG printouts were missing. When the tank owner was questioned, he stated that the probe had dissolved because their contractor had installed a regular gasoline probe.

The tank owner was required to submit SC’s “Alternative Fuel Checklist” showing that all equipment (including the probe) was compatible with E85. The checklist was received showing that the probe and all other equipment that were now installed were now compatible.

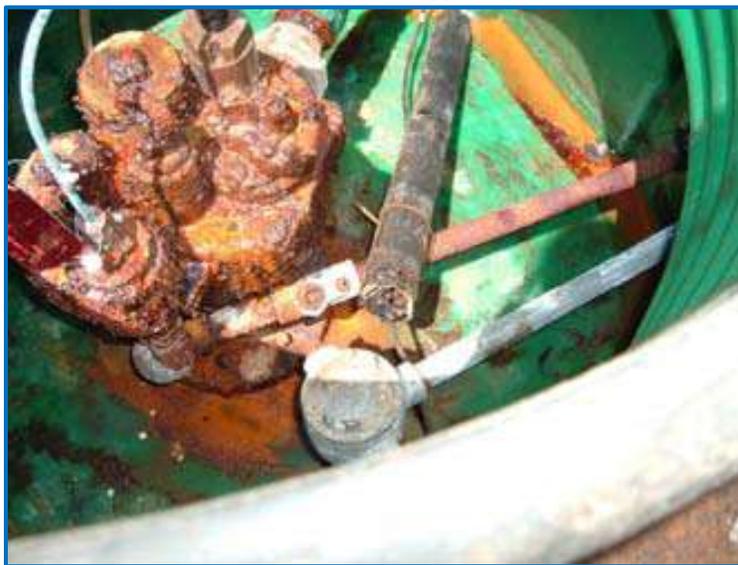
*Corroded STP*

In early 2006, prior to the formal introduction of SC's "Alternative Fuel Checklist", this site converted a tank to E85 without the knowledge of the SC UST Program. In 2007, the inspector visited this site for a routine compliance inspection. The inspector noted excessive corrosion on the submersible pump head and its associated components.

Upon receipt of a completed SC "Alternative Fuel Checklist", it was determined that the submersible pump was the appropriate "AG" (alternative fuel) model and therefore compatible with E85. The manufacturer of the submersible pump clarified that the E85 vapors had caused the paint on the submersible pump housing to run to cause the appearance of corrosion. It was confirmed that none of the internal components were affected. The manufacturer confirmed that the paint formulation used on the submersible pump had changed and that they would monitor other sites across the country for any further instances relating to paint degradation. The site was monitored for any further issues and to this date none have arisen.

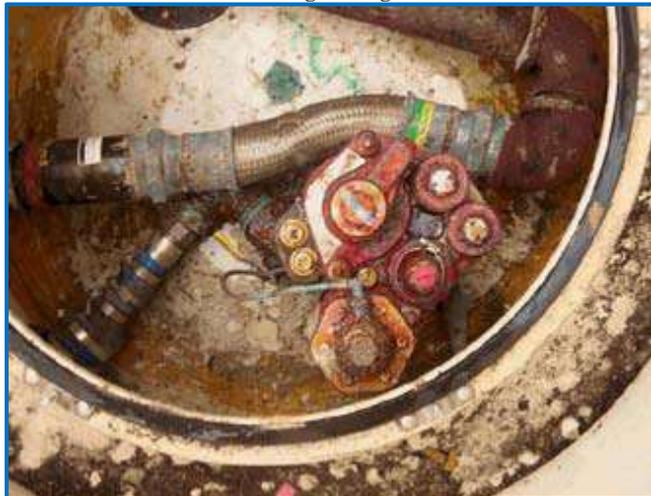
Supporting Pictures:  
*Corrosion Beginning on an STP*

Corrosion beginning on the submersible pump and its associated components was noted.

Monitoring and replacement as needed

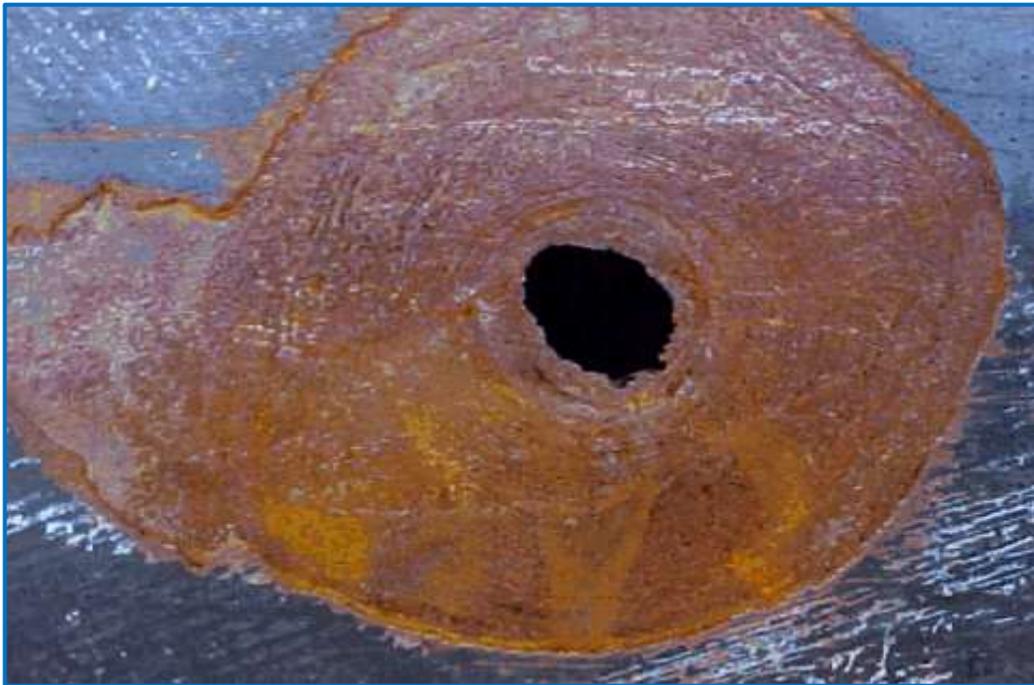
*Corrosion Plug Removed by Ethanol*

Tank tightness was not considered when converting from E10 to E85. Ethanol has the ability to dissolve previously plugged pinholes in storage tanks formed as a result of corrosion.

Release occurred. Tank was removed and remediation conducted.

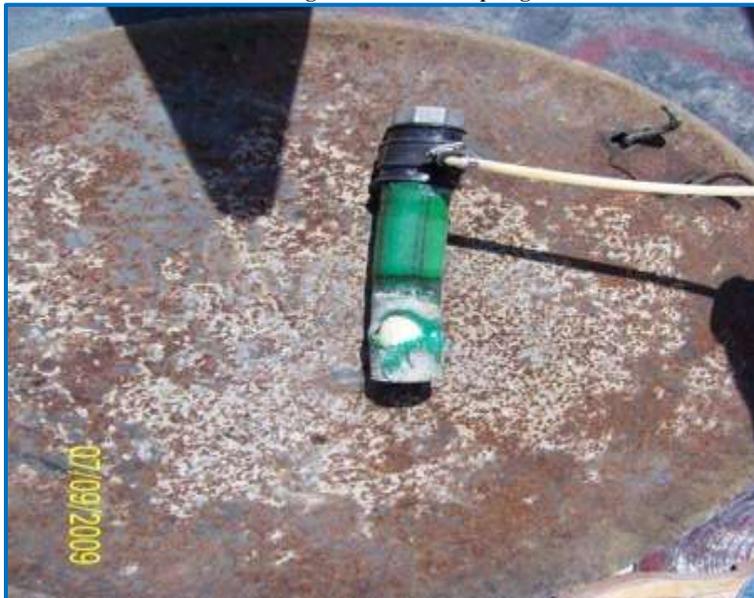
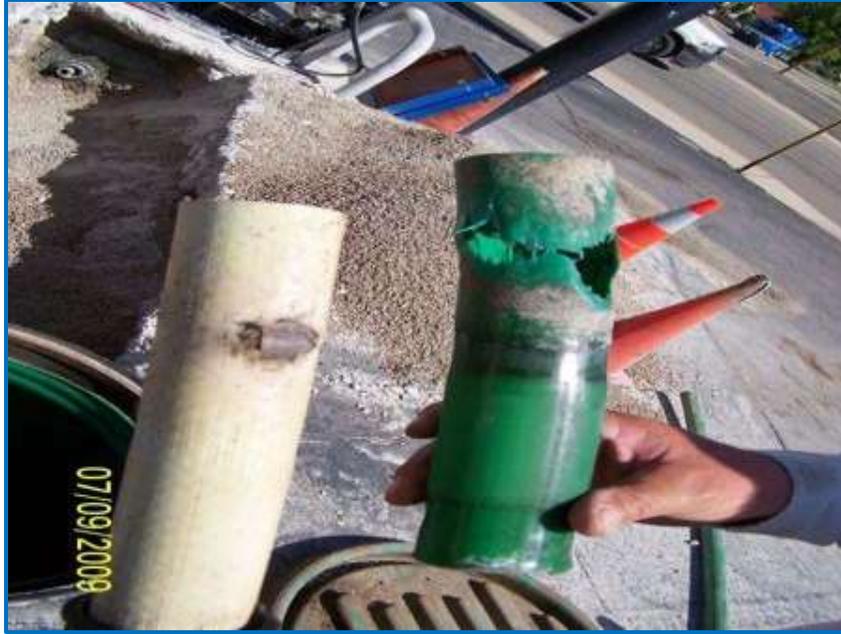
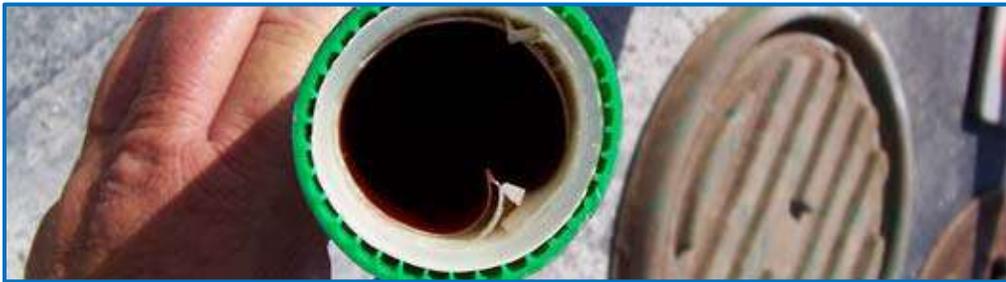
### Supporting Pictures: *Damaged Environ Piping*

During a compliance inspection in 2009, an UST inspector found product in one of the two dispenser sumps. It was discovered that the piping was leaking from between the primary and secondary walls.

During excavation of the piping around the premium STP, the UST inspectors found evidence of degradation of the outer secondary barrier. Upon further investigation, the inside of the piping was found to be deteriorated.

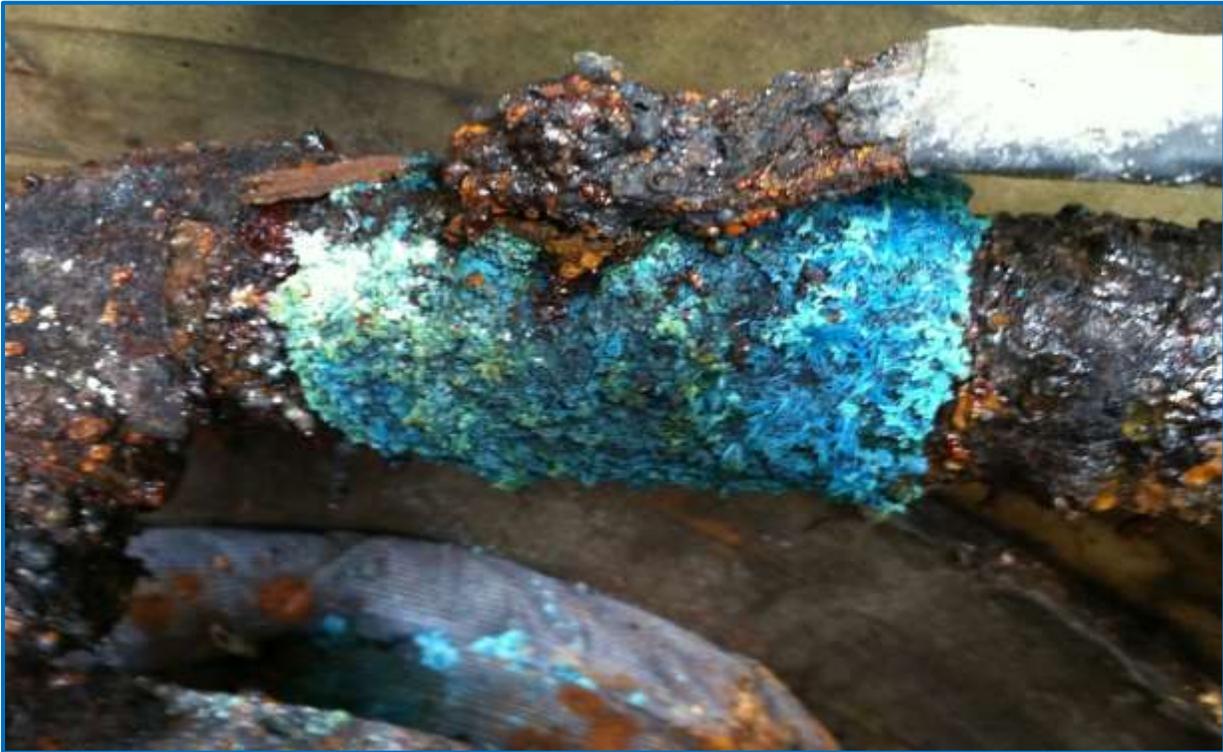
Supporting Pictures:  
*Blue Buildup*

During a compliance inspection in September 2012, the UST inspector found a blue buildup on steel components associated with the flexible piping in the subpump.

Ethanol vapors possess acidic properties and can act as a corrosive catalyst in the sump environment. This can lead to an aggressive oxidation process (similar to Missouri case study).

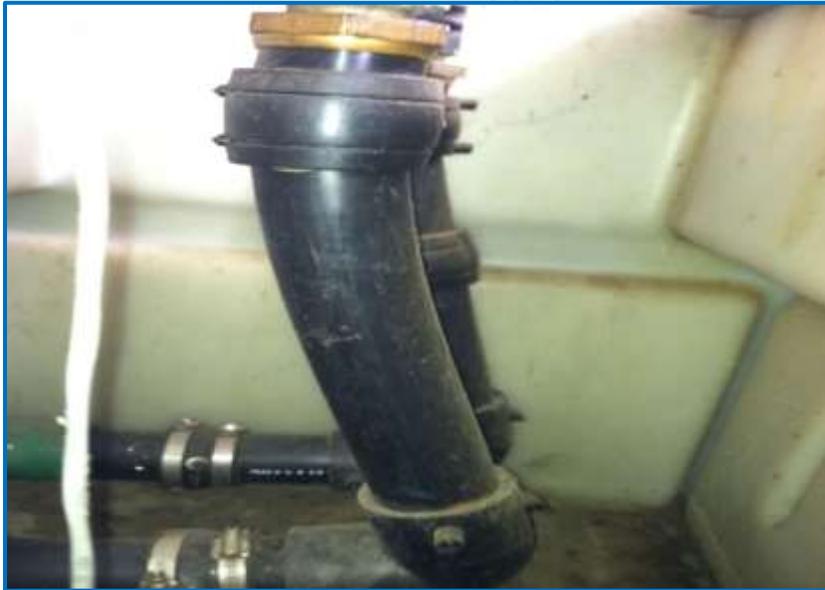
Supporting Pictures:  
*Bent UPP piping*

During a compliance inspection, it was noticed that the UPP pipe had started to bend (like previous generations of other flexible piping).

Site was asked to monitor pipe for further damage.

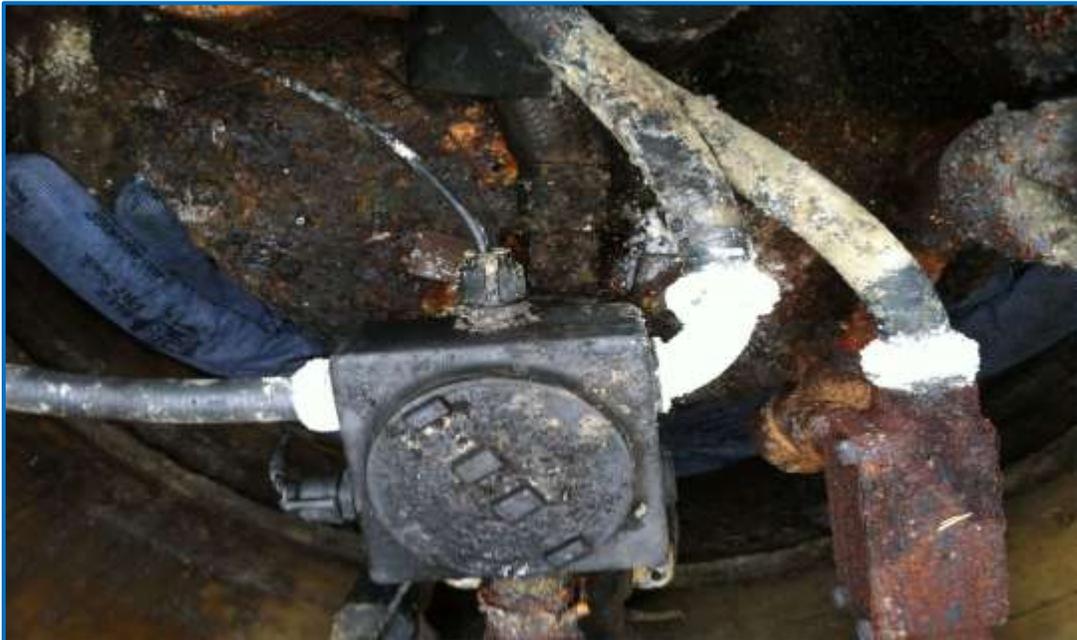
*Corrosion on Conduit in STP*

Corrosion on lead and brass components of the conduit leading to white buildup.

Monitor for further damage.

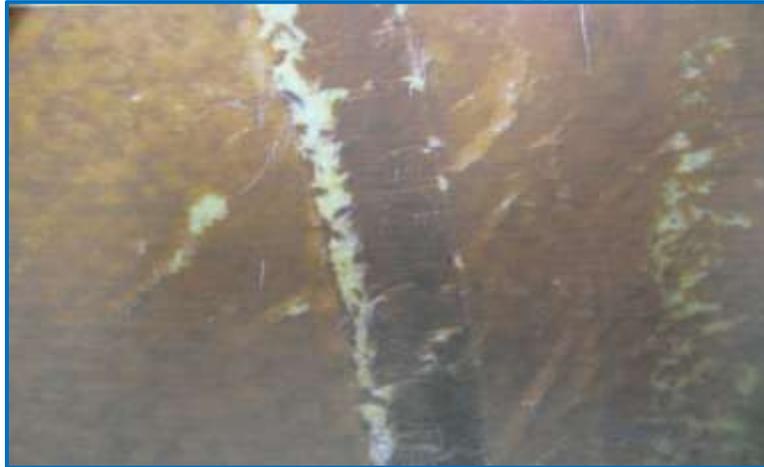
Prior to the storing of blended fuels, the USTs stored unleaded 87 and 92 octane as well as diesel. It was believed that the tanks had had been properly cleaned prior to the switching of products. The premium UST was placed in temporarily out of use (TOU) status on 12/18/2008 and was put back in service on 2/5/2009. The ATG detected the presence of water in the tank and as a result, the tank was placed back into TOU status on 2/10/2009. In 9/2009, an internal inspection of the tank was conducted. The results indicated a crack in the bottom of the tank.

*92 Octane UST – breakdown observed during pre-blast inspection*

- Super Tank: had a crack in the bottom, some breakdown of the gel coat, initial layer of the fiberglass mat and crazing was observed
- Regular Tank: slightly deteriorated gel coat was observed, some slight flaking and exposed fiber were found throughout the tank but no visible cracks noted
- Diesel Tank: slightly deteriorated gel coat was observed some slight flaking and exposed fiber were found throughout the tank but no visible cracks were observed.

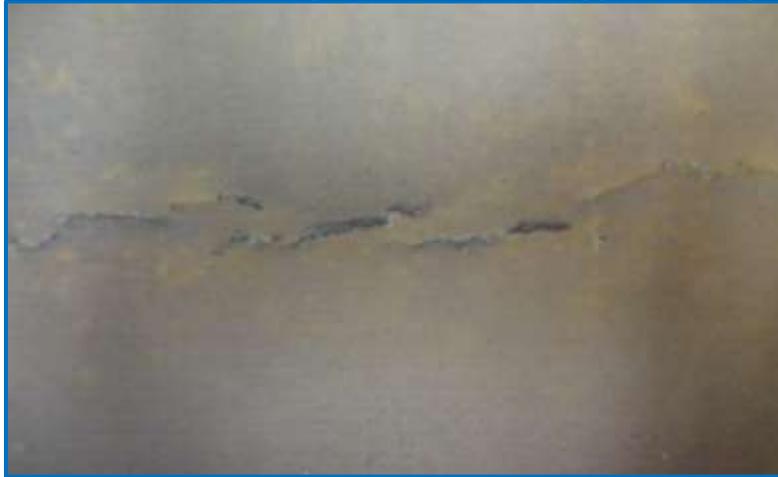
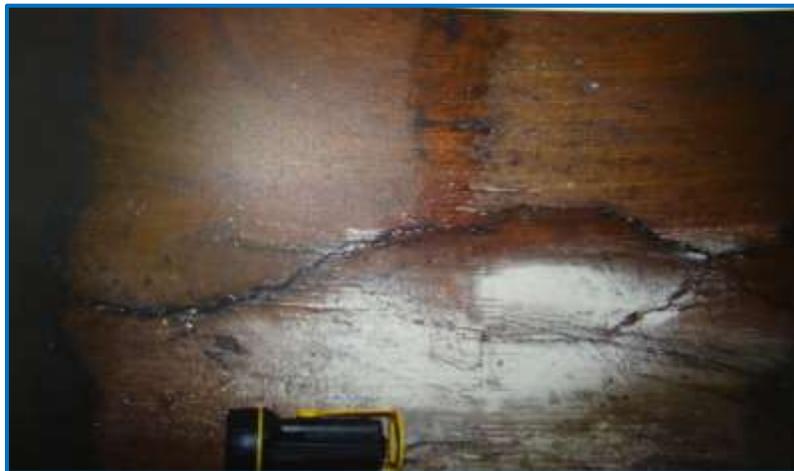
*92 Octane UST – deep crazing/crack observed during pre-blast inspection*

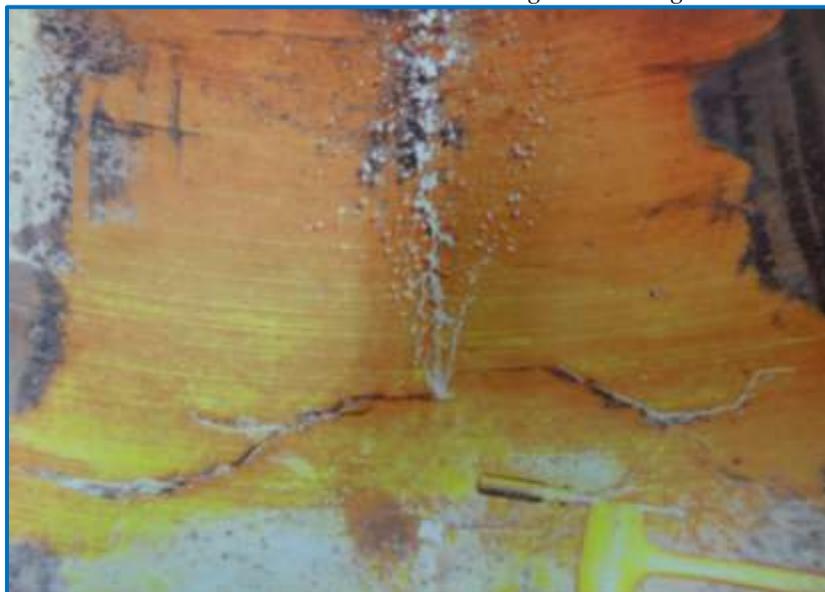
*92 Octane UST interior – water entering tank through crack*

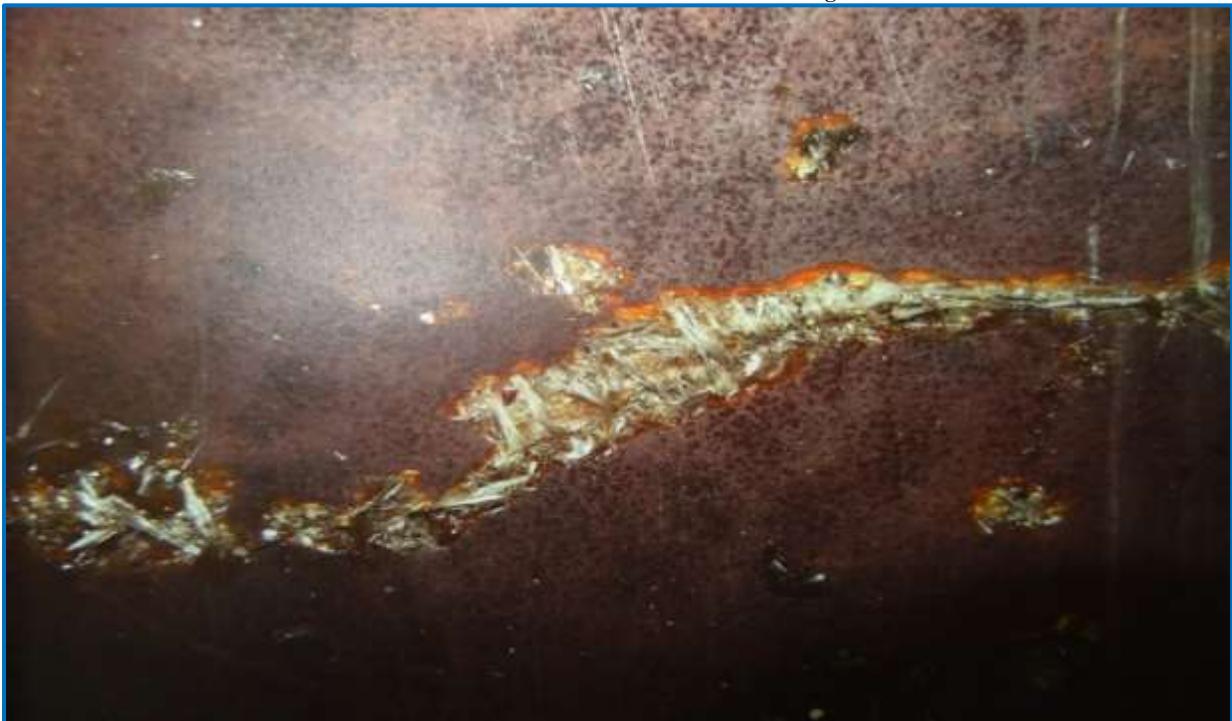
Prior to the storing of blended fuels, the USTs stored unleaded 87 and 92 octane. It was believed that the tanks had had been properly cleaned prior to the switching of products. The premium UST was placed in temporarily out of use (TOU) status in 6/2008 due to a suspected release. It was repaired and lined then brought back in service in 12/2009. A failed CSLD test was reported and as a result the tank was placed back into TOU status in 10/2010. An internal inspection of the tank revealed that the new liner was damaged. It was thought that the liner did not adhere to the fiberglass properly.

*UST 92 Octane interior view: horizontal cracking in tank shell*

A release was confirmed and all USTs were removed in early 2012.

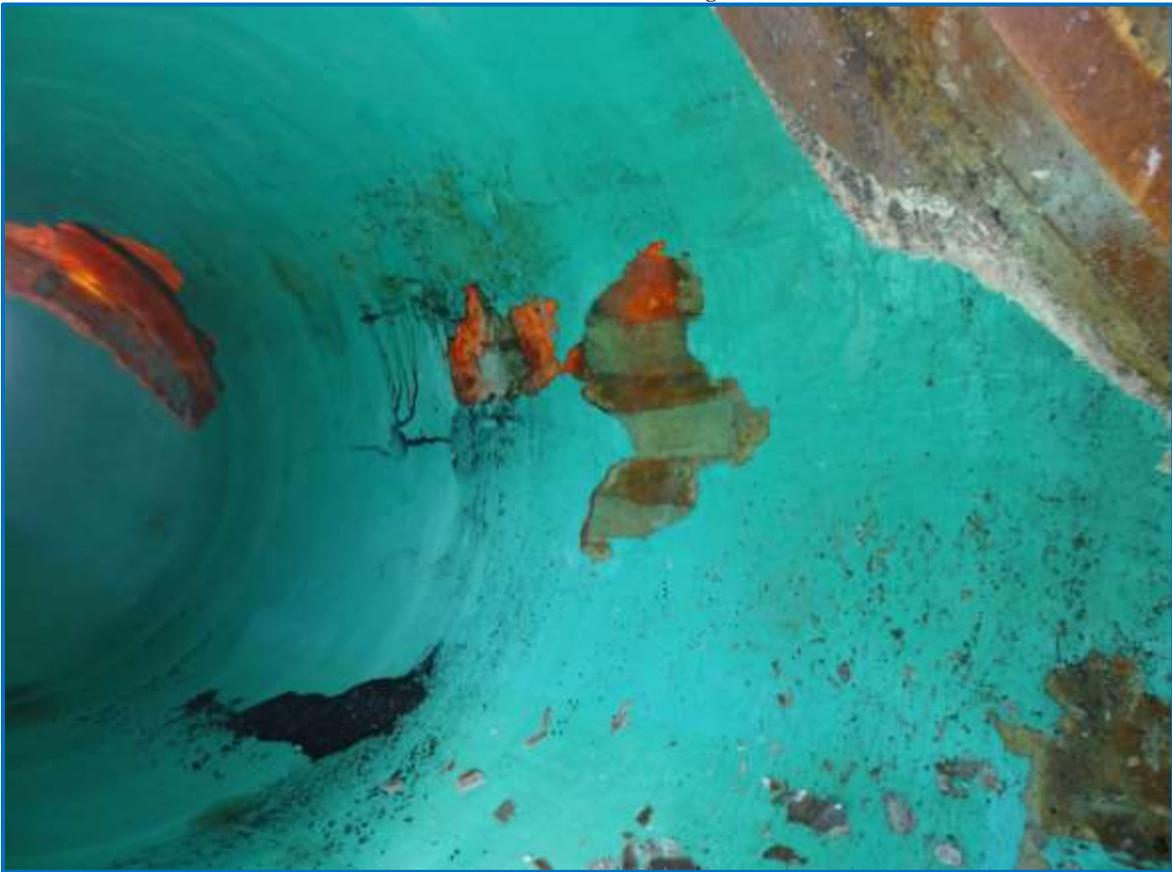
*UST 92Octane interior view: lining deteriorated*

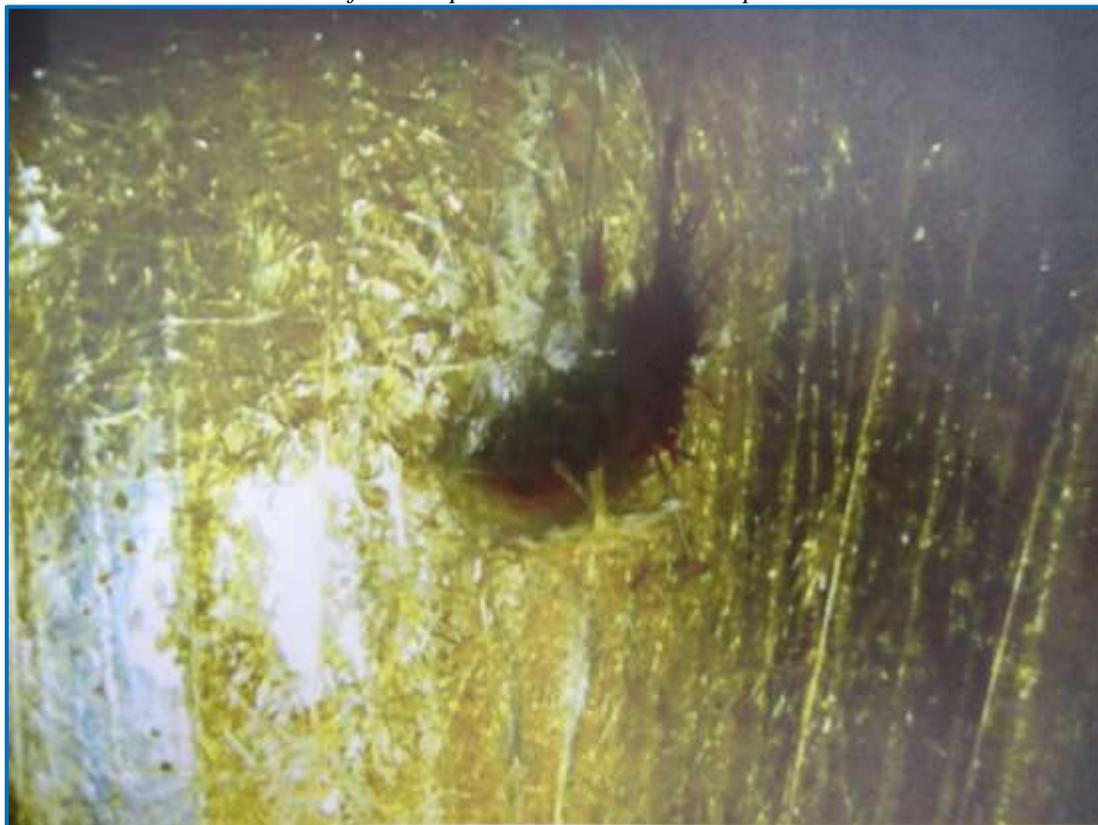
Prior to storing blended fuel, UST stored unleaded 92 octane. It was believed that the tank was interior cleaned prior to switching product. Tank was placed on a TOU status on 9/23/2009 for relining and brought back in service on 3/24/2010. Tank was again TOU on 7/16/2011 because product was found in the interstice. The tank was lined for a second time and then was brought back in service on 12/16/2011. Currently, tank is TOU since 8/6/2012 due to breach in the inner shell

*UST fibers exposed due to chemical exposure*

Tank was lined twice and is currently TOU

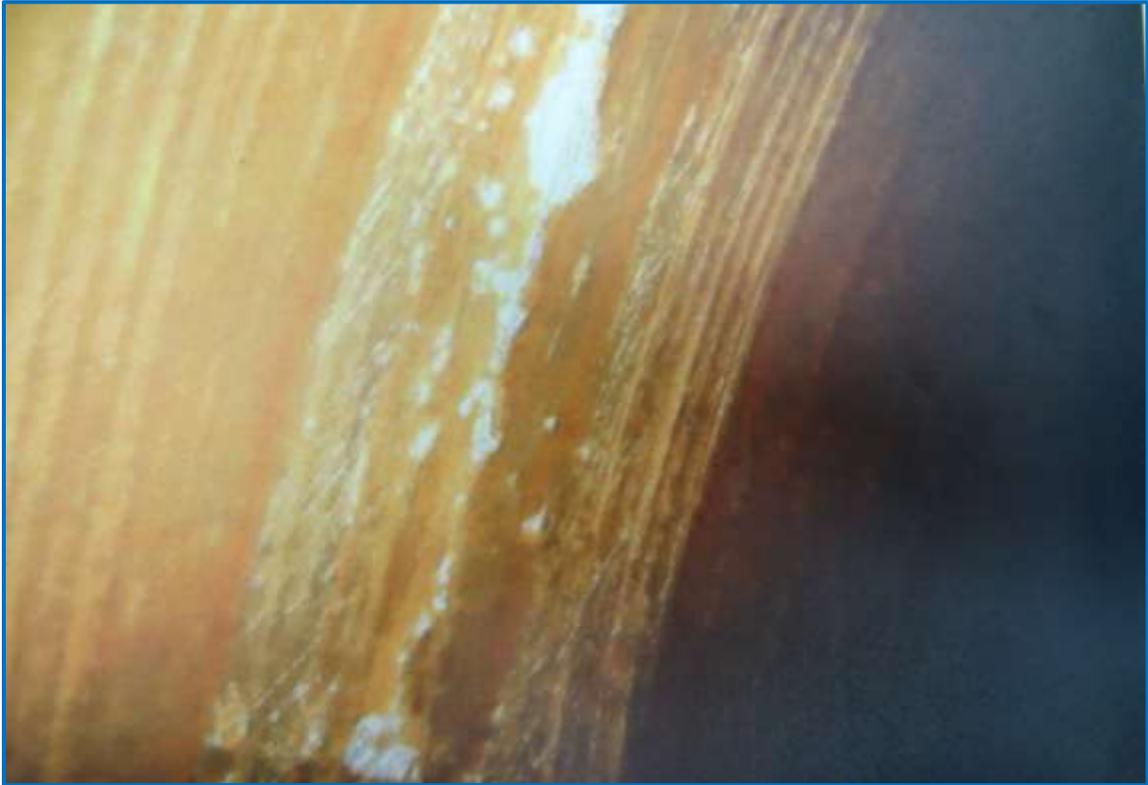
*92 Octane UST deteriorated gel-coat causing delamination*

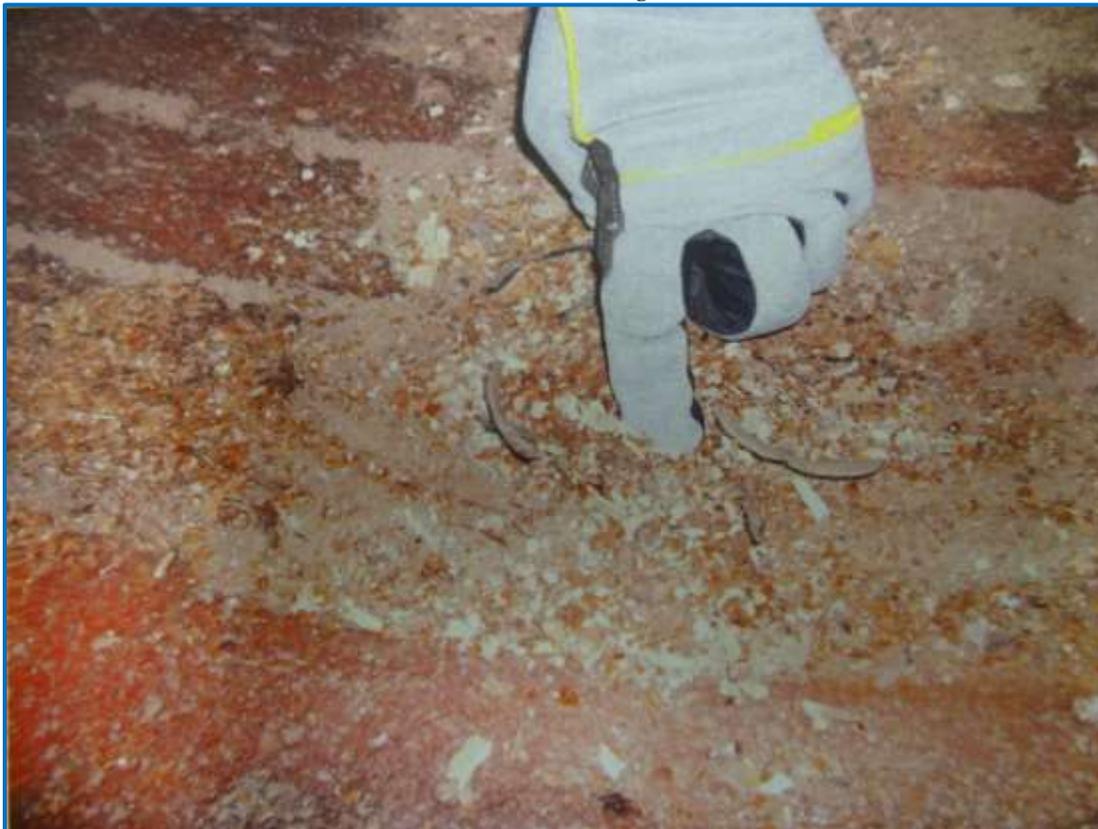
*UST 87 Octane internal view: gel deterioration*

All three USTs showed severe deterioration of internal Gel coat with exposure of fiberglass fibers. There were visible cracks as well as a 2.5 feet long crack on the bottom center and at both ends of the premium UST. There was one (1) large area of crazing in the plus tank. All tanks were eventually lined and returned to service on 10/21/2009.

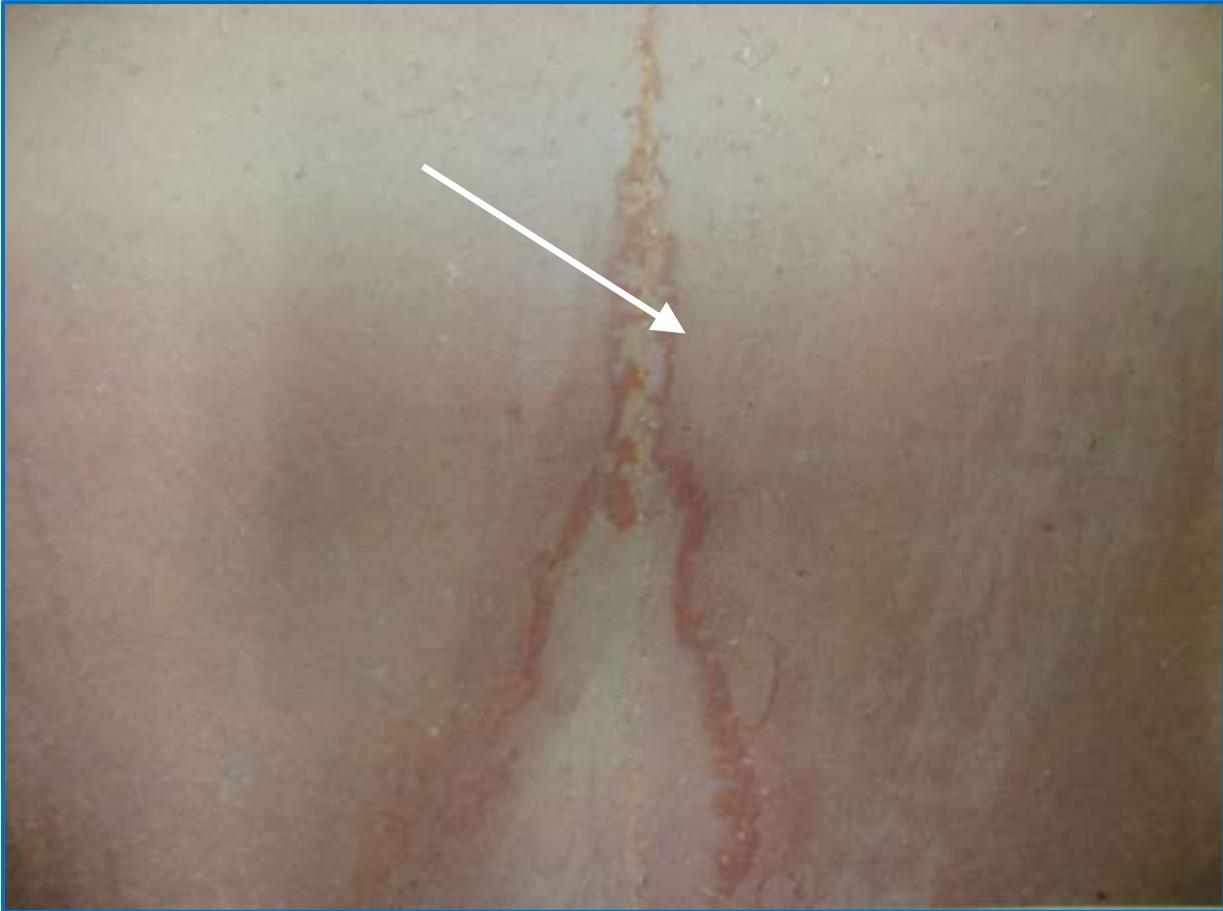
*UST 89 Octane internal view: crack*

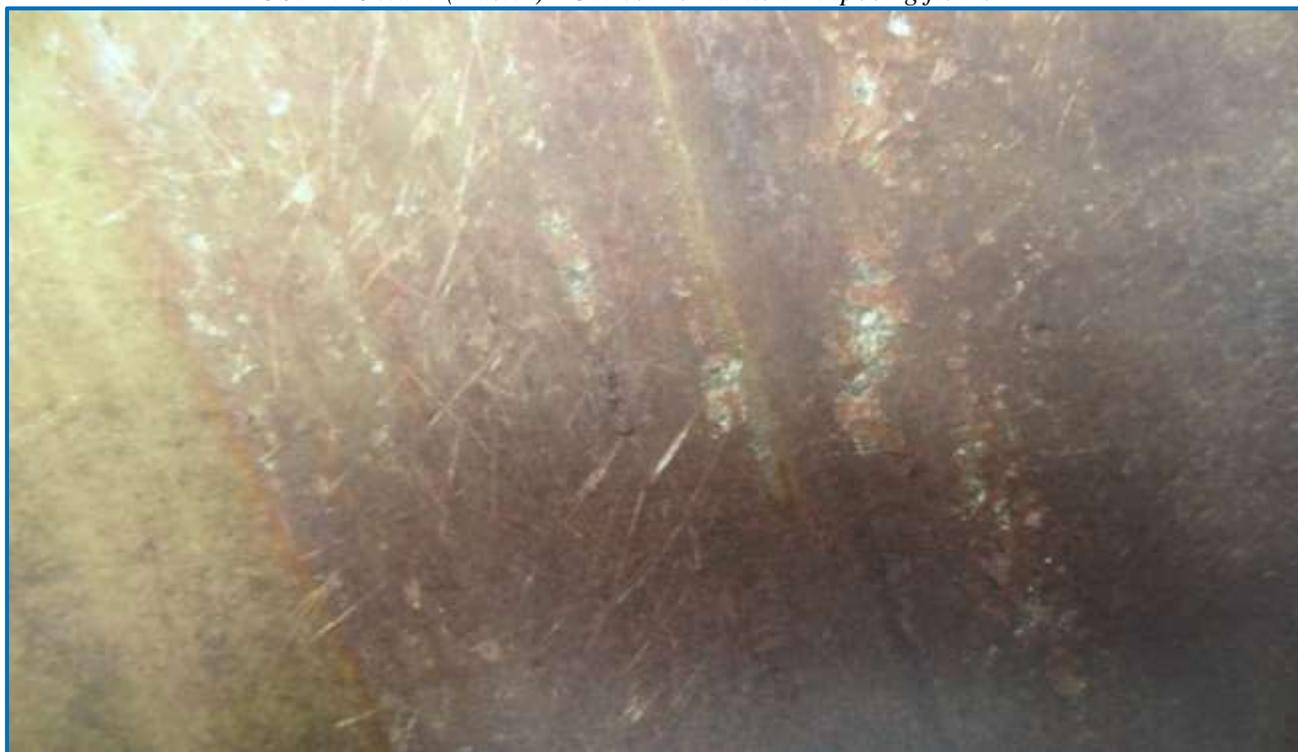
*UST 87 Octane (master) - Gel-coat breakdown exposing fibers*

- Super Tank: was in unsatisfactory condition. The gel coat exhibited breakdown and laminate layers contained creases that resulted in buckles between the stiffening ribs. Chemical attack was observed throughout the tank shell and the bulkheads. On 3/29/2011, the tank was permanently closed in place.
- Regular Tank: Master and slave tanks both exhibited some early signs of breakdown within the gel coat and laminate layers of fiberglass on the shell and bulkheads. The USTs were eventually lined.

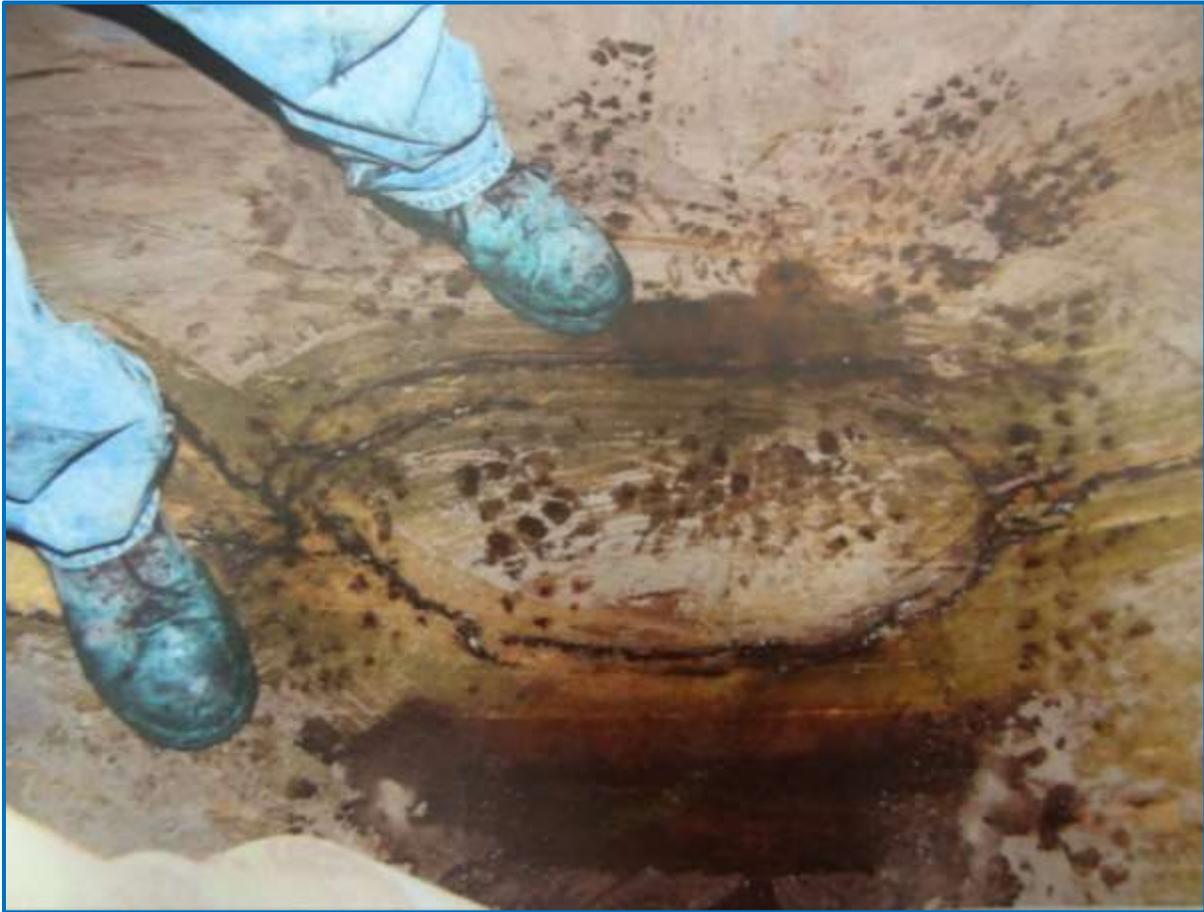
*UST 92 Octane interior – cracked shell*
