Safety Flash

BTRF CONTRACTOR RECORDABLE INJURY: FOOT INJURY FROM OUTRIGGER

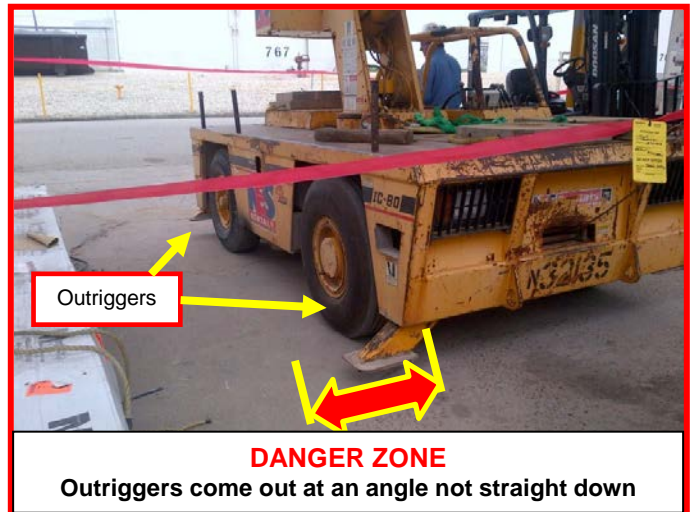
- The rigger was standing at the right front of the carry deck crane, spotting for a contract crane operator as the carry deck crane was backed out of the unit and onto Crosby Street.
- The rigger noticed the right rear outrigger was not fully retracted and alerted the operator.
- The operator stopped and attempted to raise the outrigger, but in the process operated the wrong lever resulting in the front outrigger being deployed down onto the rigger's right foot.
- The outrigger alarms sounded as the outriggers were lowered.
- The injured worker was wearing safety toed boots, which minimized the severity of the injury.

- Stay clear of the outrigger Danger Zone at all times. (*See Warning Label in picture*)
- Carry deck cranes have alarms that signal when an outrigger is being deployed. Heed the alarm when it sounds.
- The crane operator and injured worker failed to recognize the **Line of Fire** hazard.
- Good, clear communications between workers is critical and key to ensuring each task is performed safely and to avoid incidents.
- Always ensure everyone is totally clear of mobile equipment before touching any controls.
- Use the **SCAN** process to identify hazards around mobile equipment.
