SAFETY ALERT #025

Title: Grinder Fatality

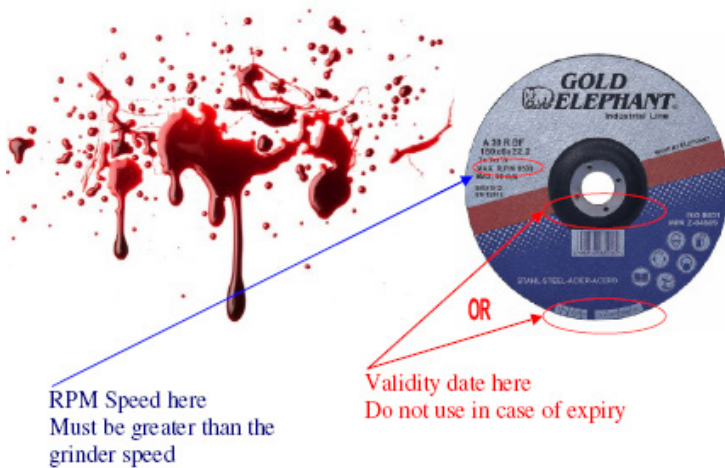
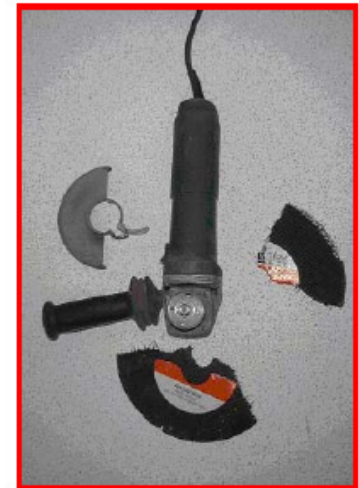
Angle grinder and disintegrated disk

A welder was carrying out maintenance on an excavator bucket. He was using an angle grinder to prepare surfaces for welding when the disk disintegrated. The hand-held angle grinder was fitted with a 230 mm diameter cutting-off wheel and when it disintegrated, fragments penetrated the victim's chest and abdomen. He was rushed to hospital by rescue helicopter but died the same day.

Initial inspections show that the grinding machine and cutting disk were not compatible. In addition, the grinder was not fitted with a guard.

Grinding machines and abrasive wheels should always be used in accordance with the manufacturer's instructions. In particular:

- Always ensure the maximum speed (the no load rpm) marked on the abrasive wheel is greater than the rated speed of the grinder.
- Do not use grinding wheels that are larger than the maximum recommended size, or worn down wheels from other grinders.
- Never use grinding wheel power tools without the wheel guard attached to the tool and positioned for maximum safety.
- Store and handle abrasive wheels with care and inspect them for chips or cracks before installing. Do not use any wheel that may be damaged.
- Cutting disks should only be used for cutting only and not for grinding purposes.
- Training on 'safe use of grinding machines' to be provided to all personnel using this equipment
