Safety Alert

March 20, 2009

Pneumatic Impact Tool Injury

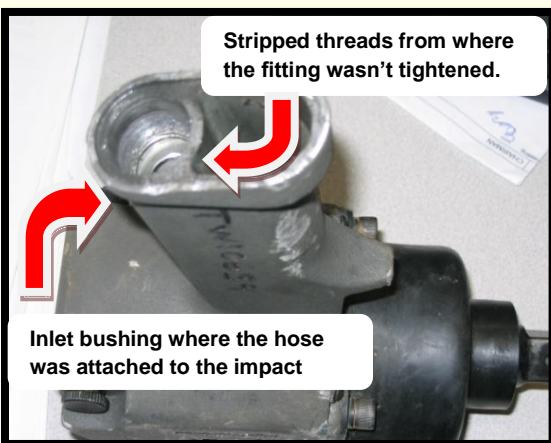
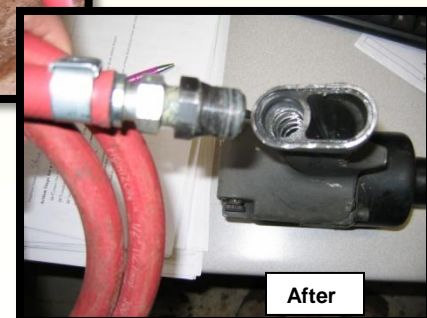
Employee was using an Ingersoll Rand pneumatic impact to tighten bolts. When he pulled the trigger on the impact, the air hose along with the connection fitting was blown off of the bottom of the tool. Air hose whipped around and hit employee on the left cheek causing some bruising and skin abrasions.

- The investigation found that the threads on the impacts inlet bushing had been stripped out due to the movement of the air hose associated with everyday use.
- The employee was on the structural steel crew performing a bolt up of the structure.
- He had been using the impact gun for half a day when the fitting came off the end.
- The vibration of the gun while in use, as well as the movement with the hose attached firm to the gun, caused the inlet bushing to come loose during operation.

- The equipment should be pre-inspected prior to use.
- After the swivels are installed, employees working with this type of tool will inspect three times a day to verify the fitting is tight.
- All new impact guns will be ordered with the swivel fittings installed or installed when they are received on the project.
- The project supervisors will monitor compliance with these requirements daily.
