Growing experience with P91/T91 forcing essential code changes

By Jeffrey F Henry, Alstom Power Inc and ASME Task Group

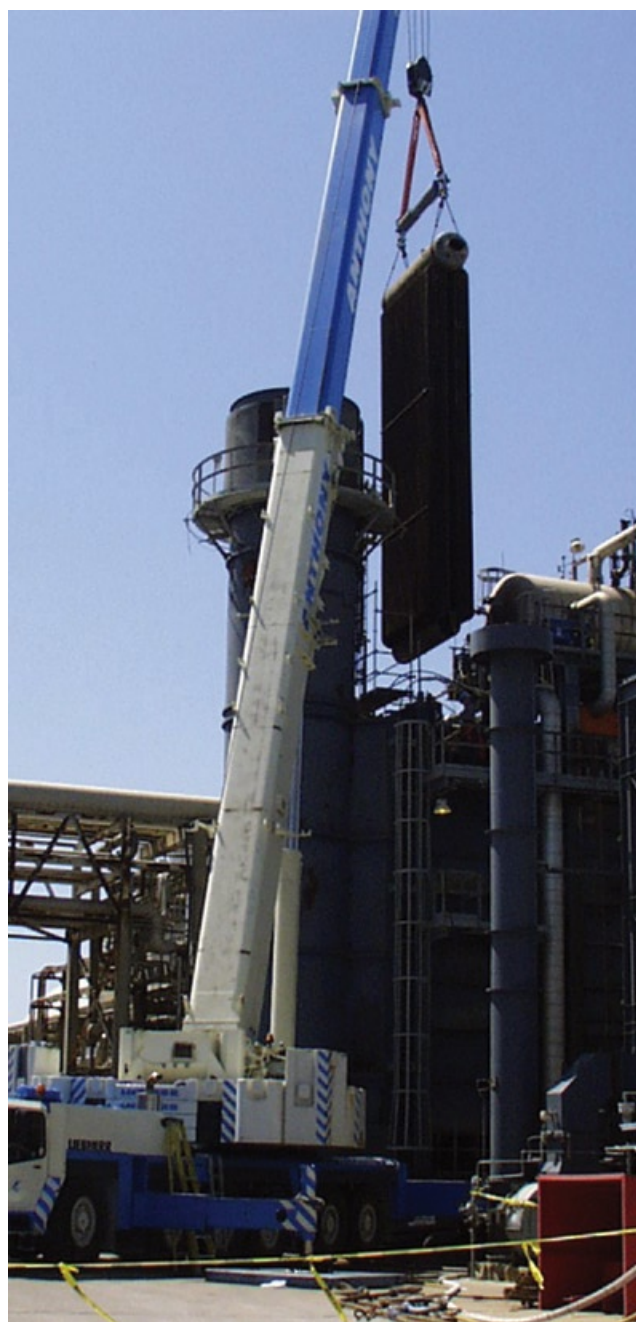
1. Grade 91 increasingly is being used in combined-cycle steam systems because of its greater resistance to thermal fatigue and enhanced creep strength compared to alternatives. However, manufacturers, constructors, and HRSG users often are unwittingly damaging the microstructure, and thereby degrading the material's mechanical properties

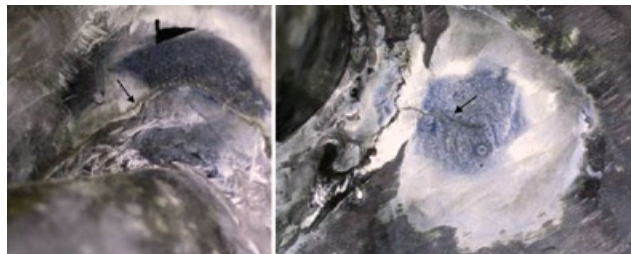
A. Metallurgical replication revealed the crack in this nozzle adjacent to the weld's heat-affected zone and through the base metal. Here, the actual metal surfaces are prepared non-destructively using grinding and polishing disks

Metallurgical replication. Fortunately, a less common method of non-destructive testing called "metallurgical replication" can help. The method, explains Leo Vega, associate metallurgical engineer, Stress Engineering Services Inc, Houston, examines the actual microstructure of a suspect metal surface. It can be used as a complement to standard NDE techniques—to confirm observations made by such methods as ultrasonic or penetrant testing—but it also can go much further to detect early stages of creep damage and cracking, and to identify the specific nature of a flaw.

The technique begins with abrasive preparation of the suspect metal surface using successively finer grits of grinding and polishing disks, followed by a final diamond-impregnated cloth (Fig A). A sampling procedure then records and preserves the topography of the metallographic specimen as a negative relief on a cellulose acetate film or replica.

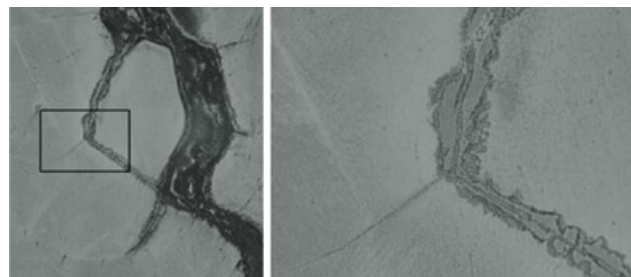
B. The microstructure of a suspect metal surface is revealed on a cellulose acetate film, or "replica." The replica can be studied at the plant to provide prompt results, or it can be sent to a lab for even more sophisticated evaluation using special microscopes

Vega says that a portable microscope with up to 400X magnification can be used in the powerplant to study the prepared metal surfaces, as well as to confirm the quality of the replica. These results can be presented to plant personnel during the on-site visit, so the technique saves a lot of time during a shutdown. For even more sophisticated evaluation, the metallurgical replica can be sent to a laboratory to be studied with a light optical microscope or a scanning electron microscope (Fig B).

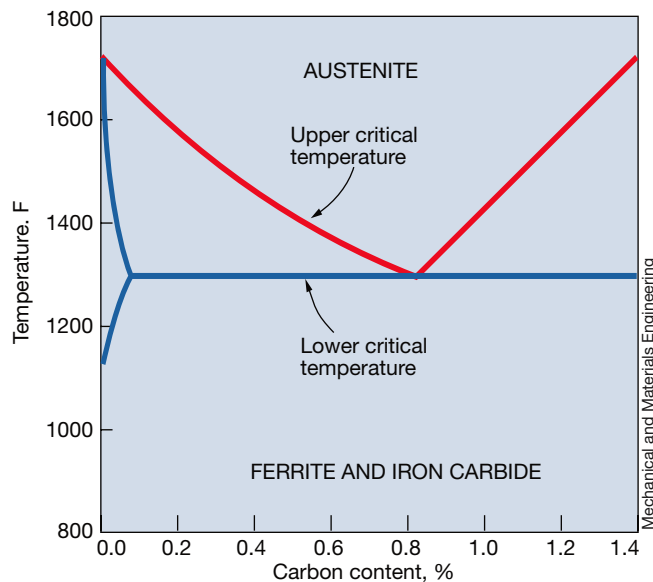
2. Two important parameters for Grade 91 components are (1) the lower critical transformation temperature (AC_1), above which the alloy's phase transformation from martensite back into austenite begins, and (2) the upper critical transformation temperature, above which the phase transformation to austenite is complete

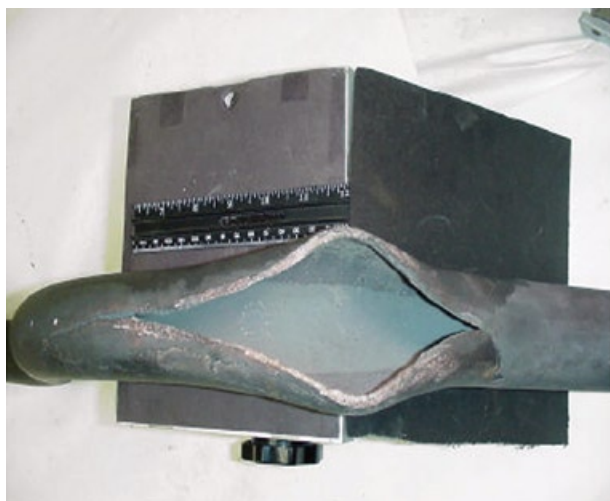
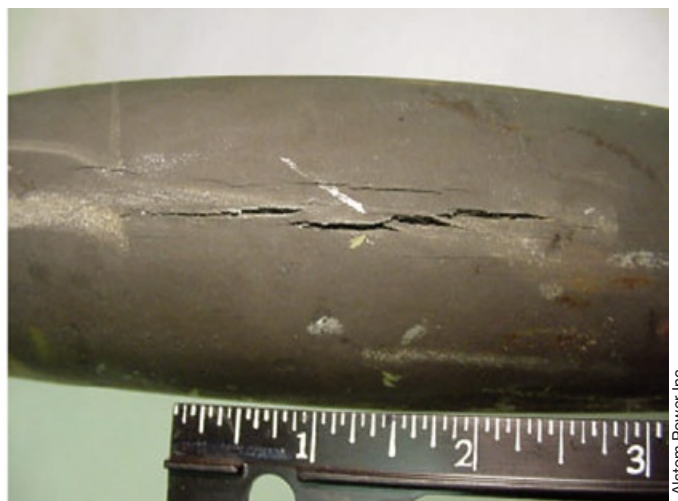
3. These superheater tubes fabricated from Grade 91 material failed after only four years of service in a conventional fossil-fired boiler. The lot of tubing from which they were fabricated had been exposed to improper intercritical heat treatment

causes the substantial reduction in strength observed in the Type IV (refer to sidebar for definition) region of welds made using these alloys (Fig 3). In a Type IV failure, cracking takes place in the fine-grained section of the heat-affected zone of a weldment. There have been about a dozen such failures in P91/T91 components, mostly in the UK, where the alloy has been in service longer than in the US. These failures are a matter of significant concern because they have occurred at a relatively early stage in component life—20,000 to 40,000 hours—and at lower operating temperatures than the maximum design temperature of 1110F.
