Puncture Injury in Close Proximity to the Eye:

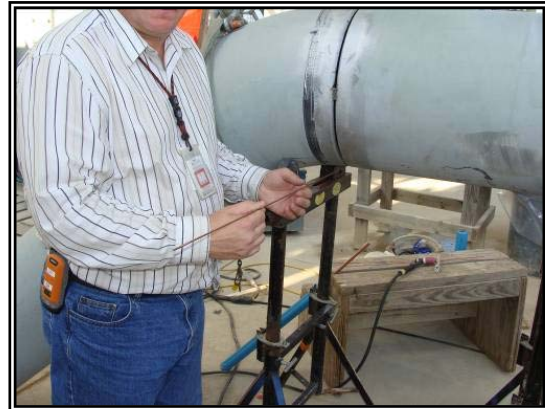
During the process of welding tacks on an 18" pipe, a welder left a TIG rod, approximately 2 foot long, in place when leaving the immediate area. At that time, a pipefitter was sweeping in the immediate area and stooped down to check the fit for adequate spacing. The end of the TIG rod punctured the pipefitter in the area between the right eye and nasal airway, resulting in significant injury.

- Never leave welding rods protruding from welds unattended.
- Limit the length of rods when possible.
- If a welding rod becomes stuck or lodged in the weld, ensure crew members in the area are aware of the hazard and a method of protection is put in place until the hazard can be eliminated.
- Evaluate area before acting and/or performing tasks to ensure potential hazards are recognized and controlled.
- Employ danger tape, cap end covers and / or other similar means to identify this and similar hazards when they exist during working activities
