# STURGEON SAFETY ALERT

Sturgeon's Colorado C&I group suffered its fourth OSHA recordable injury on November 5, at Denver Health.

# STURGEON SAFETY RESULTS

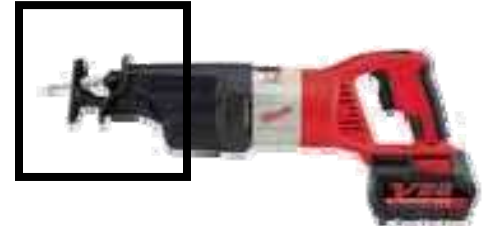
Employee was using a Milwaukee cordless V28 Sawzall reciprocating saw (shown here) to demo flex in wall while performing customer requested rework to relocate a panel we had already installed. While performing the necessary demolition, the blade of the sawzall got pinched, causing the sawzall to move in lieu of the blade. This abrupt bucking motion caused the employee's hand to slip over the molded hand guard, with the ring finger of his left hand entering the unprotected area between the ram and the housing of the blade, tearing open a deep cut on the tip of finger.

Contributing factors to this injury were the awkward angle/position of the sawzall and the inadequate protection around the large opening in ram and housing area.

The Safety Committee is investigating other brands of reciprocating saws to determine if there is a model with more effective hand and finger protection covering this area, which they could recommend to the Tool Room. They have identified a corded model with very good protection.

Due to the large number of cordless Milwaukee sawzalls on our jobsites, it is recommended that use and safety concerns regarding this tool be a topic for discussion during Foreman Morning Huddles anytime this tool is to be used.

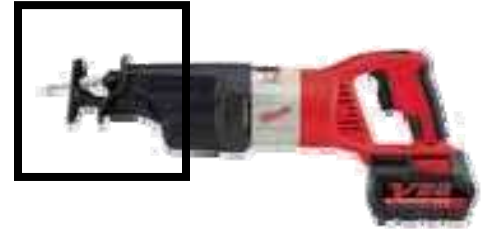
In late November 2008, Sturgeon's Colorado C&I group issued a Safety alert as a result of an employee suffering an OSHA recordable injury. As you probably remember, the employee was using a Milwaukee cordless V28 Sawzall reciprocating saw (shown here) to demo flex in wall while performing customer requested rework to relocate a panel we had already installed. While performing the necessary demolition, the blade of the sawzall got pinched, causing the sawzall to move in lieu of the blade. This abrupt bucking motion caused the employee's hand to slip over the molded hand guard, with the ring finger of his left hand entering the unprotected area between the ram and the housing of the blade, tearing open a deep cut on the tip of finger.
