A Final Report for

TESTING FOR COMPATIBILITY OF STEEL WITH BIODIESEL

SwRI® Project No. 08.13070

April 7, 2008

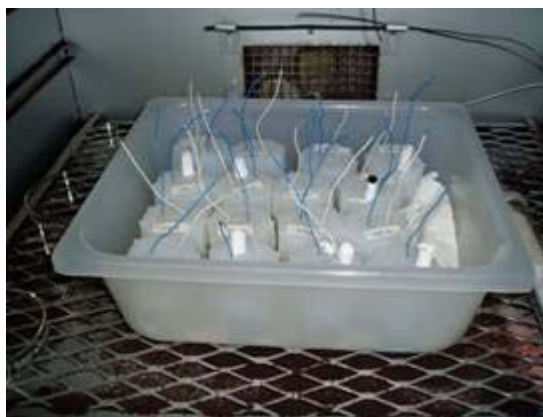
Oven during testing

Test cells in oven

Figure 3. Photograph of test setup used in electrochemical tests.

The cells were placed in an oven at 43°C. The impedance spectra were collected once a week during the 90-day exposure. The cells were disassembled, the specimens visually inspected, photographed and weighed after 1 month, 2 months and 3 months in the case of the first set and after 1.5 months and 3 months in the case of the second set.

The test setup is shown in Figure 3.

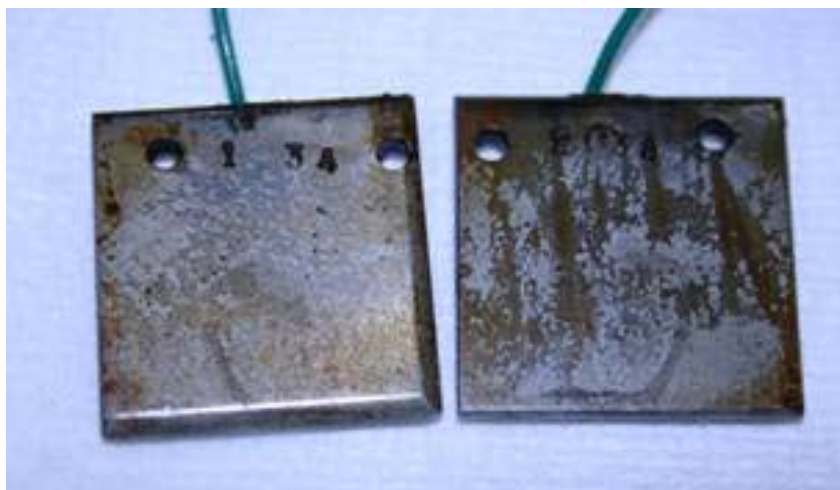
Figure 6. Photographs of carbon steel specimens polished to 600 grit, then exposed to 20% animal-based biodiesel + 80% 4000 ppm S petroleum diesel blend with the presence of 1 vol% water for 3 months.

In most cases, the amount of surface rusting was slightly higher in 100% ULSD than in soy-based biodiesel or soy-based biodiesel + ULSD blends. The extent of surface rusting was also slightly higher in the case of the animal-based biodiesel and blends when compared to the soy-based biodiesel and its blends. No difference in the amount of surface rusting was seen with and without the addition of water and between ULSD and 4000-ppm sulfur petroleum diesel. The surface rusting was caused by a reaction between the surface oxide/tarnish layer of the metal and the fuel blend. The surface rust formed even on polished specimens, although to a lesser extent, as shown in Figure 6.

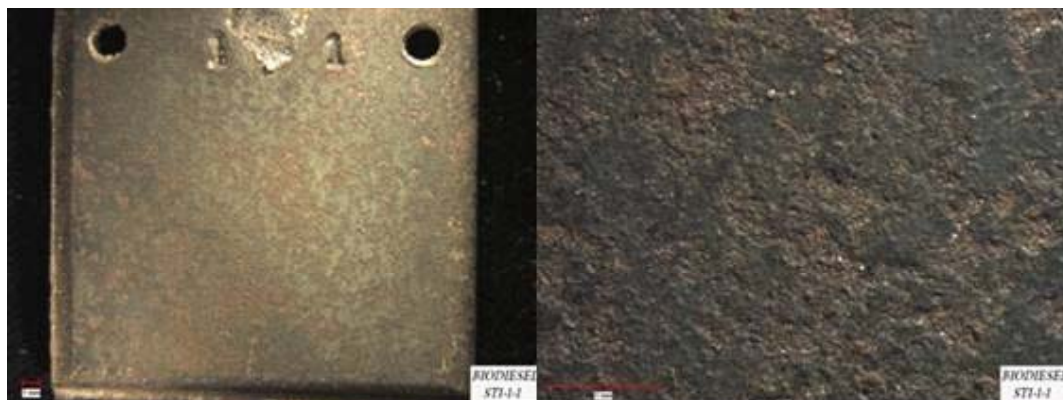
Figure 8. Low magnification optical microscope images of carbon steel test coupons exposed to fuel blends: (a) 100% soy-based biodiesel, no water added; (b) 50% biodiesel + 50% ULSD, no water added; (c) 100% ULSD, no water added.

To further investigate the surface damage observed on the test coupons, low magnification optical micrographs were taken. Representative micrographs for each set of exposures are shown in Figures 8 and 9, respectively.

The micrographs confirm the visual observations, that is, only a small amount of surface damage is present on the test coupons; no extensive general corrosion damage or pitting was observed. The aggressive fuel blend caused the most extensive pitting damage on the surface, as expected. Even these pits, however, were very shallow; the deepest pit found on the surface was approximately 13 μm deep as indicated by the depth profile shown in Figure 10. All other surface damage found on the specimens was under 5 μm deep.

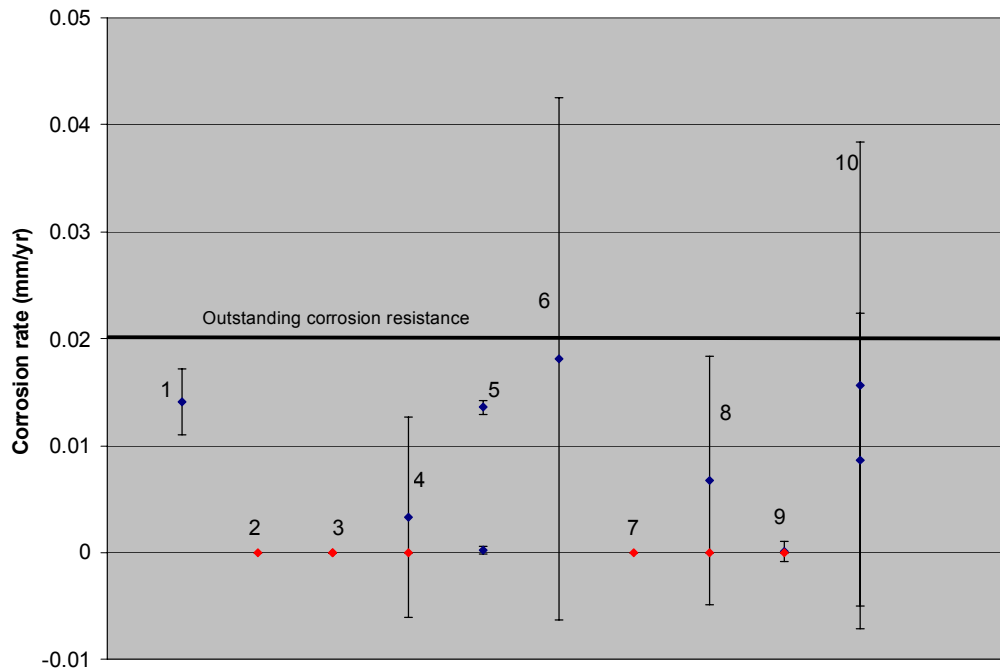
Figure 11. Corrosion rates calculated from mass changes of steel test coupons as a function of solution chemistry (set 1): (1) 100% soy-based biodiesel, no water added; (2) 50% biodiesel + 50% ULSD, no water added; (3) 20% biodiesel + 80% ULSD, no water added; (4) 5% biodiesel + 95% ULSD, no water added; (5) 100% ULSD, no water added; (6) 100% biodiesel + 1 vol% water; (7) 50% biodiesel + 50% ULSD + 1 vol% water; (8) 20% biodiesel + 80% ULSD + 1 vol% water; (9) 5% biodiesel + 95% ULSD + 1 vol% water; (10) 100% ULSD + 1 vol% water.

The calculated corrosion rates for each set are shown in Figures 11 and 12, respectively. The corrosion rates were assumed to be zero if mass gain was observed on the test coupons (red datapoints).

The corrosion rates were not significant in the case of the first set of exposures indicating the lack of corrosion in the system. The average corrosion rates were below 0.02 mm/yr, which corresponded to outstanding relative corrosion resistance for typical ferrous and nickel alloys¹. No apparent correlation was found between the corrosion rate and solution chemistry (Figure 11).

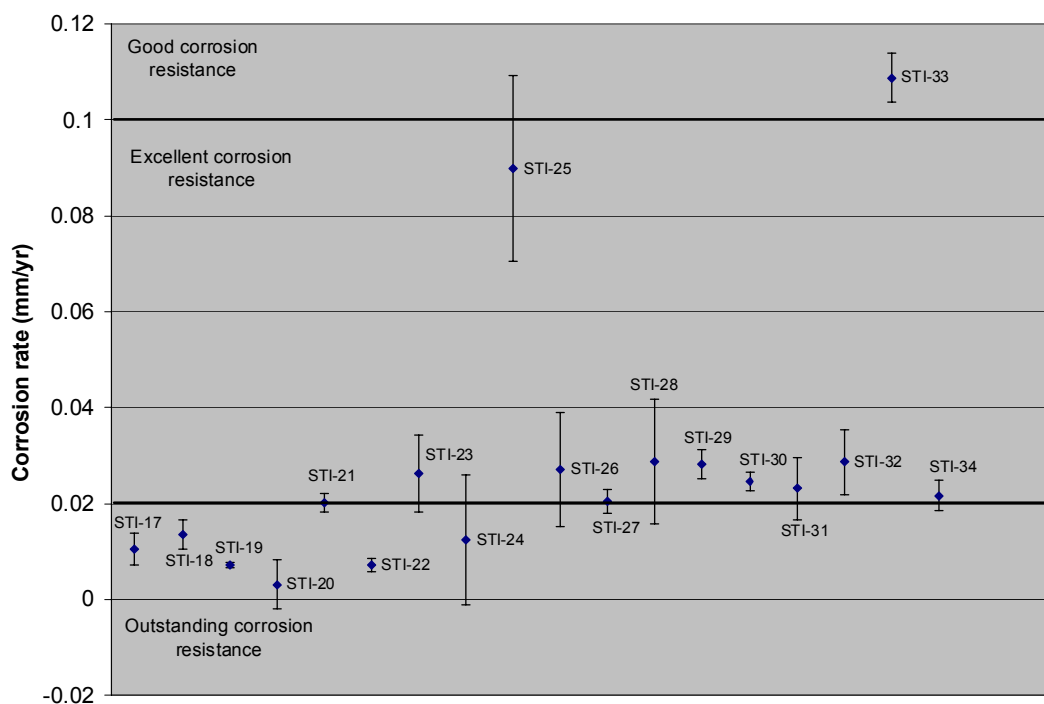
Figure 12. Corrosion rates calculated from mass changes of steel test coupons as a function of solution chemistry (set 2). The data labels correspond to the solution IDs in Table 2.

In the case of the second set of exposures, mass loss was observed in all cases; thus, corrosion rates were calculated for all fuel blends. Most of the average corrosion rate values were below 0.04 mm/yr, indicating outstanding or excellent corrosion resistance. The corrosion rates were slightly higher in a blend containing 5% animal-based biodiesel, 95% ULSD fuel blend with the presence of 1 vol% water. No trends were found between the corrosion rates and solution chemistry, similarly to set 1. Surface polishing was found to have no effect on the corrosion rate of steel (STI-30 and STI-34). The corrosion rate observed in the aggressive fuel blend was the highest of all tested solutions, as expected; although even this corrosion rate was small (< 0.12 mm/yr) and it corresponded to good corrosion resistance on the relative corrosion resistance scale¹.

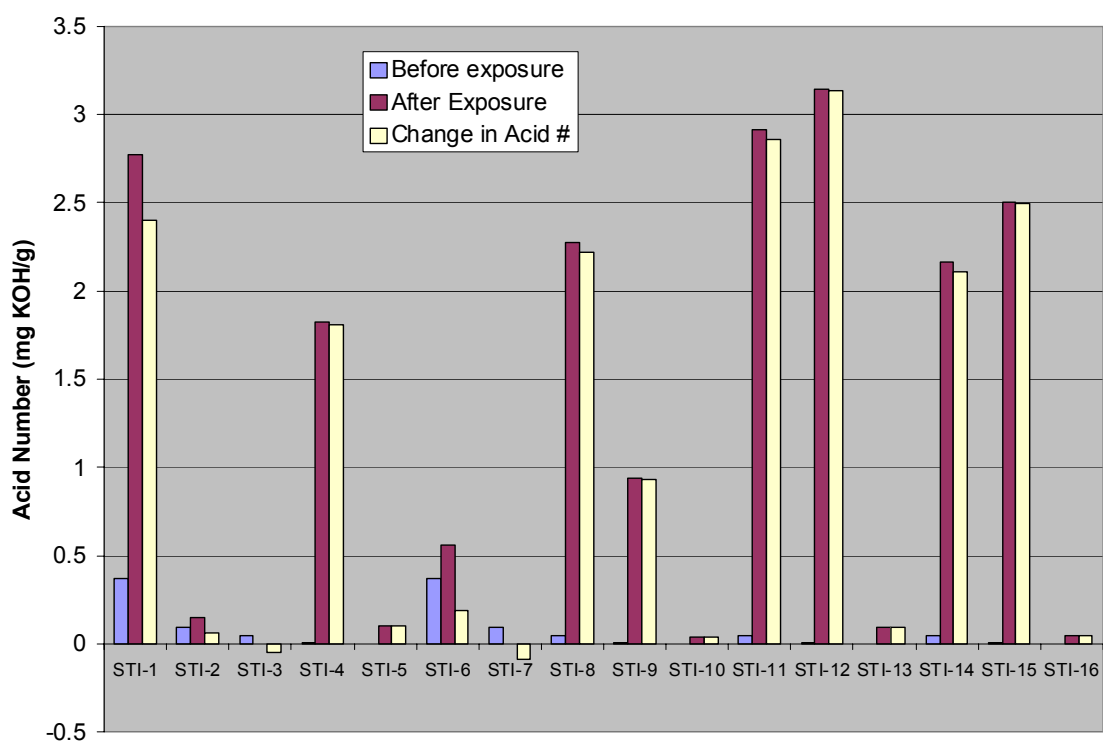
Figure 13. Acid numbers measured in fuel blends containing soy-based biodiesel before and after 90-day exposure to 46°C, as well as change in acid number.

The measured values and the changes in acid numbers are shown in Figures 13 and 14.

The measured acid number values varied between 0 and 3.2, with no apparent correlation between acid number and fuel composition. Upon exposure, the acid number generally increased slightly, although in some instances it decreased. The change in acid number was correlated with the corrosion rate determined from mass loss using correlation factor. The correlation factor between the change in acid number and corrosion rate was found to be -0.256 and -0.382 for the soy- and animal based biodiesels, respectively, indicating no strong correlation between change in acid number and corrosion rate.
