Repurposing underground fuel tanks for aboveground use: A dangerous game

USTs as ASTs: A dangerous game

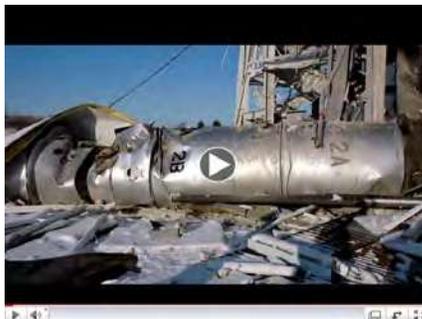
Falling Through the Cracks

The video contains an animation which depicts the stress corrosion cracking that accumulated over time in the walls of the vessel where synthetic quartz crystals were manufactured under extremely high pressures and temperatures.

CSB Chairperson Rafael Moure-Eraso said, "The video dramatically describes the important findings of the CSB investigation - pressure vessels did not meet code requirements, but were granted an exemption; internal corrosion inspections were recommended but never performed; and finally a specific warning was made to the company by its insurer. But at every level, the risk of catastrophic vessel failure was overlooked and public safety, literally and figuratively, fell through the cracks."

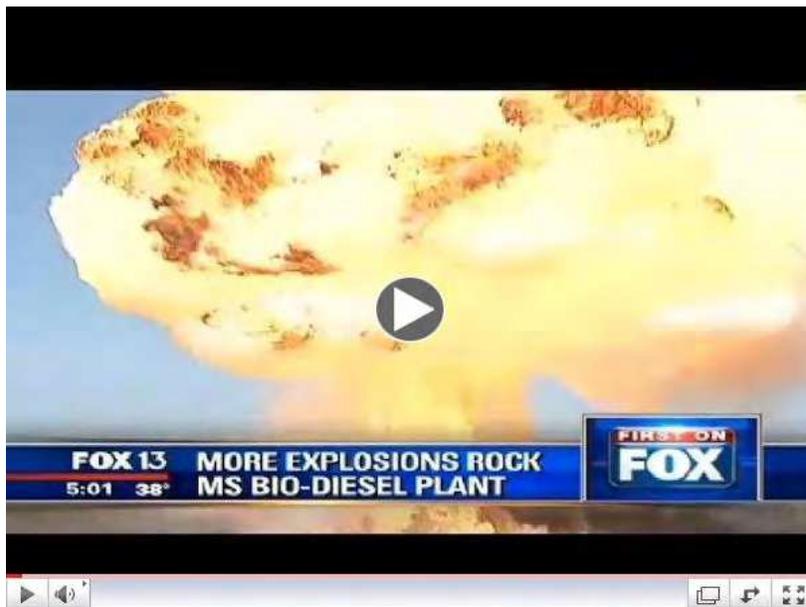
Explosions, Massive Fire Rock New Albany Biodiesel Plant

On January 22, an explosion and fire occurred at a biodiesel plant that converts chicken fat to alternative fuel. Despite the explosion being heard, seen, and felt for miles, nobody was injured. It did knock out power to a town a few miles away. First responders were unable to fight the fire effectively with water due to the presence of reactive chemicals in other tanks, and remaining tanks at the plant eventually exploded as the fire burned itself out. Some area residents evacuated and a local school was closed the following day.

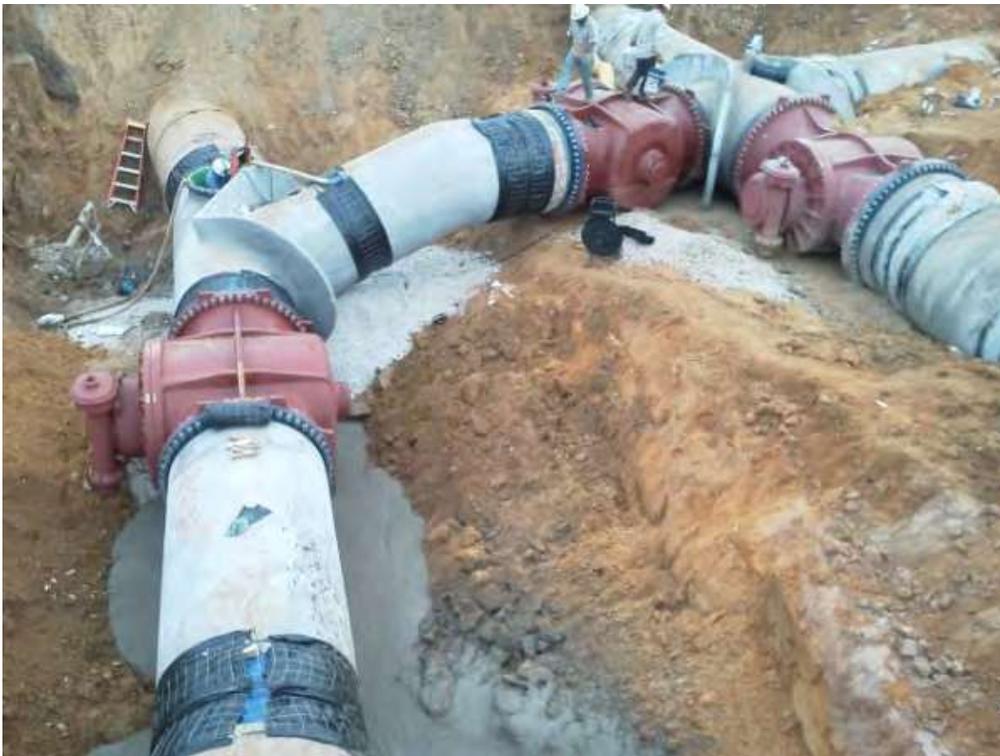
Steel Water Pipe Fabrication Award
Mid-America Pipe Fabrication & Supply, Scammon KS
Influent Pump Station at Dallas Central WWTP

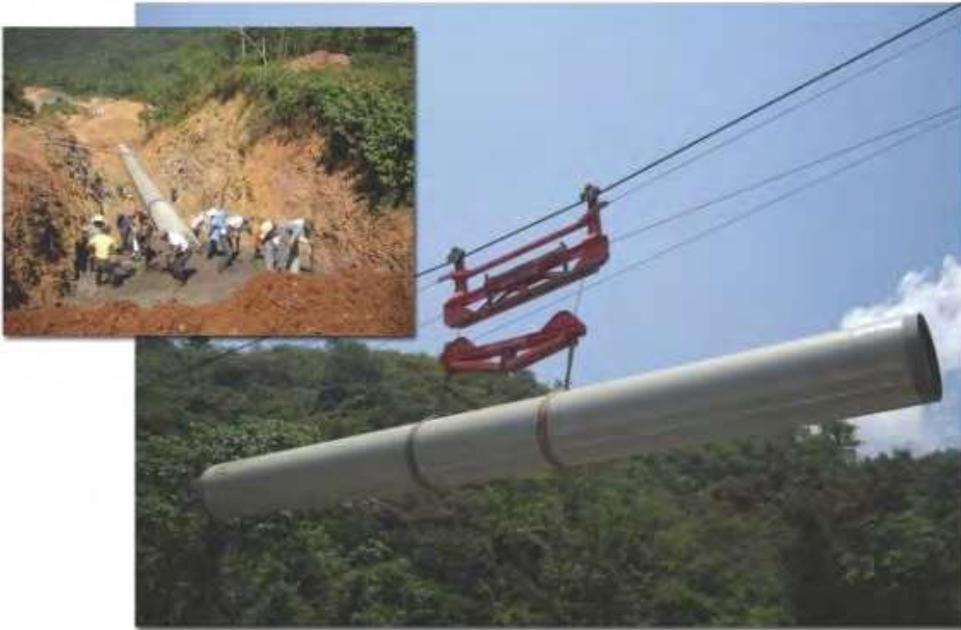
Steel Water Pipeline Project Award
Ameron International, Rancho Cucamonga CA
Choloma Hydroelectric Project, Senahu, Guatemala

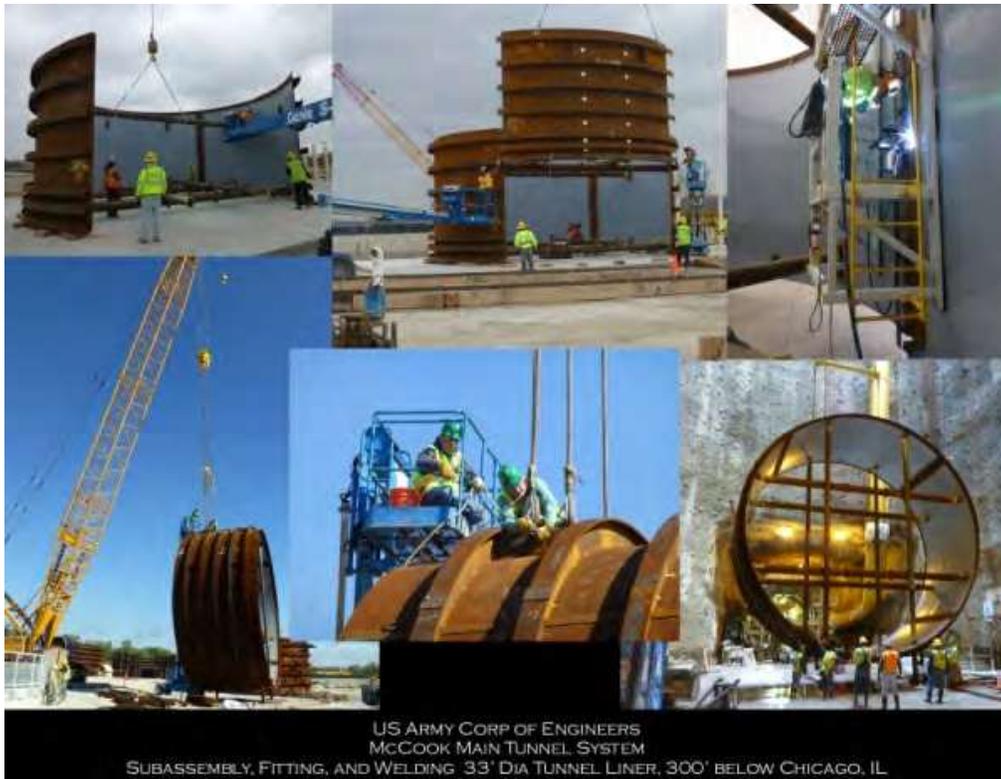
Affiliate Steel Water Pipe Project Award
National Welding Co., Midvale UT
McCook Main Tunnel Liner, Chicago
