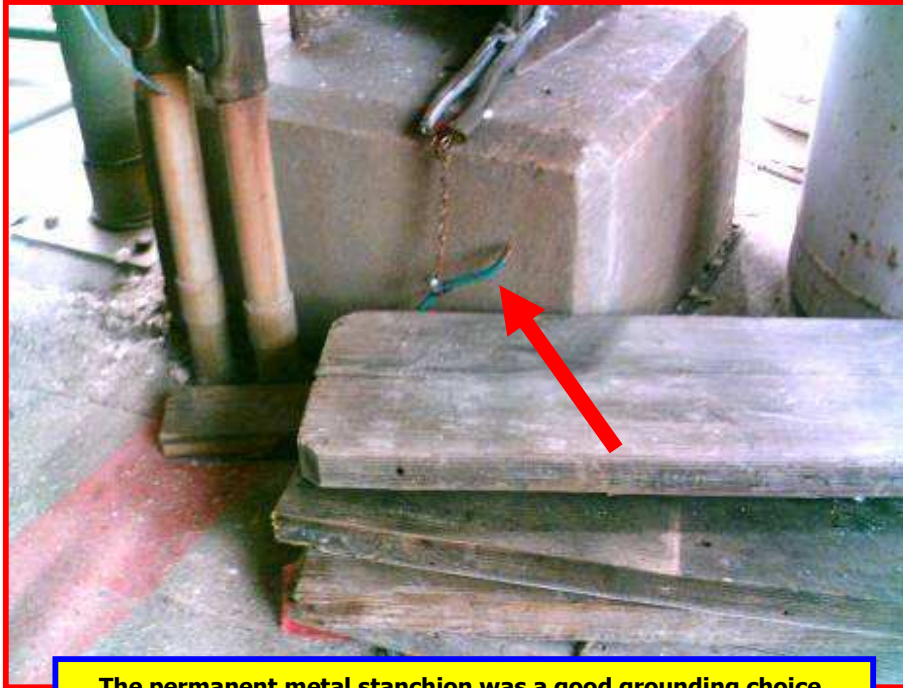
The permanent metal stanchion was a good grounding choice, but the ground wire has pulled loose from the clamp. The chain is attached to the insulation and is not making a good electrical connection. **This is not a suitable ground.**

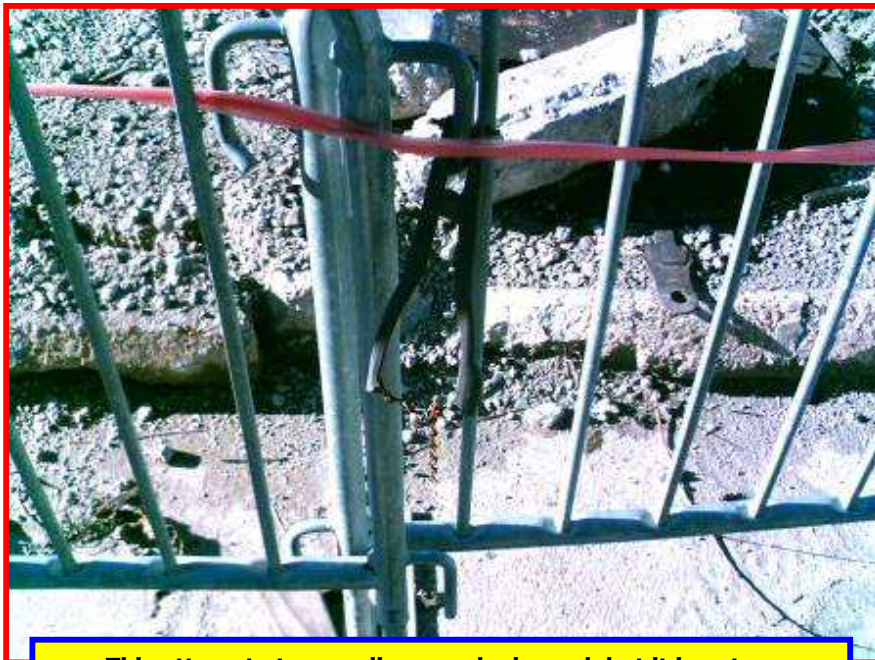
This attempt at grounding may look good, but it is not an effective ground. The metal barricade is sitting on the concrete. It is isolated from earth ground, making it a poor choice for grounding.

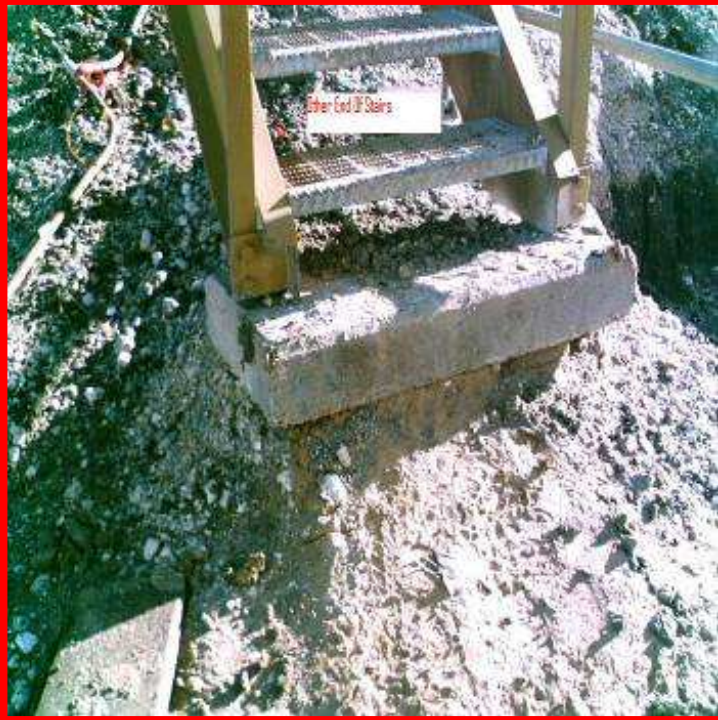
How about these stairs? See how the foundation is just sitting on top of the earth? Note that there is no underground foundation (rebar) that goes down into the soil. **This would not serve as a good ground.**

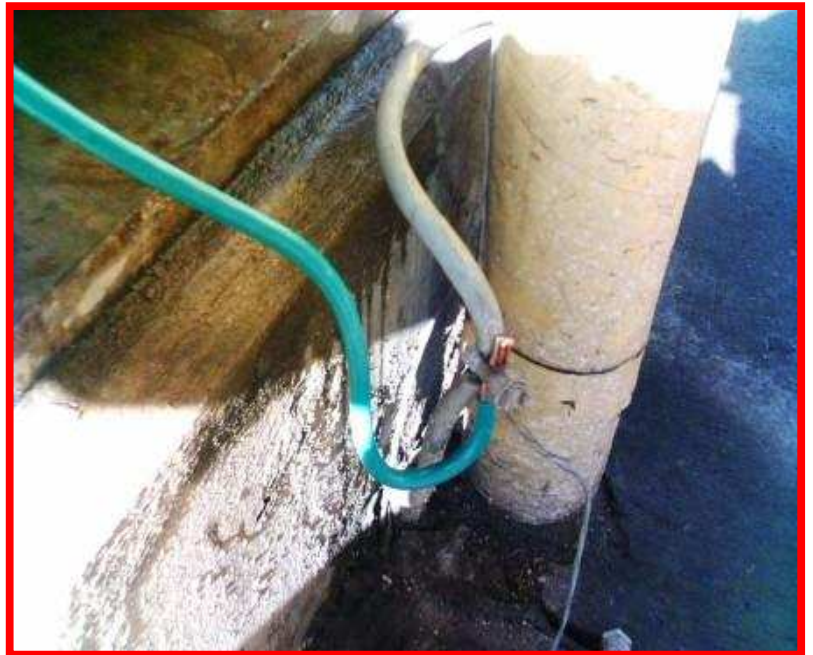
This would be a good place to attach a ground. Green wiring as shown is part of the unit ground grid. Note the green wire that is running down into the ground goes to the underground grid system.
