PRODUCT NOTICE — SNAPHOOKS

Capital Safety is aware of an assembly issue with snaphooks manufactured by a supplier. These snaphooks are widely used components in fall protection products. The issue concerns missing or improperly installed rivets (see photograph below). The manufacturer symbol is a stamped “Y” as shown in the photograph.

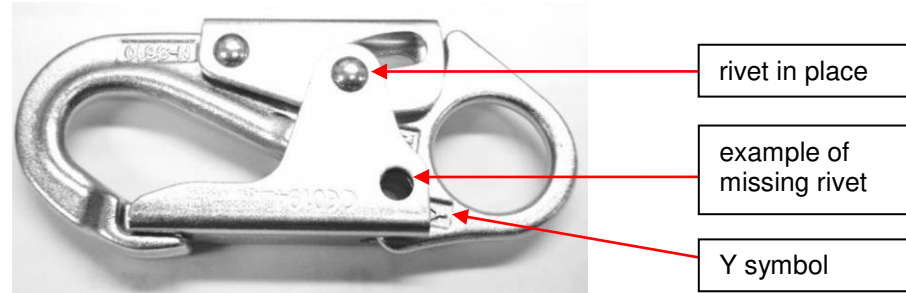
The picture above is a representative model snaphook – other models are also affected.

Capital Safety has verified that the supplier implemented an appropriate corrective action program. The supplier’s notification (above) has an imbedded video demonstration of its revised process.
