# **Compatibility Considerations for UST Systems**

**Final Report**

**Updated May 2016**

**Emerging Fuels Task Force  
Tanks Subcommittee**

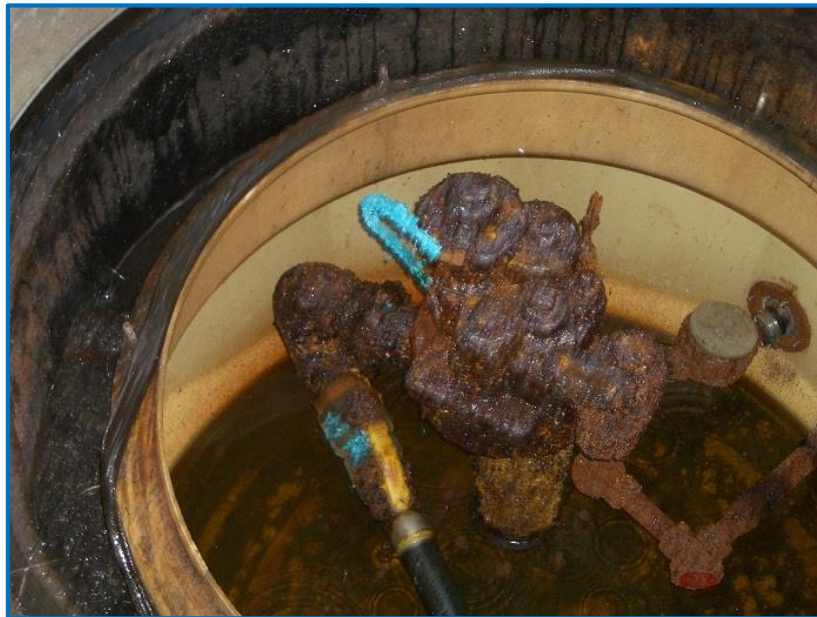
Cover Photo: The picture shows corrosion and acetate crystal formation commonly found in STP sumps for systems storing gasoline-ethanol blends.

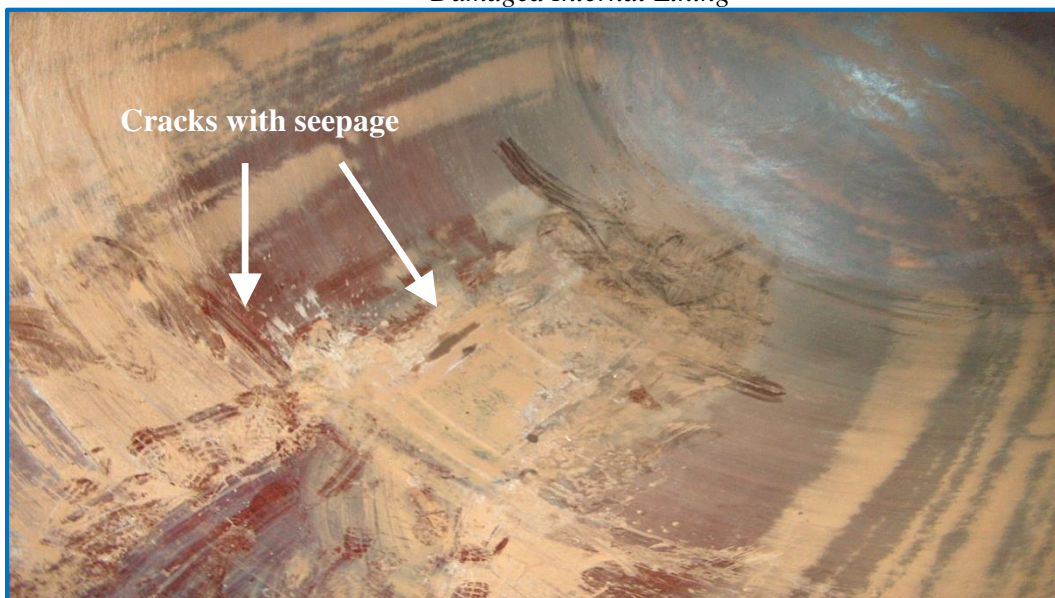
Supporting Pictures:  
*Damaged Internal Lining*

Premium Unleaded gasoline tank installed in 1987 (note: E10 was used as a “winter blend” in AZ fuel starting in approx. 1988). In October 2011 the owner noticed an inventory issue and called their contractor. Automatic tank gauge (ATG) results did not indicate a leak; however, the inspector went through inventory records and found several hundred gallons of fuel missing. The contractor conducted a tank tightness test that failed.

The contractor called the inspector and the tank was emptied to mitigate any further release. The contractor contacted the manufacturer. A 10' x 10' hole was cut into the cement and the manufacturer entered the tank on November 1, 2011. The manufacturer discovered several cracks on the bottom of the tank. ADEQ was notified that the tank is to be re-lined.

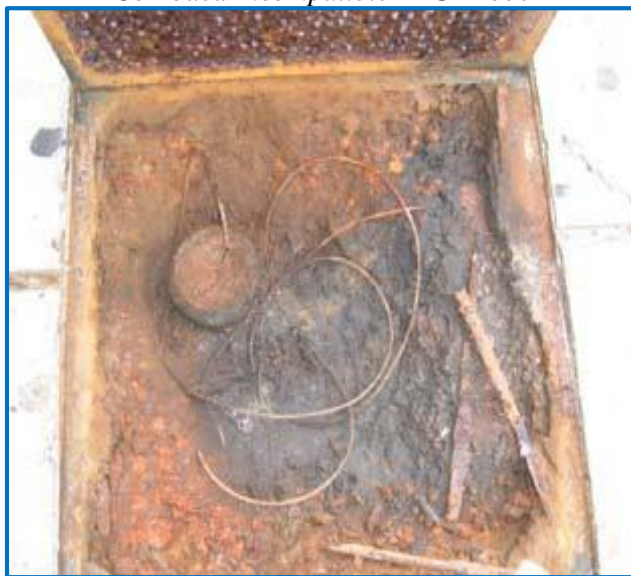
*Corroded Incompatible ATG Probe*

In 2005, prior to the introduction of the “Alternative Fuel Checklist”, this site converted a tank to E85 without the knowledge of the SC UST Program. An inspector performing a routine inspection discovered that the upgrade had taken place. In 2007, the inspector returned for the annual inspection and noticed that several months of ATG printouts were missing. When the tank owner was questioned, he stated that the probe had dissolved because their contractor had installed a regular gasoline probe.

The tank owner was required to submit SC’s “Alternative Fuel Checklist” showing that all equipment (including the probe) was compatible with E85. The checklist was received showing that the probe and all other equipment were now installed were now compatible.

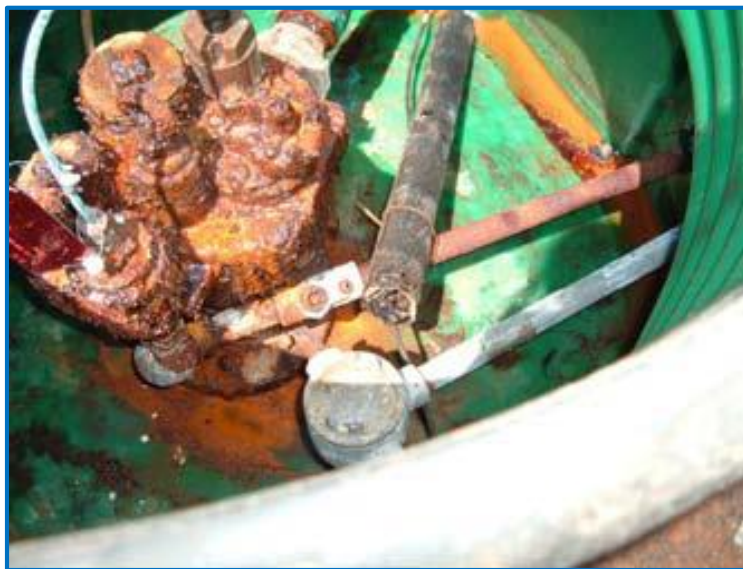
*Corroded STP*

In early 2006, prior to the formal introduction of SC's "Alternative Fuel Checklist", this site converted a tank to E85 without the knowledge of the SC UST Program. In 2007, the inspector visited this site for a routine compliance inspection. The inspector noted excessive corrosion on the submersible pump head and its associated components.

Upon receipt of a completed SC "Alternative Fuel Checklist", it was determined that the submersible pump was the appropriate "AG" (alternative fuel) model and therefore compatible with E85. The manufacturer of the submersible pump clarified that the E85 vapors had caused the paint on the submersible pump housing to run to cause the appearance of corrosion. It was confirmed that none of the internal components were affected. The manufacturer confirmed that the paint formulation used on the submersible pump had changed and that they would monitor other sites across the country for any further instances relating to paint degradation. The site was monitored for any further issues and to this date none have arisen.

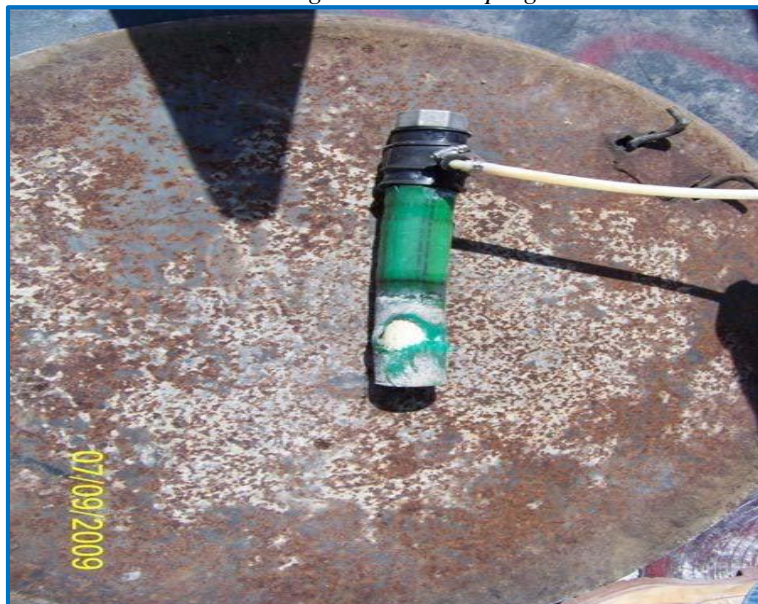
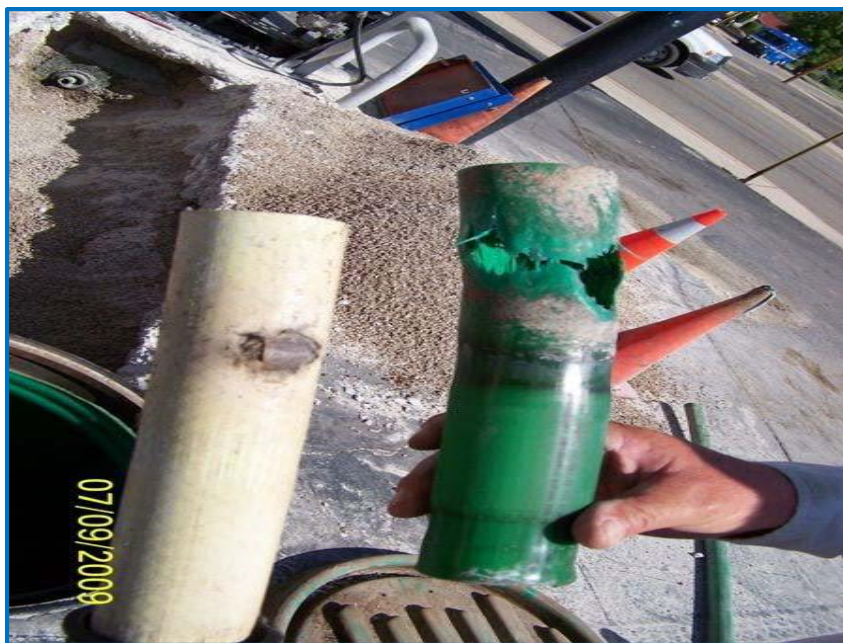
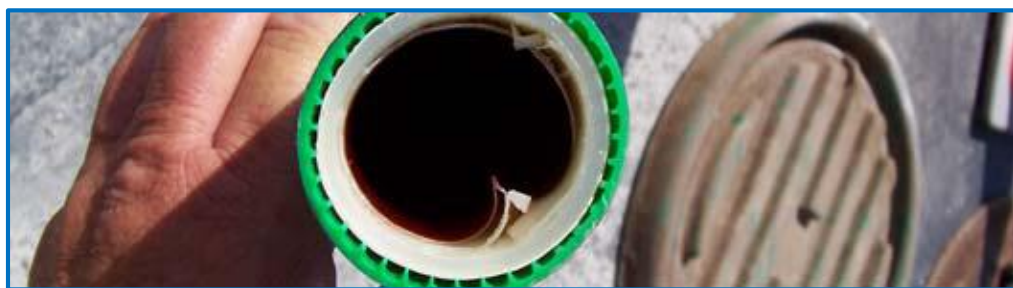
Supporting Pictures:  
*Damaged Environ Piping*

During a compliance inspection in 2009, a UST inspector found product in one of the two dispenser sumps. It was discovered that the piping was leaking from between the primary and secondary walls.

During excavation of the piping around the premium STP, the UST inspectors found evidence of degradation of the outer secondary barrier. Upon further investigation, the inside of the piping was found to be deteriorated.

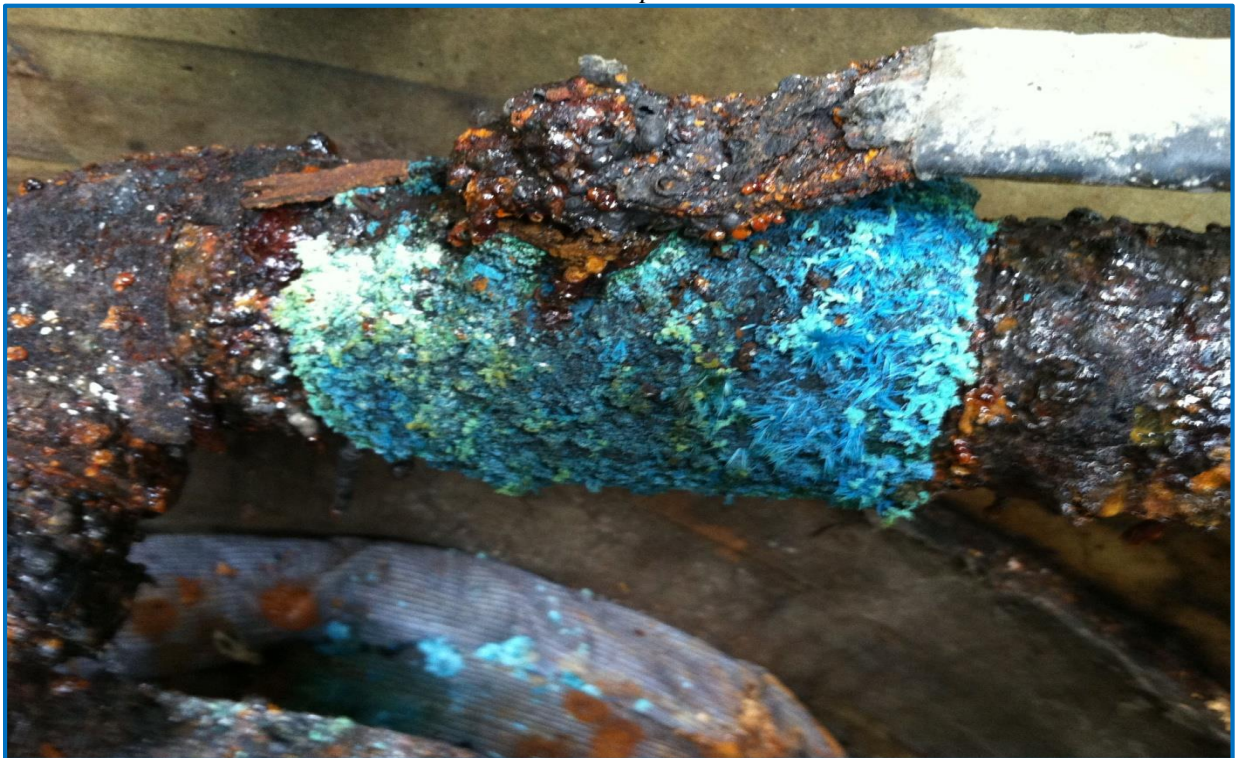
*Blue Buildup*

During a compliance inspection in September 2012, the UST inspector found a blue buildup on steel components associated with the flexible piping in the subpump.

Ethanol vapors possess acidic properties and can act as a corrosive catalyst in the sump environment. This can lead to an aggressive oxidation process (similar to Missouri case study).

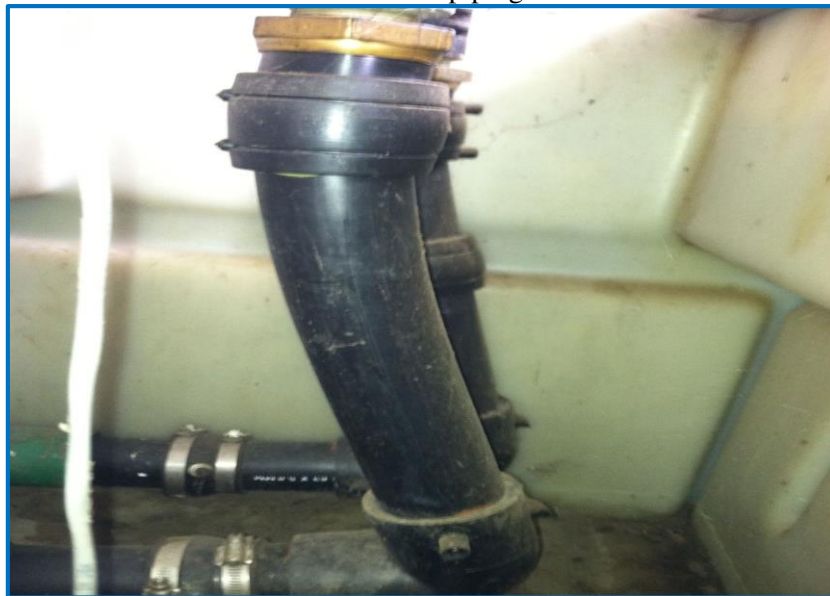
Supporting Pictures:  
Bent UPP piping

During a compliance inspection, it was noticed that the UPP pipe had started to bend (like previous generations of other flexible piping).

Site was asked to monitor pipe for further damage.

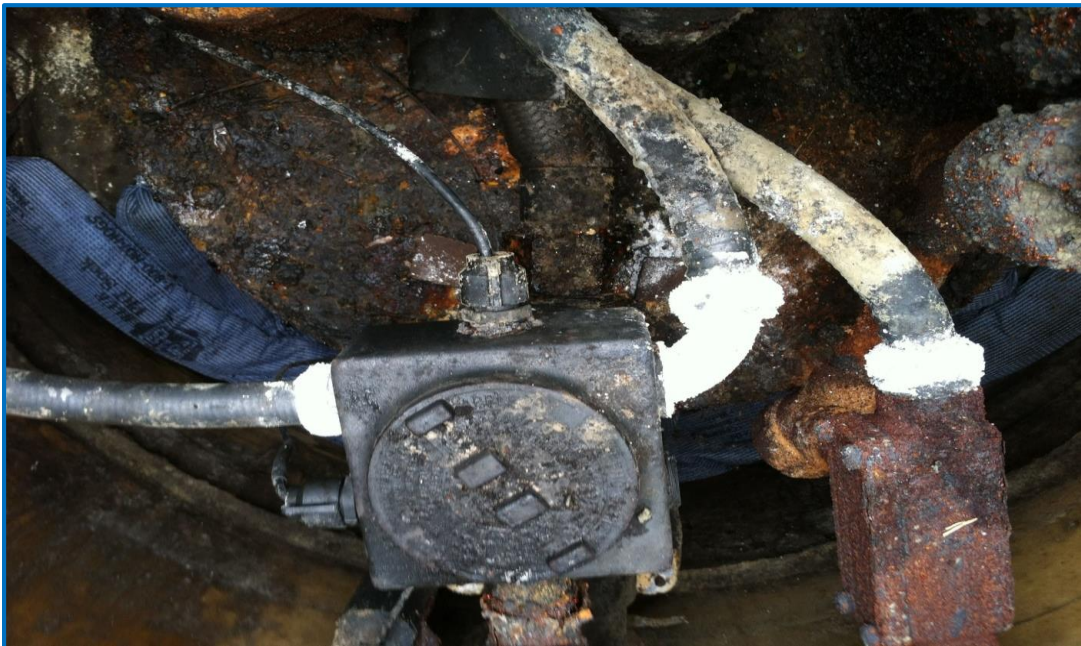
*Corrosion on Conduit in STP*

Corrosion on lead and brass components of the conduit leading to white buildup.

Monitor for further damage.

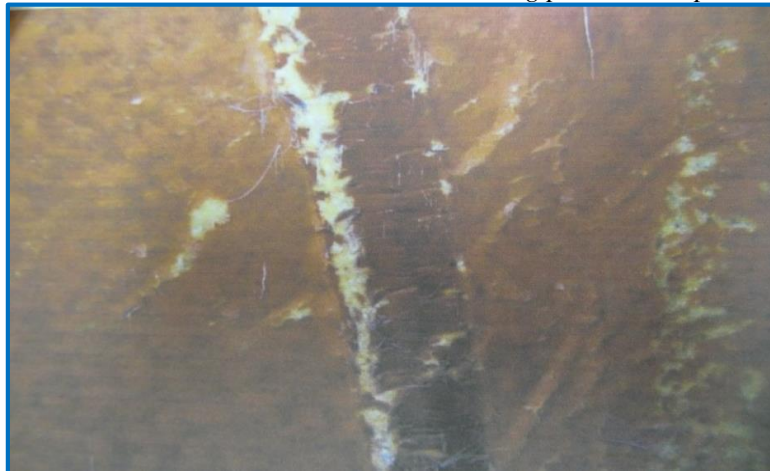
*92 Octane UST – breakdown observed during pre-blast inspection*

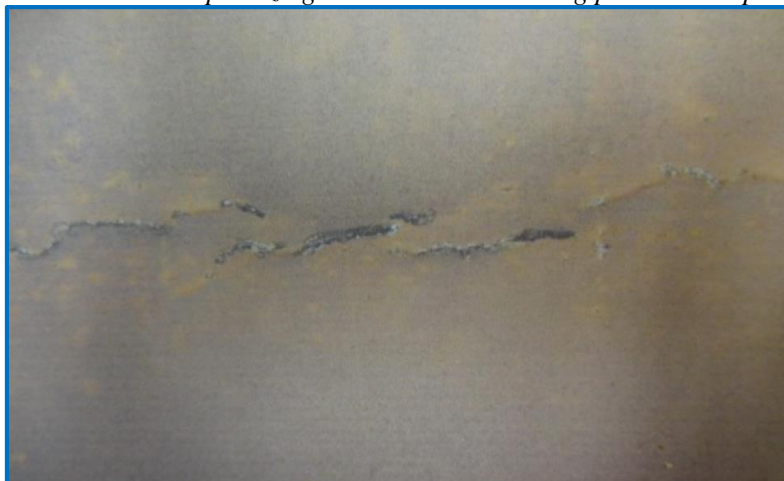
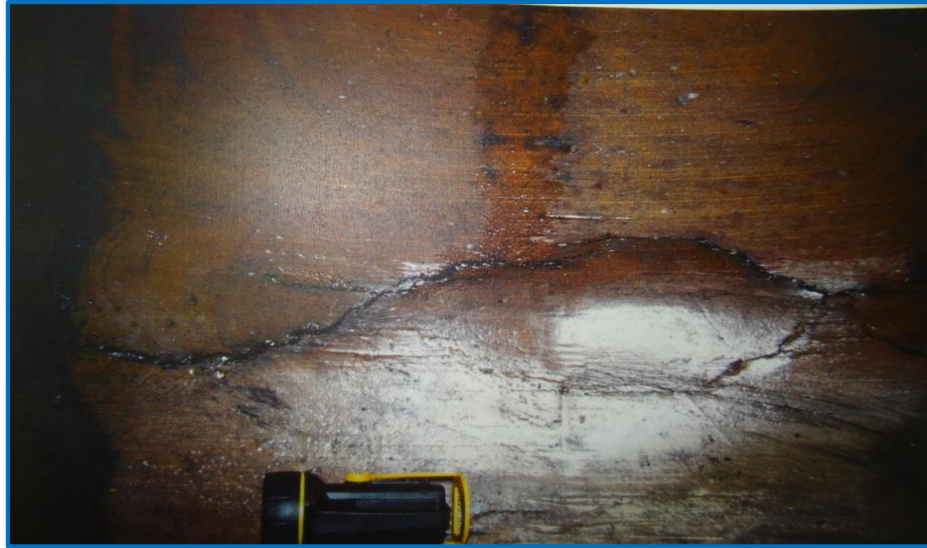
*92 Octane UST – deep crazing/crack observed during pre-blast inspection*

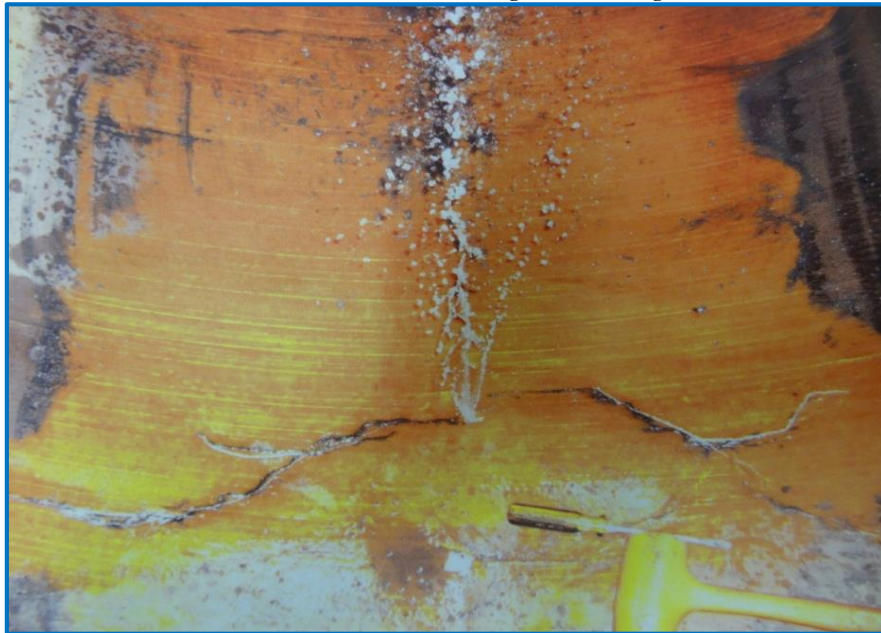
*92 Octane UST interior – water entering tank through crack*

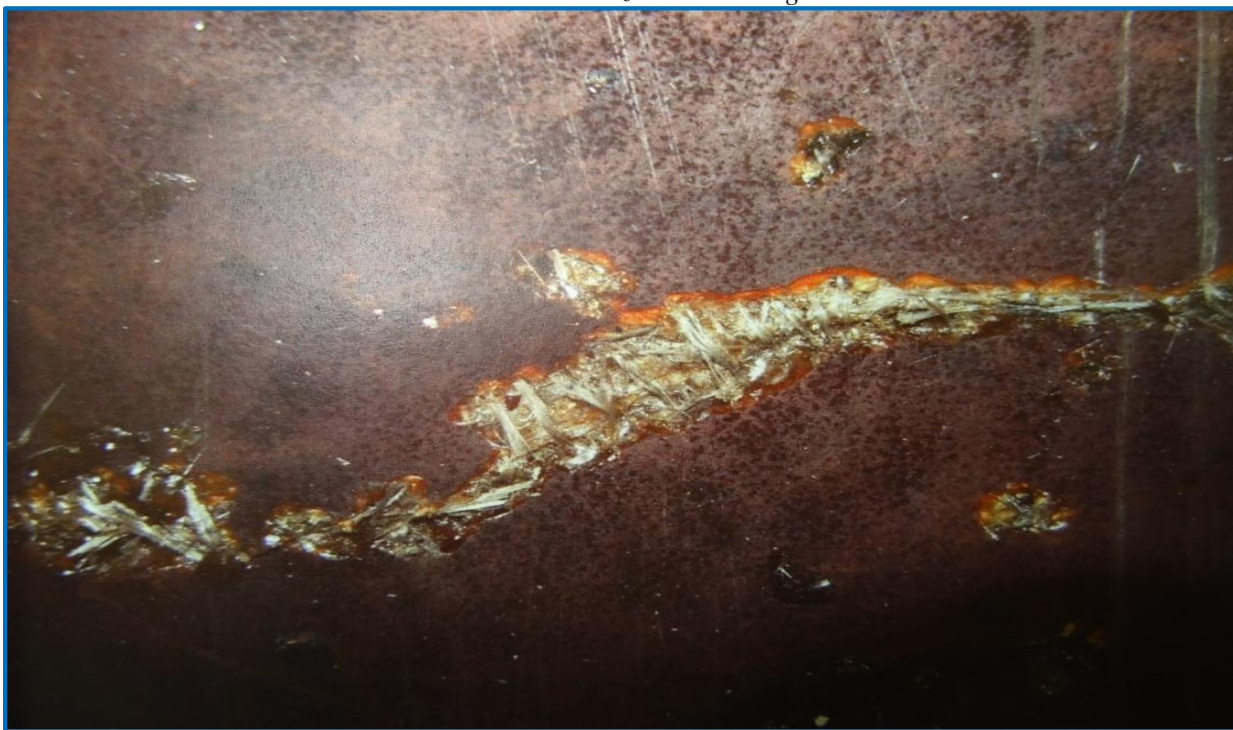
*UST 92 Octane interior view: horizontal cracking in tank shell*

A release was confirmed and all USTs were removed in early 2012.

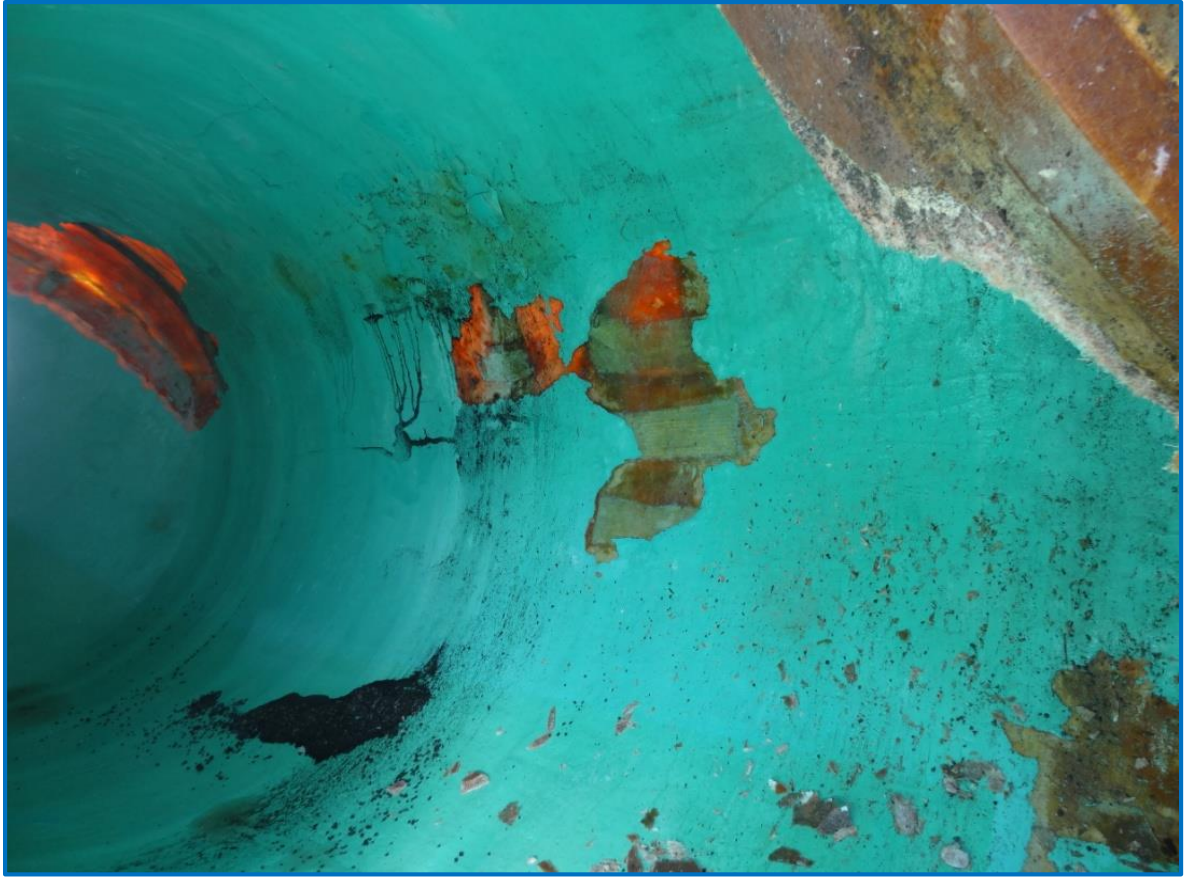
*UST 92 Octane interior view: lining deteriorated*

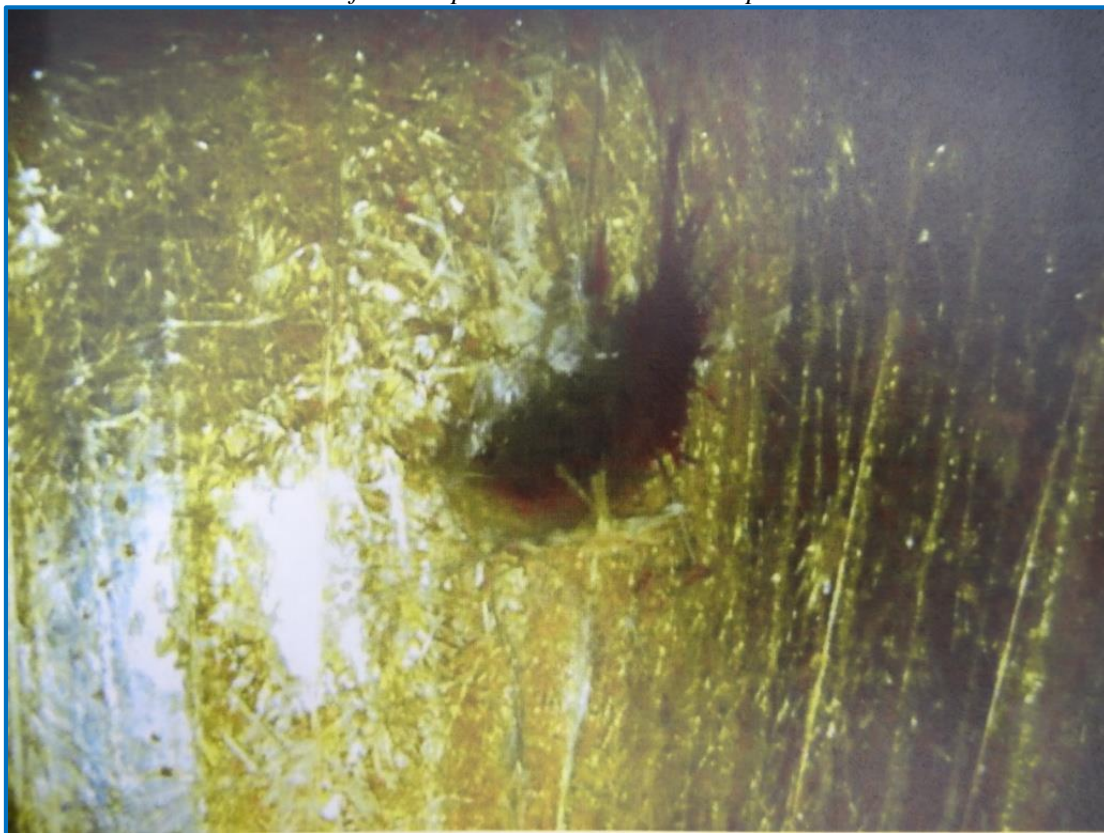
*UST fibers exposed due to chemical exposure*

Tank was lined twice and is currently TOU

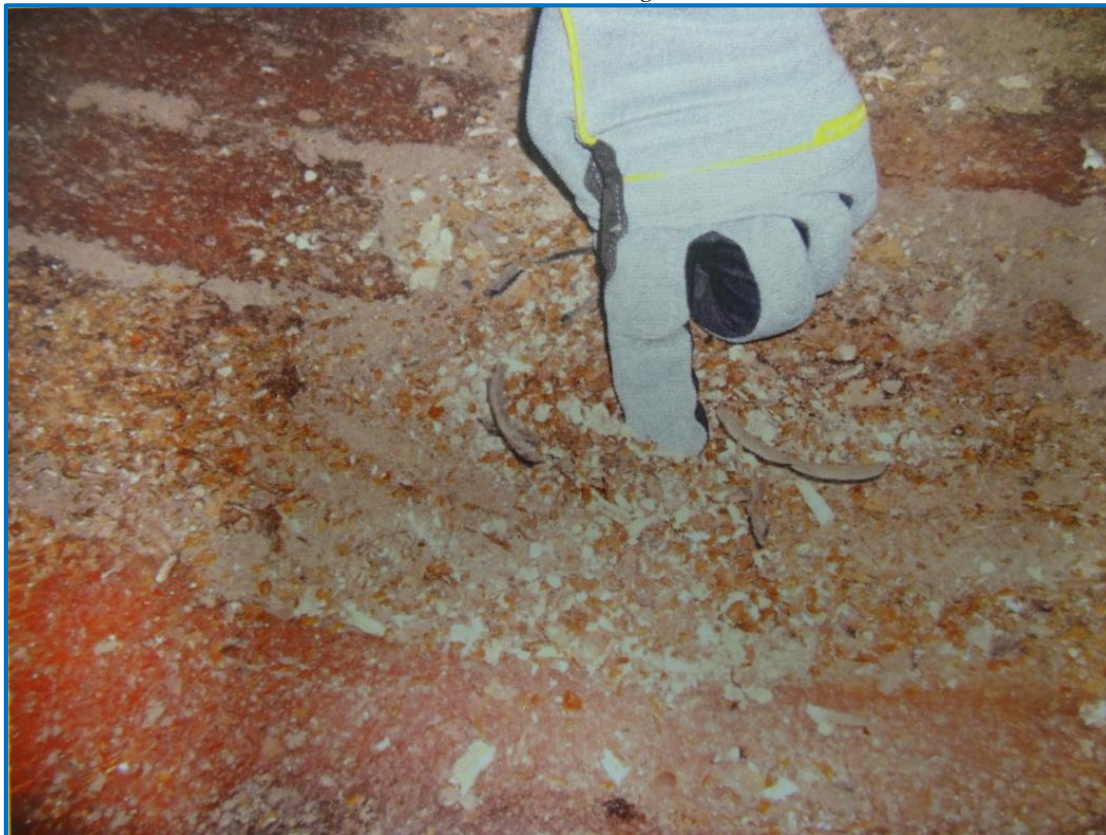
*UST 87 Octane internal view: gel deterioration*

All three USTs showed severe deterioration of internal Gel coat with exposure of fiberglass fibers. There were visible cracks as well as a 2.5 feet long crack on the bottom center and at both ends of the premium UST. There was one (1) large area of crazing in the plus tank. All tanks were eventually lined and returned to service on 10/21/2009.

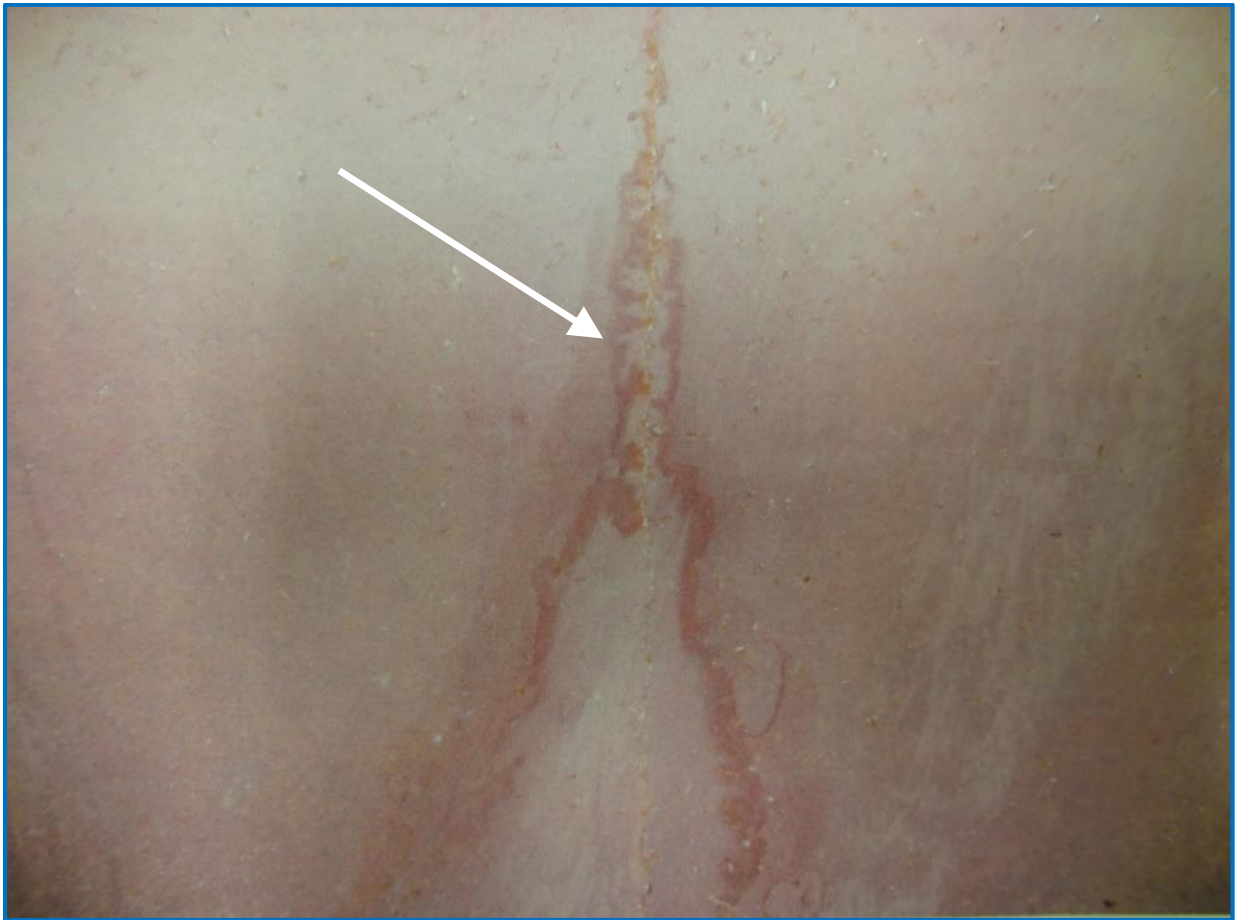
*UST 89 Octane internal view: crack*

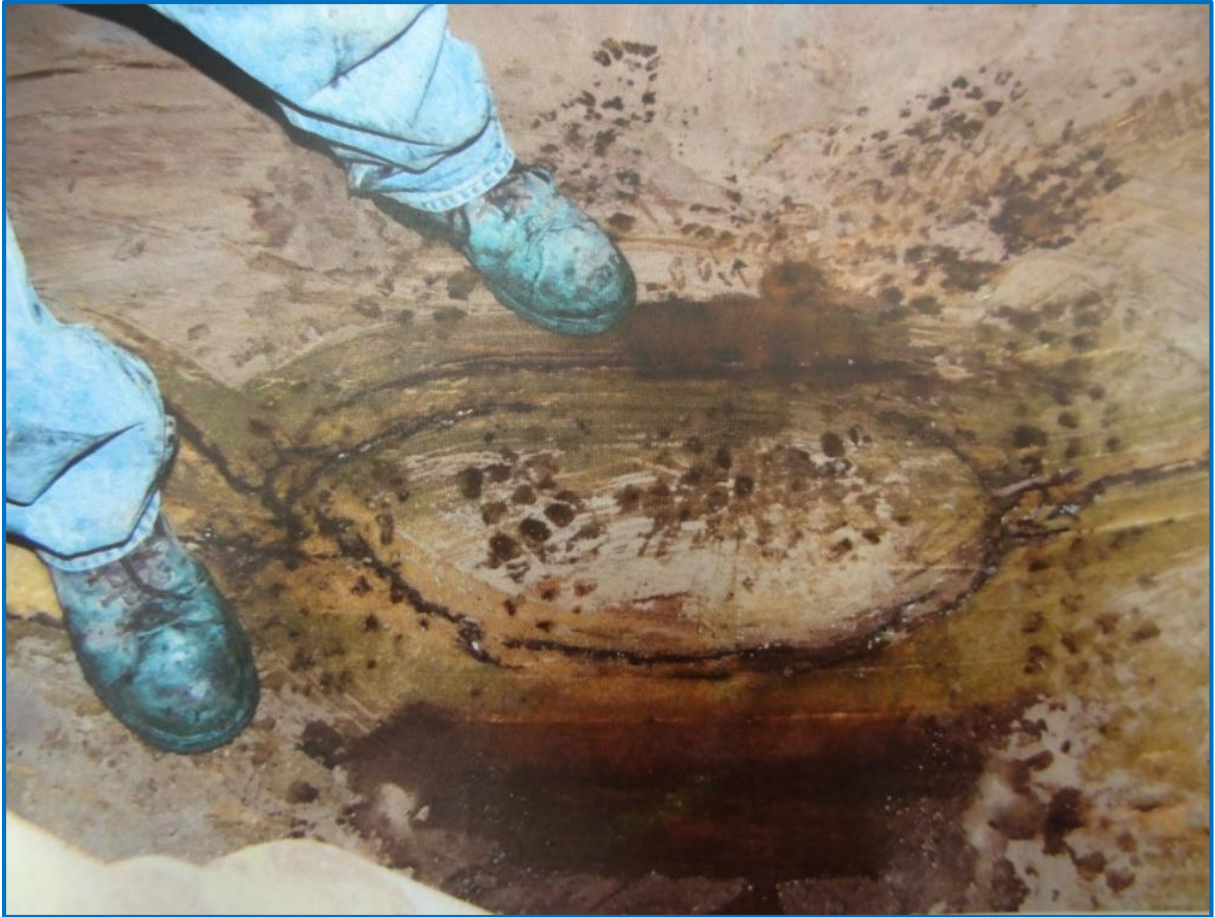
*UST 92 Octane interior – cracked shell*

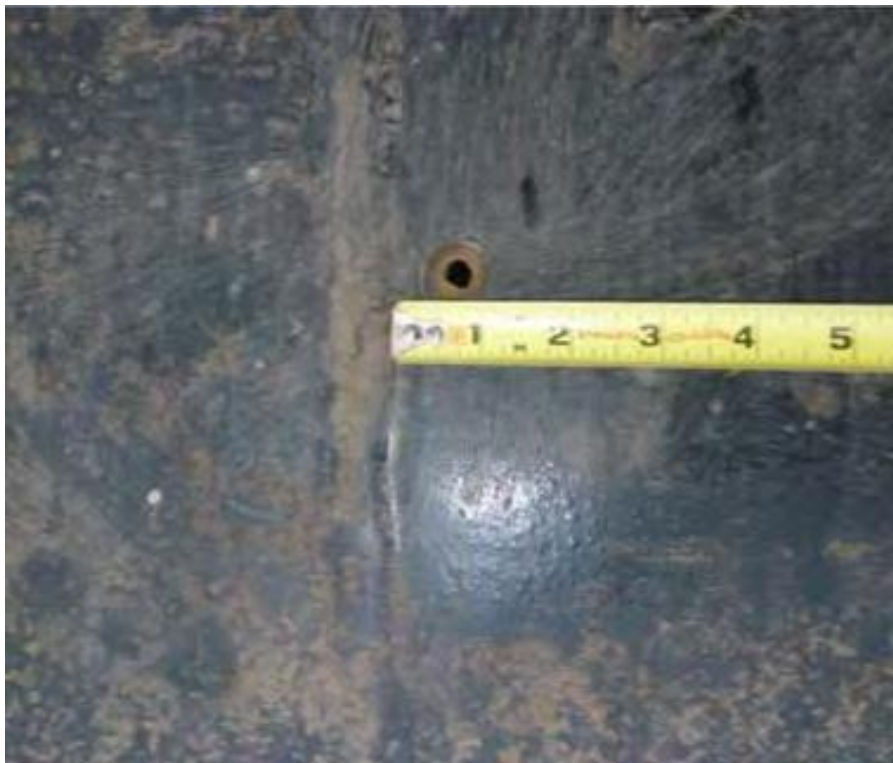
Supporting Pictures:  
*Exterior Photo*

Explosive vapors in building adjacent to site (required evacuation of building). Release was confirmed, LNAPL identified in monitoring well (depth to water: 10-13 feet), estimated volume of loss 9,700 gallons, actual gasoline recovered >14,000 gallons.

Release from perforation in tank caused by internal corrosion. Tank was removed. Total cleanup costs estimated at over \$900,000.
