Compatibility of UST Systems with Biofuels

**Final Report
June 2013**

**Alternative Fuels Workgroup
Tanks Subcommittee**

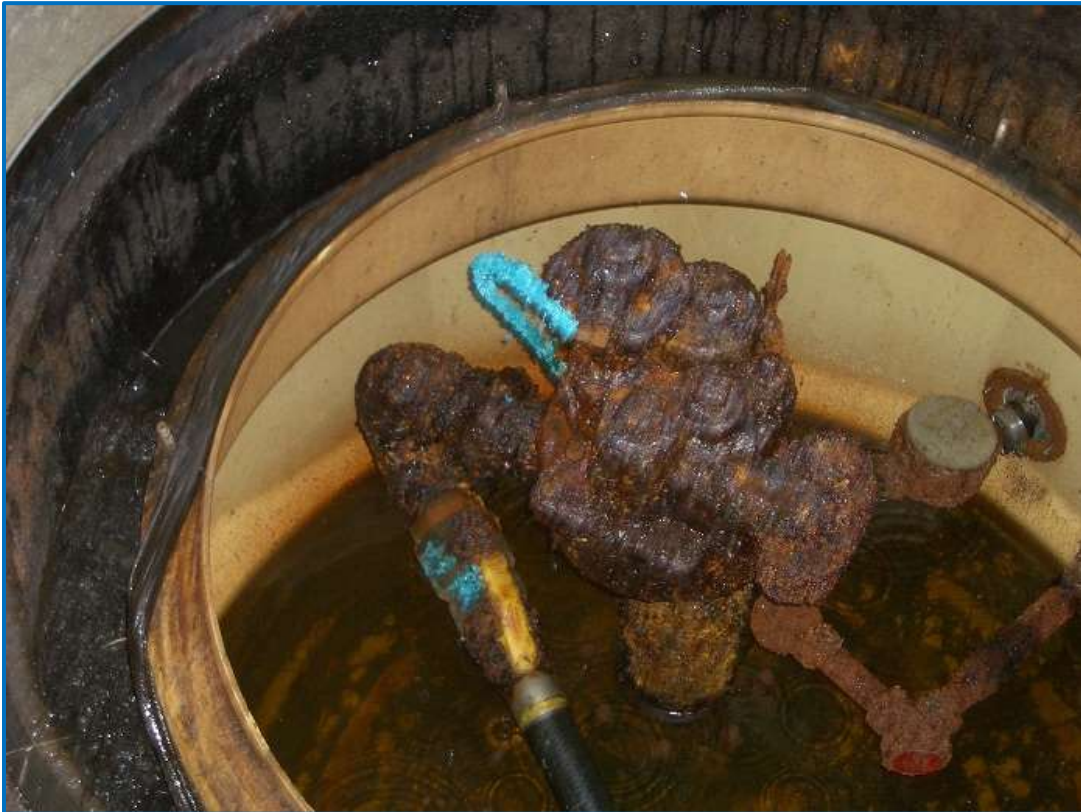
Cover Photo: The picture shows corrosion and acetate crystal formation commonly found in Submersible Turbine Pump (STP) sumps for systems storing gasoline-ethanol blends.

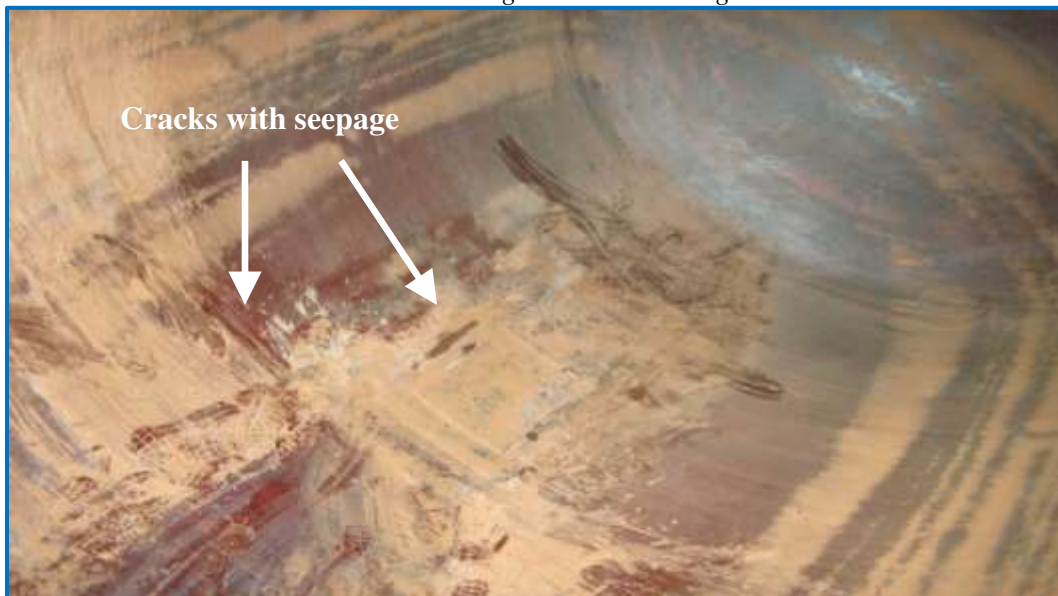
Supporting Pictures: *Damaged Internal Lining*

Premium Unleaded gasoline tank installed in 1987 (note: E10 was used as a “winter blend” in AZ fuel starting in approx. 1988). In October 2011 the owner noticed an inventory issue and called their contractor. Automatic tank gauge (ATG) results did not indicate a leak; however, the inspector went through inventory records and found several hundred gallons of fuel missing. The contractor conducted a tank tightness test that failed.

The contractor called the inspector and the tank was emptied to mitigate any further release. The contractor contacted the manufacturer. A 10' x 10' hole was cut into the cement and the manufacturer entered the tank on November 1, 2011. The manufacturer discovered several cracks on the bottom of the tank. Arizona Department of Environmental Quality (DEQ) was notified that the tank is to be re-lined.

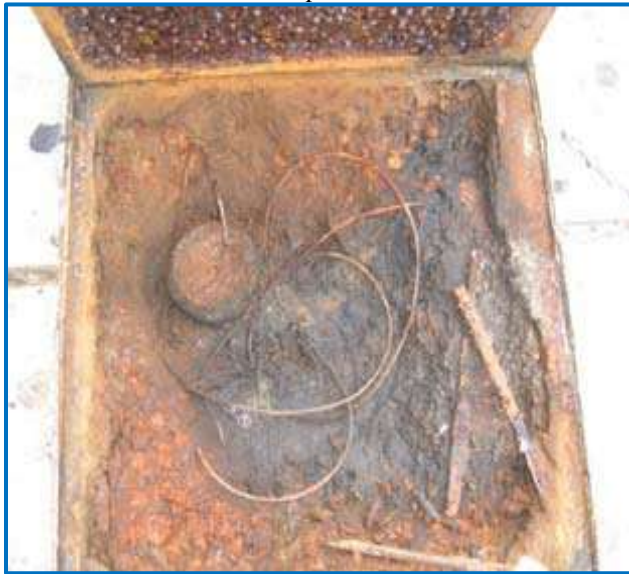
Corroded Incompatible ATG Probe

In 2005, prior to the introduction of the “Alternative Fuel Checklist”, this site converted a tank to E85 without the knowledge of the SC UST Program. An inspector performing a routine inspection discovered that the upgrade had taken place. In 2007, the inspector returned for the annual inspection and noticed that several months of ATG printouts were missing. When the tank owner was questioned, he stated that the probe had dissolved because their contractor had installed a regular gasoline probe.

The tank owner was required to submit SC’s “Alternative Fuel Checklist” showing that all equipment (including the probe) was compatible with E85. The checklist was received showing that the probe and all other equipment that were now installed were now compatible.

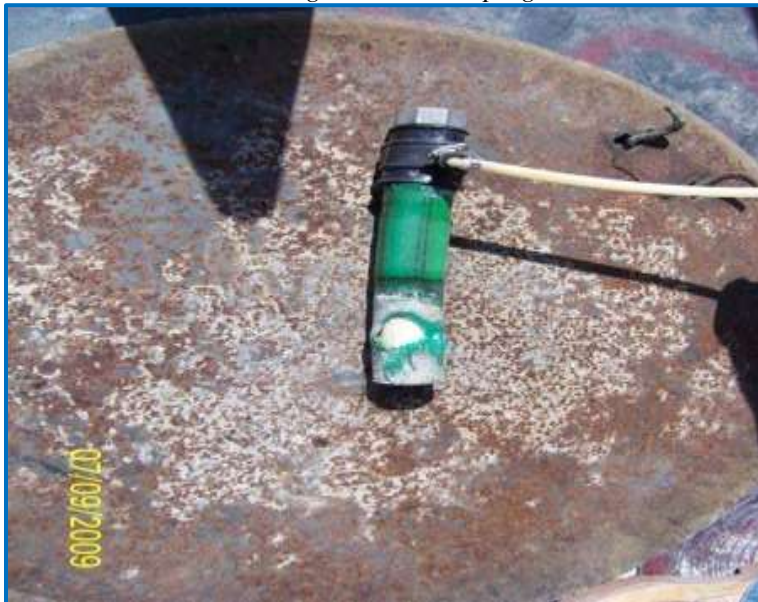
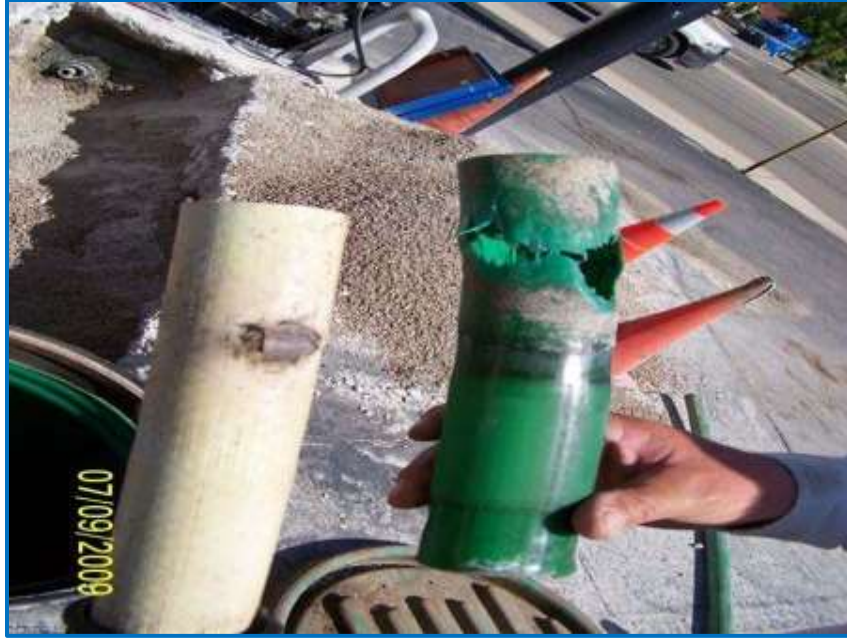
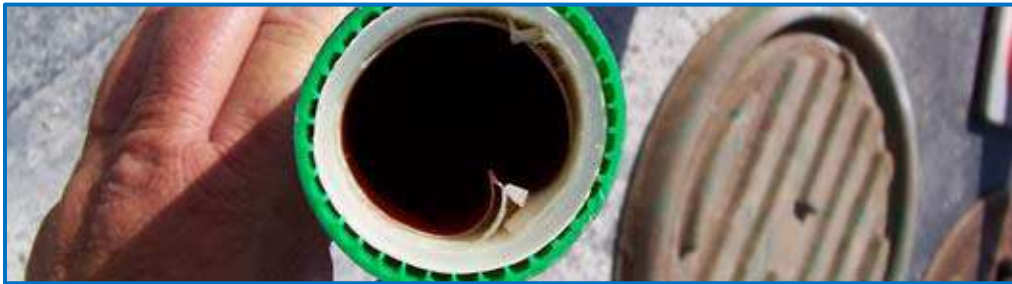
Supporting Pictures: *Damaged Environ Piping*

During a compliance inspection in 2009, an UST inspector found product in one of the two dispenser sumps. It was discovered that the piping was leaking from between the primary and secondary walls.

During excavation of the piping around the premium STP, the UST inspectors found evidence of degradation of the outer secondary barrier. Upon further investigation, the inside of the piping was found to be deteriorated.

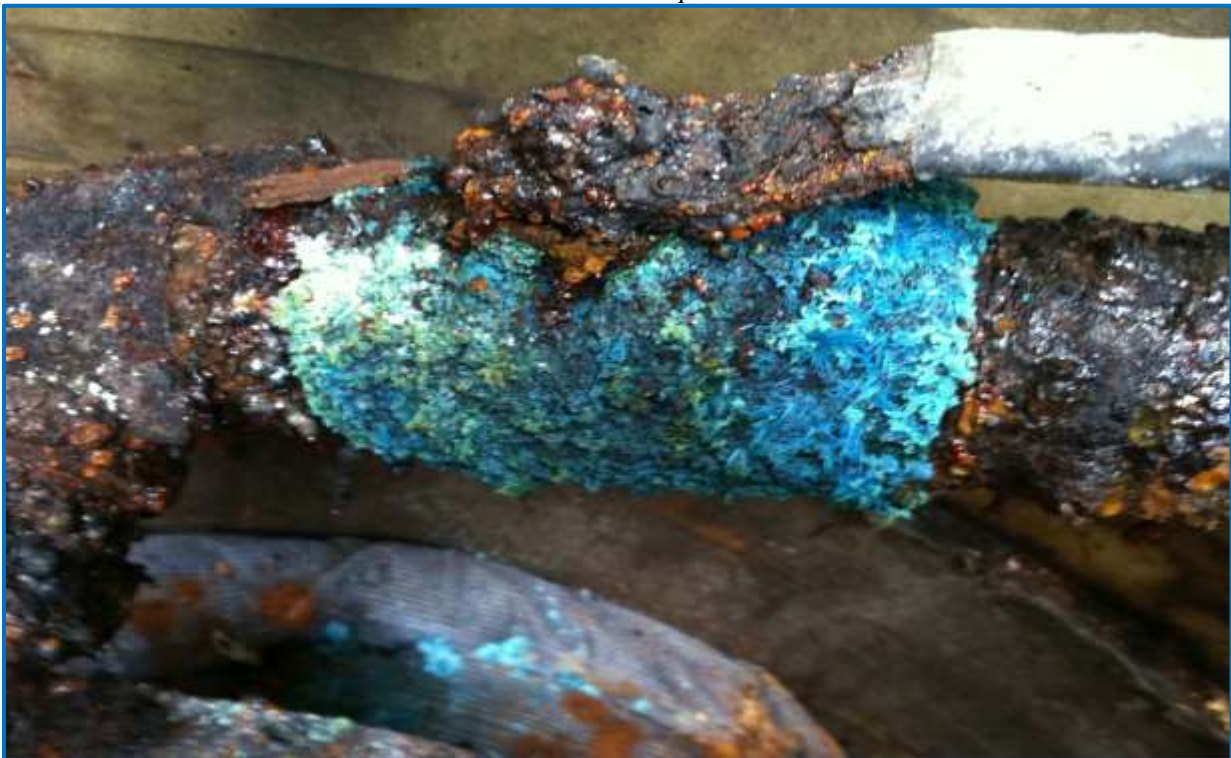
Supporting Pictures: *Blue Buildup*

During a compliance inspection in September 2012, the UST inspector found a blue buildup on steel components associated with the flexible piping in the subpump.

Ethanol vapors possess acidic properties and can act as a corrosive catalyst in the sump environment. This can lead to an aggressive oxidation process (similar to Missouri case study).

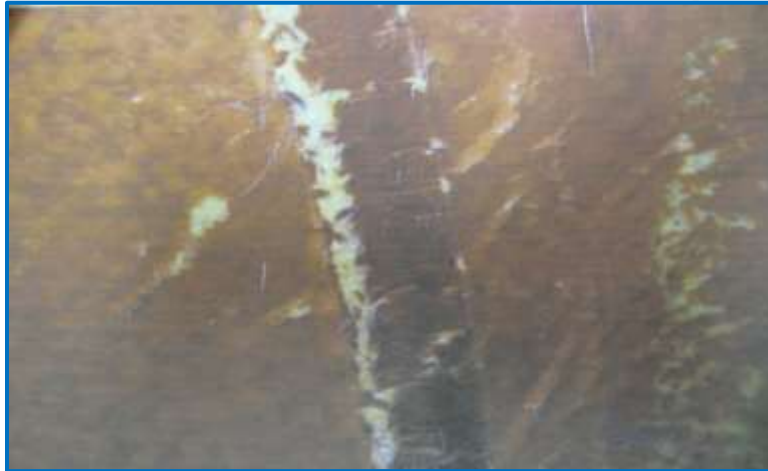
Prior to the storing of blended fuels, the USTs stored unleaded 87 and 92 octane as well as diesel. It was believed that the tanks had had been properly cleaned prior to the switching of products. The premium UST was placed in temporarily out of use (TOU) status on 12/18/2008 and was put back in service on 2/5/2009. The ATG detected the presence of water in the tank and as a result, the tank was placed back into TOU status on 2/10/2009. In 9/2009, an internal inspection of the tank was conducted. The results indicated a crack in the bottom of the tank.

92 Octane UST – breakdown observed during pre-blast inspection

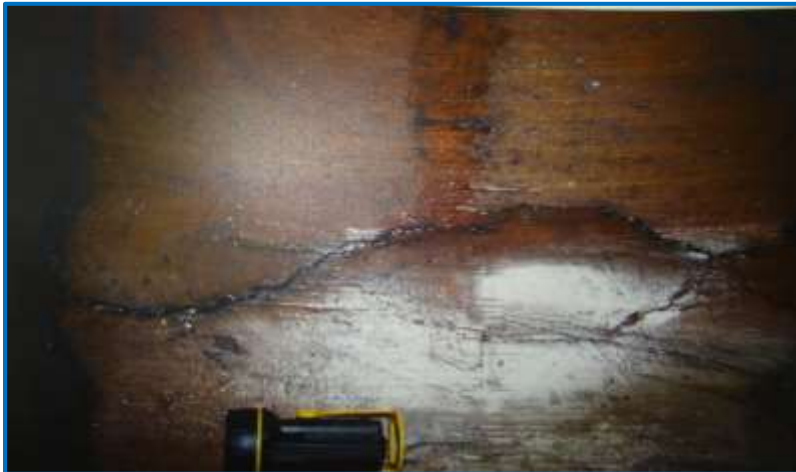
92 Octane UST – deep crazing/crack observed during pre-blast inspection

- Super Tank: had a crack in the bottom, some breakdown of the gel coat, initial layer of the fiberglass mat and crazing was observed
- Regular Tank: slightly deteriorated gel coat was observed, some slight flaking and exposed fiber were found throughout the tank but no visible cracks noted
- Diesel Tank: slightly deteriorated gel coat was observed some slight flaking and exposed fiber were found throughout the tank but no visible cracks were observed.

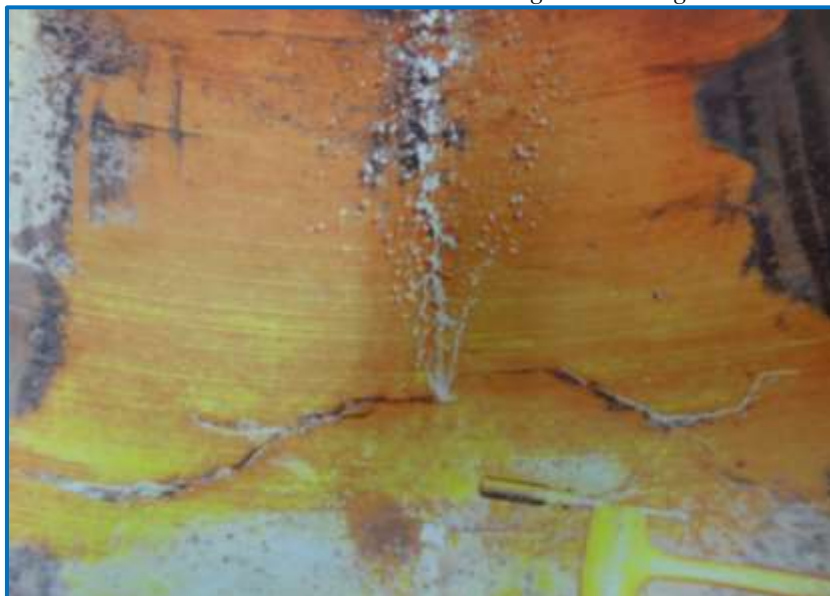
92 Octane UST interior – water entering tank through crack

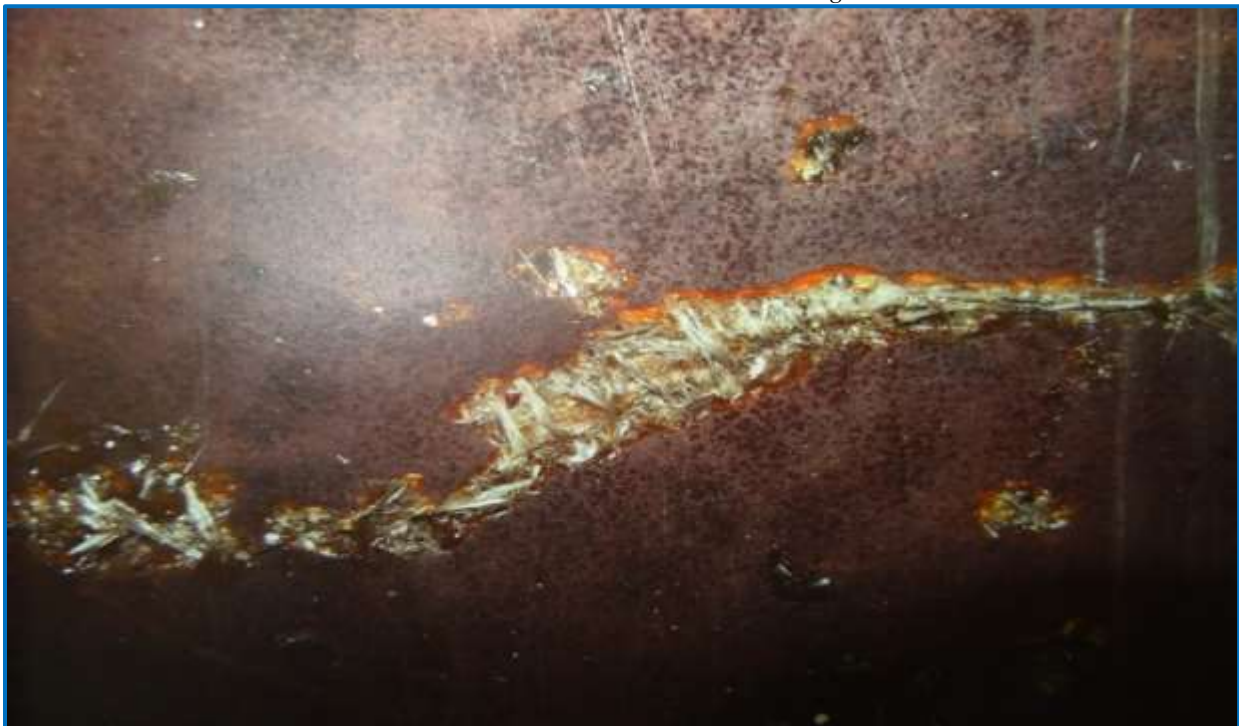
Prior to the storing of blended fuels, the USTs stored unleaded 87 and 92 octane. It was believed that the tanks had had been properly cleaned prior to the switching of products. The premium UST was placed in temporarily out of use (TOU) status in 6/2008 due to a suspected release. It was repaired and lined then brought back in service in 12/2009. A failed CSLD test was reported and as a result the tank was placed back into TOU status in 10/2010. An internal inspection of the tank revealed that the new liner was damaged. It was thought that the liner did not adhere to the fiberglass properly.

UST 92 Octane interior view: horizontal cracking in tank shell

A release was confirmed and all USTs were removed in early 2012.

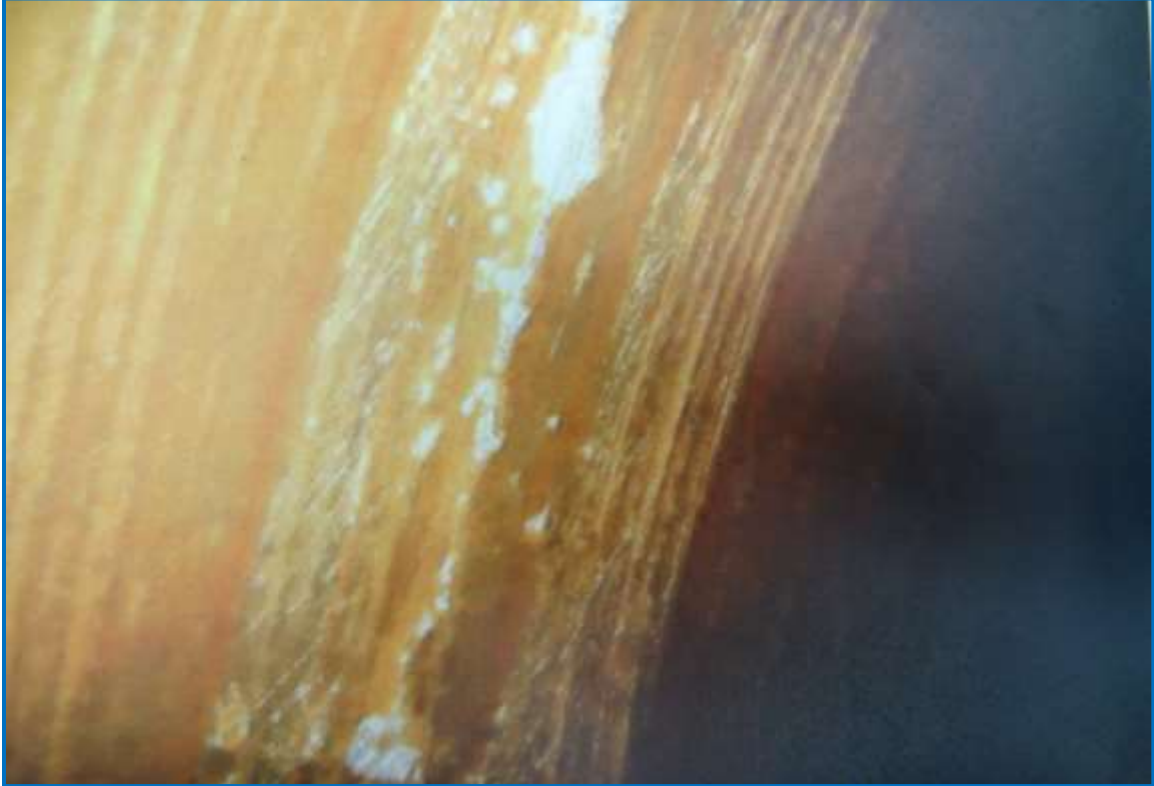
92 Octane UST deteriorated gel-coat causing delamination

Tank was lined twice and is currently TOU

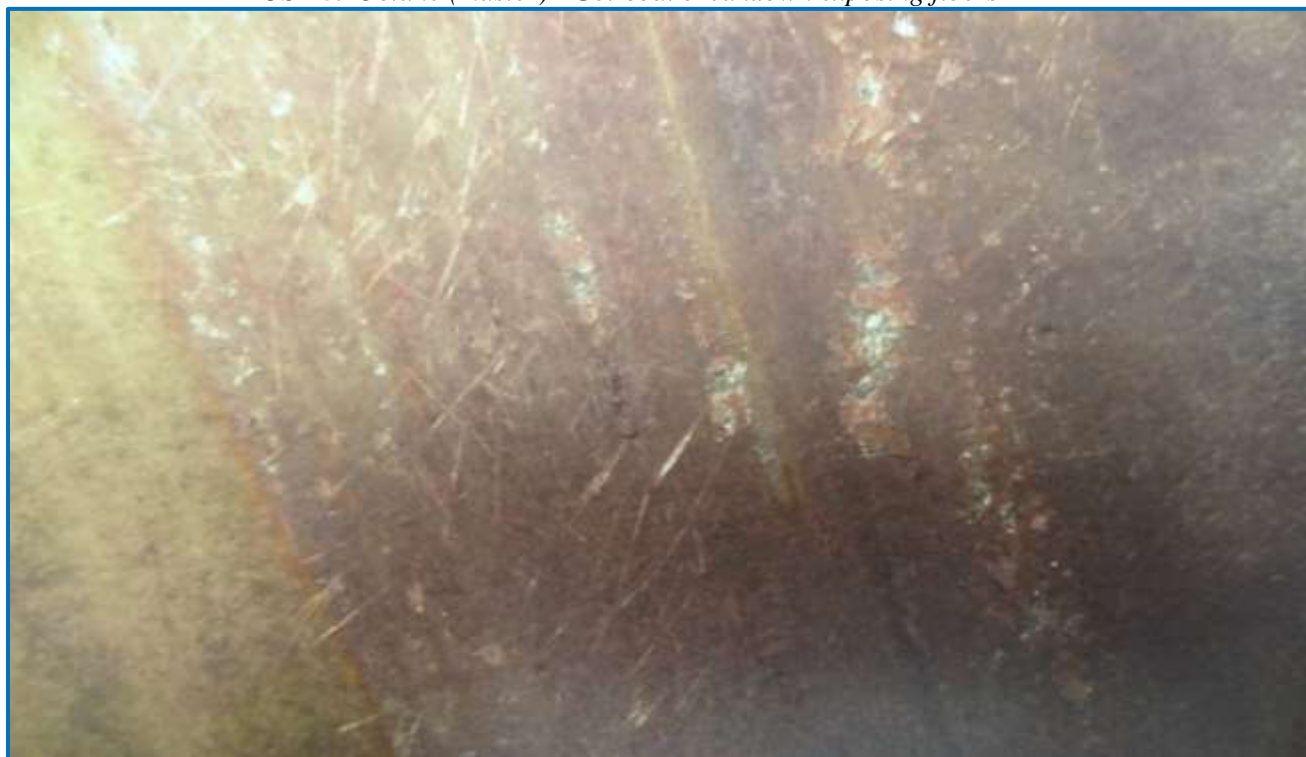
UST 87 Octane (master) - Gel-coat breakdown exposing fibers

- Super Tank: was in unsatisfactory condition. The gel coat exhibited breakdown and laminate layers contained creases that resulted in buckles between the stiffening ribs. Chemical attack was observed throughout the tank shell and the bulkheads. On 3/29/2011, the tank was permanently closed in place.
- Regular Tank: Master and slave tanks both exhibited some early signs of breakdown within the gel coat and laminate layers of fiberglass on the shell and bulkheads. The USTs were eventually lined.
