Compatibility of UST Systems with Biofuels

**Final Report
June 2013**

**Alternative Fuels Workgroup
Tanks Subcommittee**

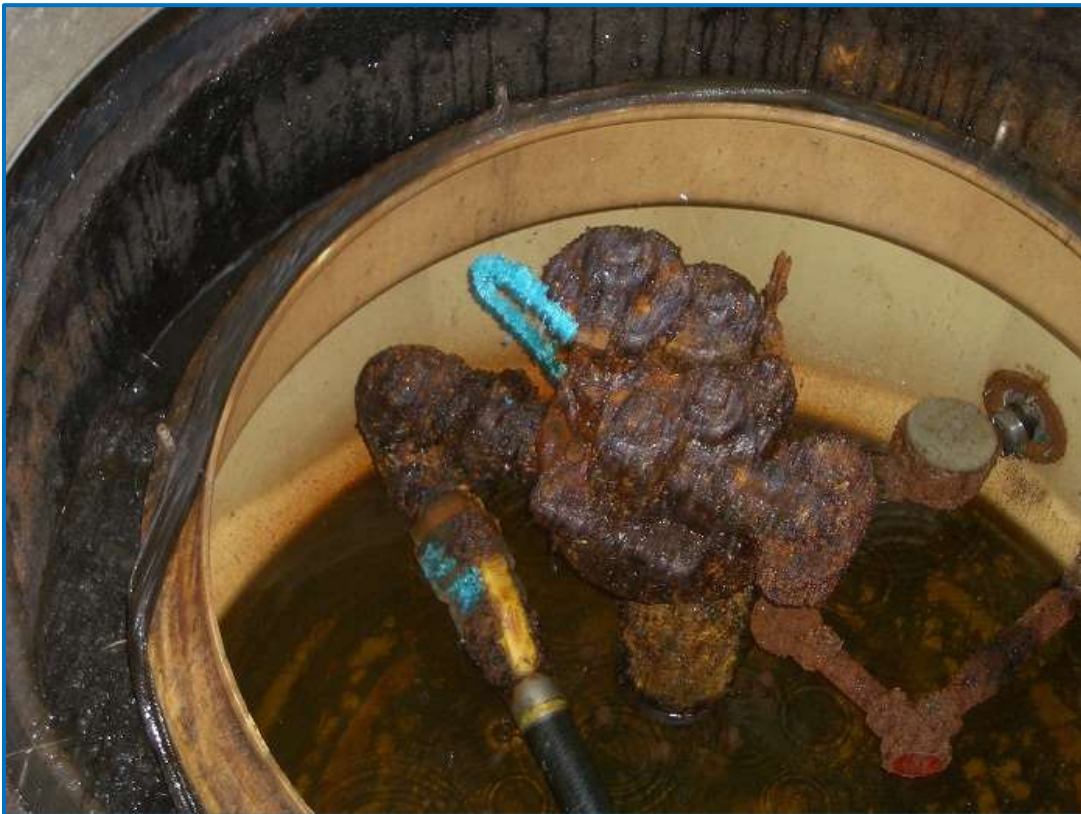
Cover Photo: The picture shows corrosion and acetate crystal formation commonly found in Submersible Turbine Pump (STP) sumps for systems storing gasoline-ethanol blends.

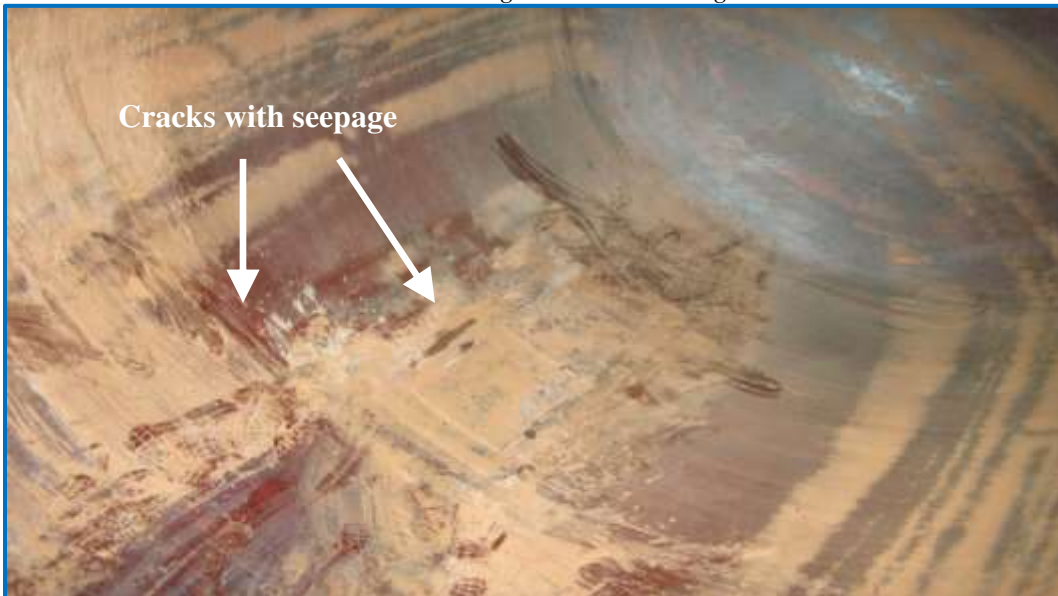
Supporting Pictures: *Damaged Internal Lining*

Premium Unleaded gasoline tank installed in 1987 (note: E10 was used as a “winter blend” in AZ fuel starting in approx. 1988). In October 2011 the owner noticed an inventory issue and called their contractor. Automatic tank gauge (ATG) results did not indicate a leak; however, the inspector went through inventory records and found several hundred gallons of fuel missing. The contractor conducted a tank tightness test that failed.

The contractor called the inspector and the tank was emptied to mitigate any further release. The contractor contacted the manufacturer. A 10' x 10' hole was cut into the cement and the manufacturer entered the tank on November 1, 2011. The manufacturer discovered several cracks on the bottom of the tank. Arizona Department of Environmental Quality (DEQ) was notified that the tank is to be re-lined.

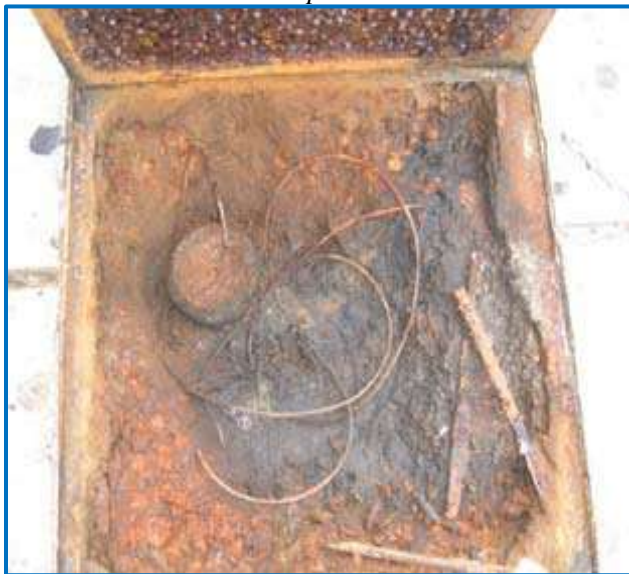
Corroded Incompatible ATG Probe

In 2005, prior to the introduction of the “Alternative Fuel Checklist”, this site converted a tank to E85 without the knowledge of the SC UST Program. An inspector performing a routine inspection discovered that the upgrade had taken place. In 2007, the inspector returned for the annual inspection and noticed that several months of ATG printouts were missing. When the tank owner was questioned, he stated that the probe had dissolved because their contractor had installed a regular gasoline probe.

The tank owner was required to submit SC’s “Alternative Fuel Checklist” showing that all equipment (including the probe) was compatible with E85. The checklist was received showing that the probe and all other equipment that were now installed were now compatible.

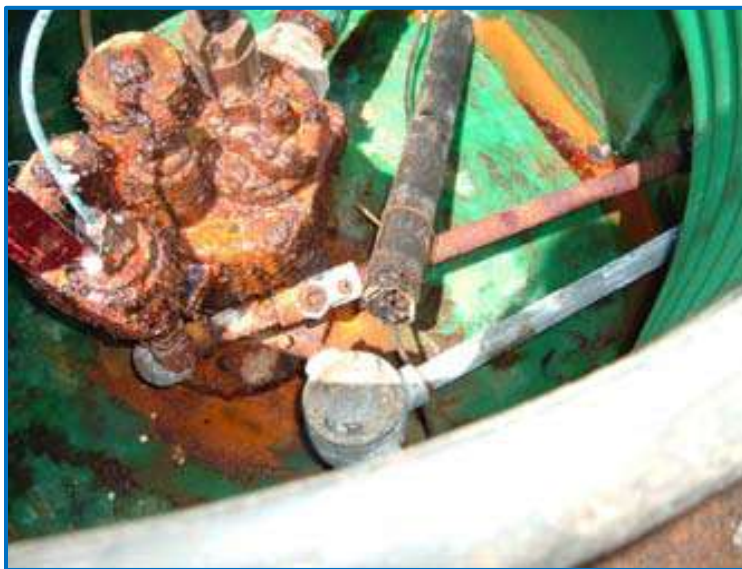
Corroded STP

In early 2006, prior to the formal introduction of SC's "Alternative Fuel Checklist", this site converted a tank to E85 without the knowledge of the SC UST Program. In 2007, the inspector visited this site for a routine compliance inspection. The inspector noted excessive corrosion on the submersible pump head and its associated components.

Upon receipt of a completed SC "Alternative Fuel Checklist", it was determined that the submersible pump was the appropriate "AG" (alternative fuel) model and therefore compatible with E85. The manufacturer of the submersible pump clarified that the E85 vapors had caused the paint on the submersible pump housing to run to cause the appearance of corrosion. It was confirmed that none of the internal components were affected. The manufacturer confirmed that the paint formulation used on the submersible pump had changed and that they would monitor other sites across the country for any further instances relating to paint degradation. The site was monitored for any further issues and to this date none have arisen.

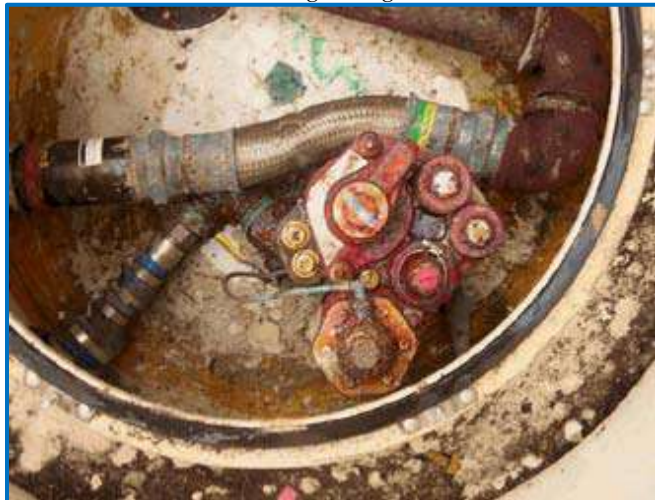
Corrosion beginning on the submersible pump and its associated components was noted.

Supporting Pictures:
Corrosion Beginning on an STP

Monitoring and replacement as needed

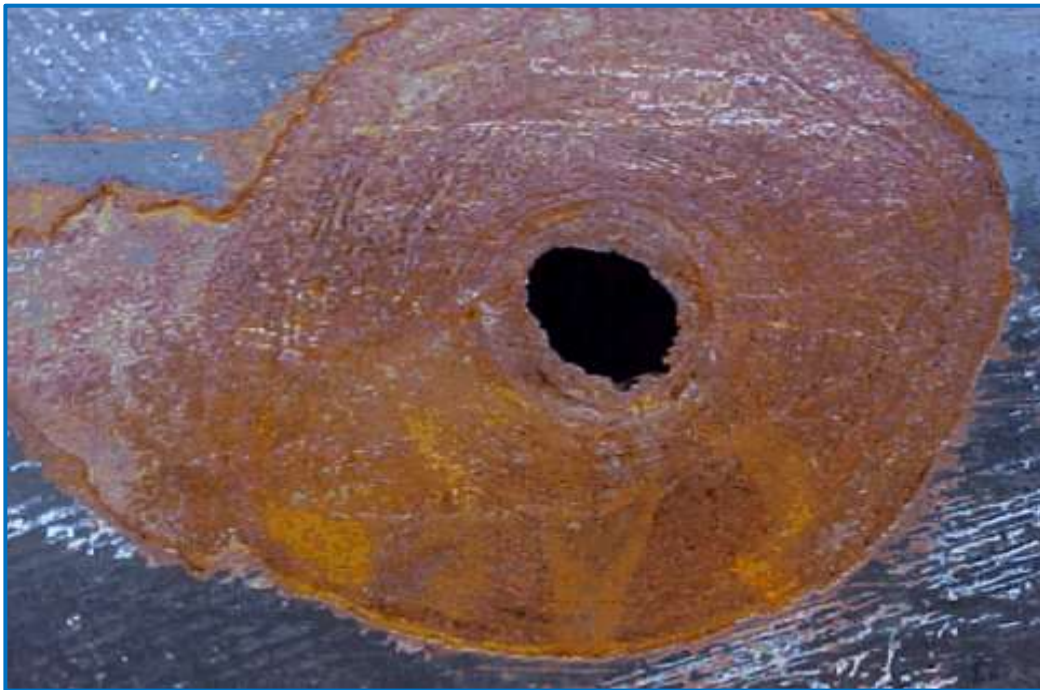
Corrosion Plug Removed by Ethanol

Tank tightness was not considered when converting from E10 to E85. Ethanol has the ability to dissolve previously plugged pinholes in storage tanks formed as a result of corrosion.

Release occurred. Tank was removed and remediation conducted.

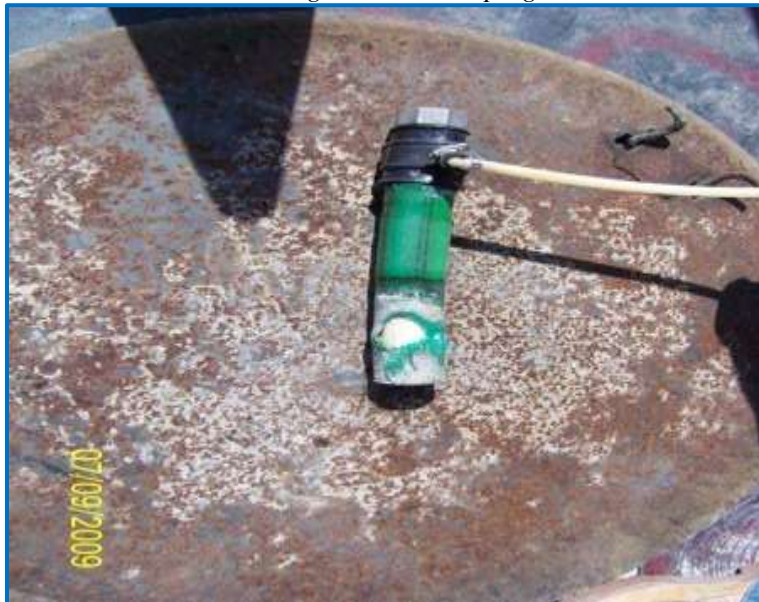
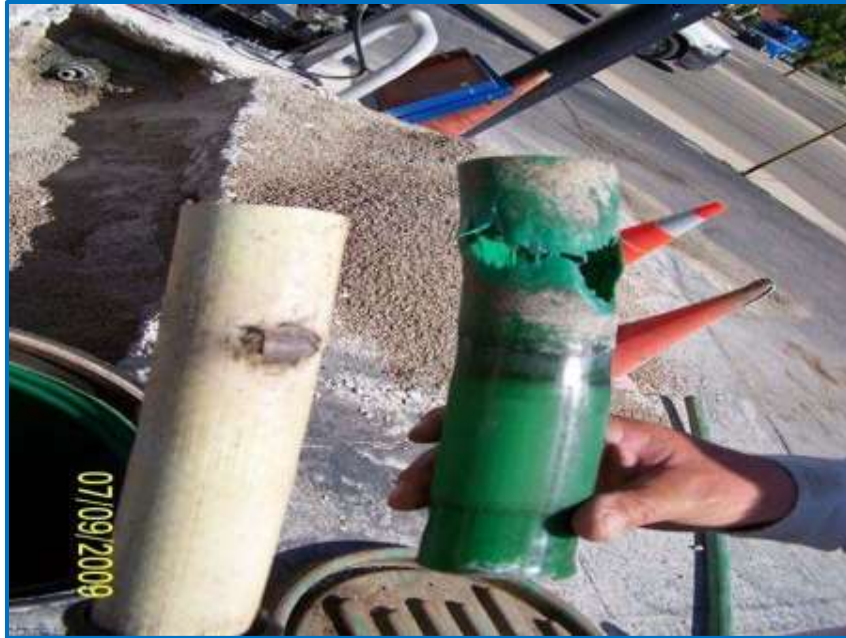
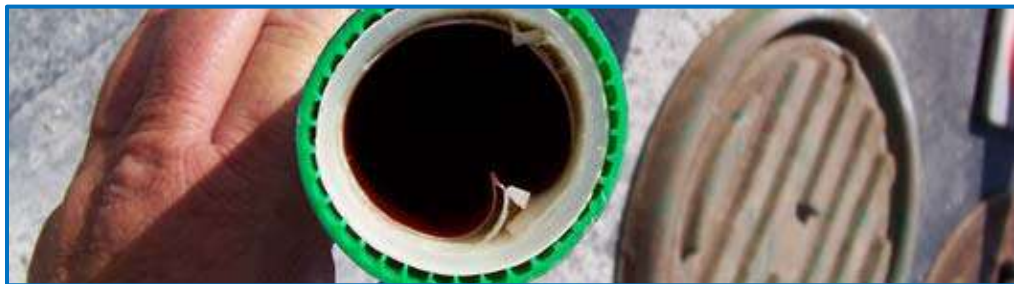
Supporting Pictures: *Damaged Environ Piping*

During a compliance inspection in 2009, an UST inspector found product in one of the two dispenser sumps. It was discovered that the piping was leaking from between the primary and secondary walls.

During excavation of the piping around the premium STP, the UST inspectors found evidence of degradation of the outer secondary barrier. Upon further investigation, the inside of the piping was found to be deteriorated.

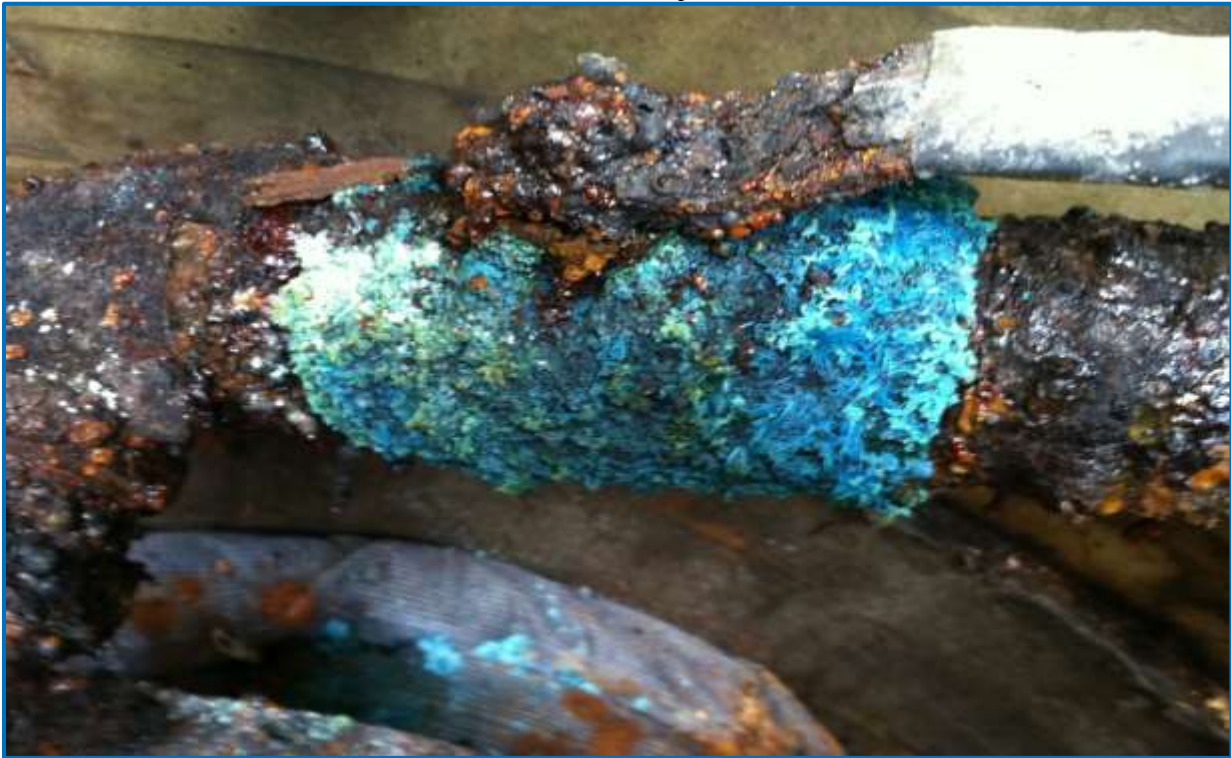
Supporting Pictures: *Blue Buildup*

During a compliance inspection in September 2012, the UST inspector found a blue buildup on steel components associated with the flexible piping in the subpump.

Ethanol vapors possess acidic properties and can act as a corrosive catalyst in the sump environment. This can lead to an aggressive oxidation process (similar to Missouri case study).

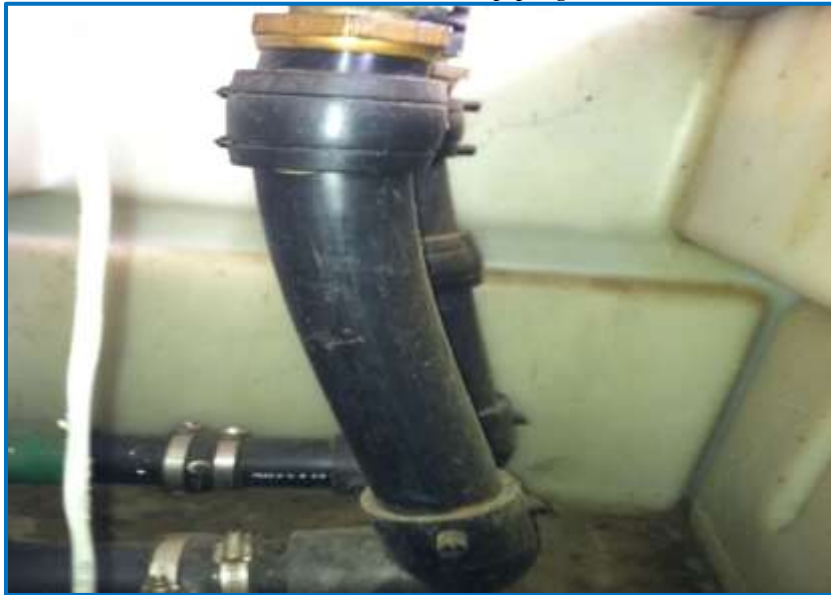
Supporting Pictures:
Bent UPP piping

During a compliance inspection, it was noticed that the UPP pipe had started to bend (like previous generations of other flexible piping).

Site was asked to monitor pipe for further damage.

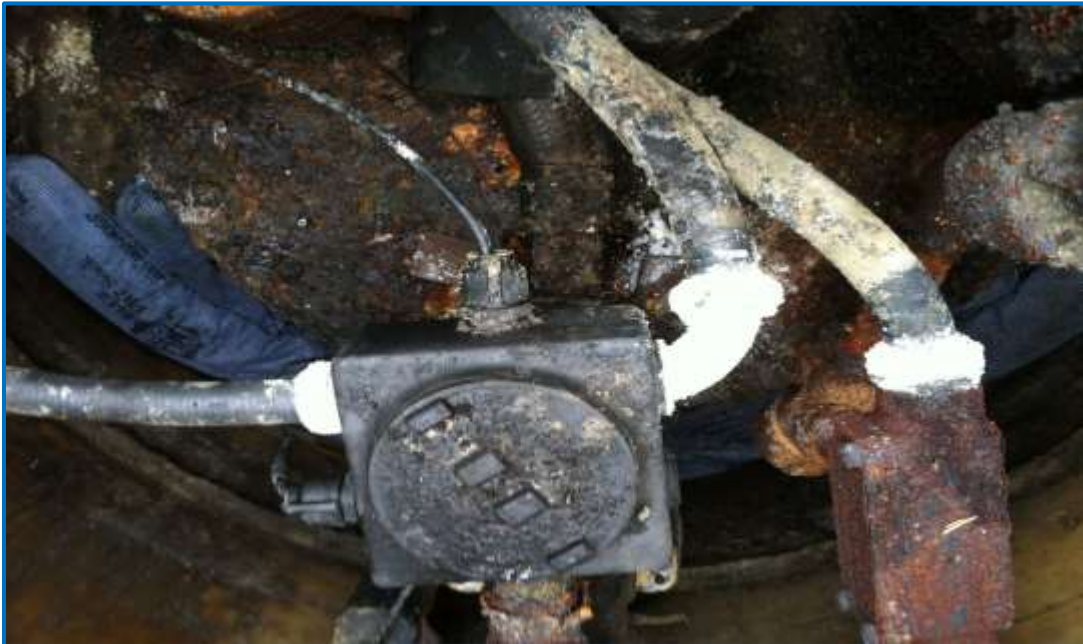
Corrosion on lead and brass components of the conduit leading to white buildup.

Corrosion on Conduit in STP

Monitor for further damage.

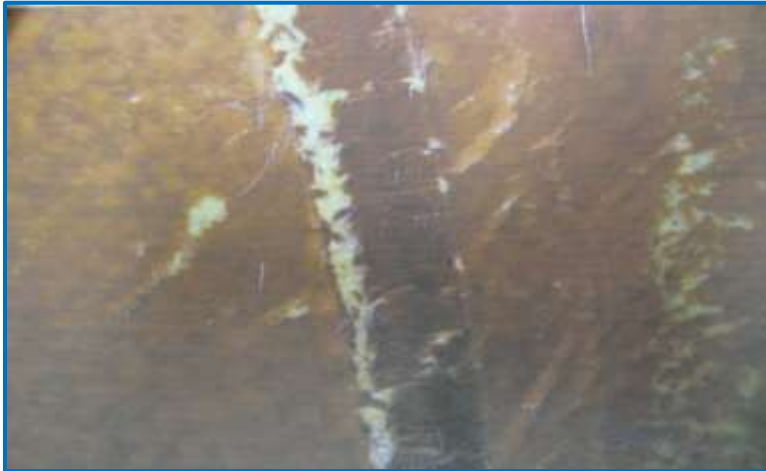
Prior to the storing of blended fuels, the USTs stored unleaded 87 and 92 octane as well as diesel. It was believed that the tanks had had been properly cleaned prior to the switching of products. The premium UST was placed in temporarily out of use (TOU) status on 12/18/2008 and was put back in service on 2/5/2009. The ATG detected the presence of water in the tank and as a result, the tank was placed back into TOU status on 2/10/2009. In 9/2009, an internal inspection of the tank was conducted. The results indicated a crack in the bottom of the tank.

92 Octane UST – breakdown observed during pre-blast inspection

- Super Tank: had a crack in the bottom, some breakdown of the gel coat, initial layer of the fiberglass mat and crazing was observed
- Regular Tank: slightly deteriorated gel coat was observed, some slight flaking and exposed fiber were found throughout the tank but no visible cracks noted
- Diesel Tank: slightly deteriorated gel coat was observed some slight flaking and exposed fiber were found throughout the tank but no visible cracks were observed.

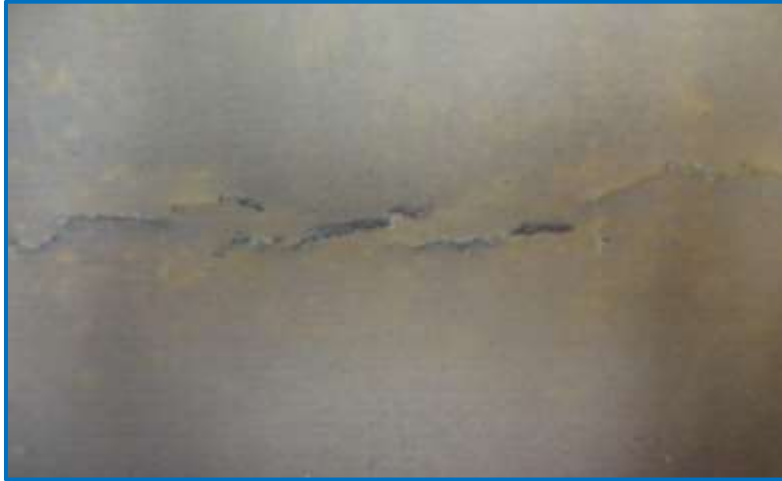
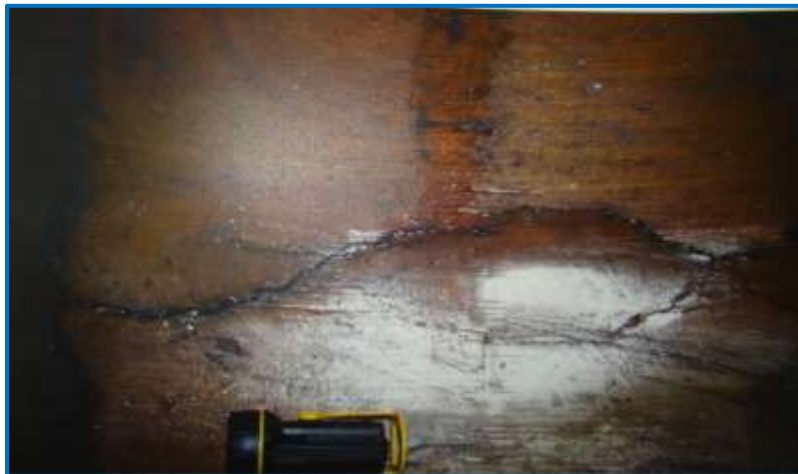
92 Octane UST – deep crazing/crack observed during pre-blast inspection

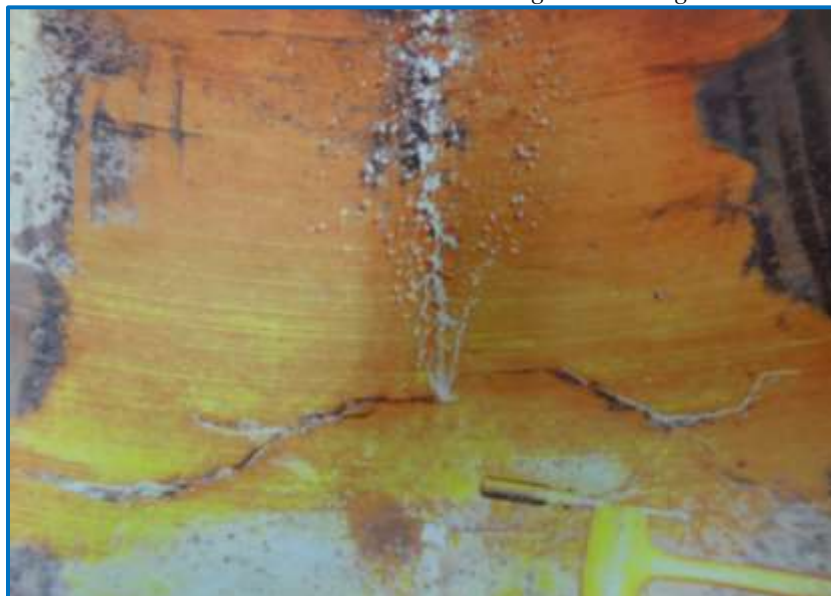
92 Octane UST interior – water entering tank through crack

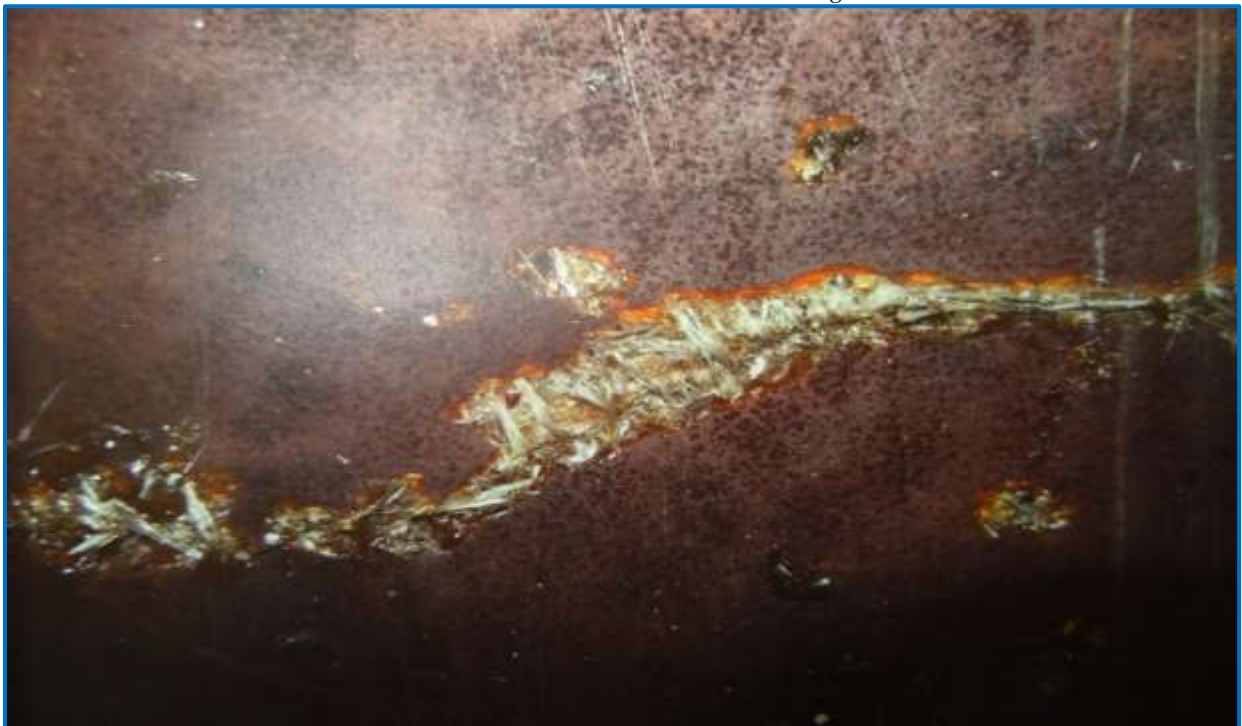
Prior to the storing of blended fuels, the USTs stored unleaded 87 and 92 octane. It was believed that the tanks had had been properly cleaned prior to the switching of products. The premium UST was placed in temporarily out of use (TOU) status in 6/2008 due to a suspected release. It was repaired and lined then brought back in service in 12/2009. A failed CSLD test was reported and as a result the tank was placed back into TOU status in 10/2010. An internal inspection of the tank revealed that the new liner was damaged. It was thought that the liner did not adhere to the fiberglass properly.

UST 92 Octane interior view: horizontal cracking in tank shell

A release was confirmed and all USTs were removed in early 2012.

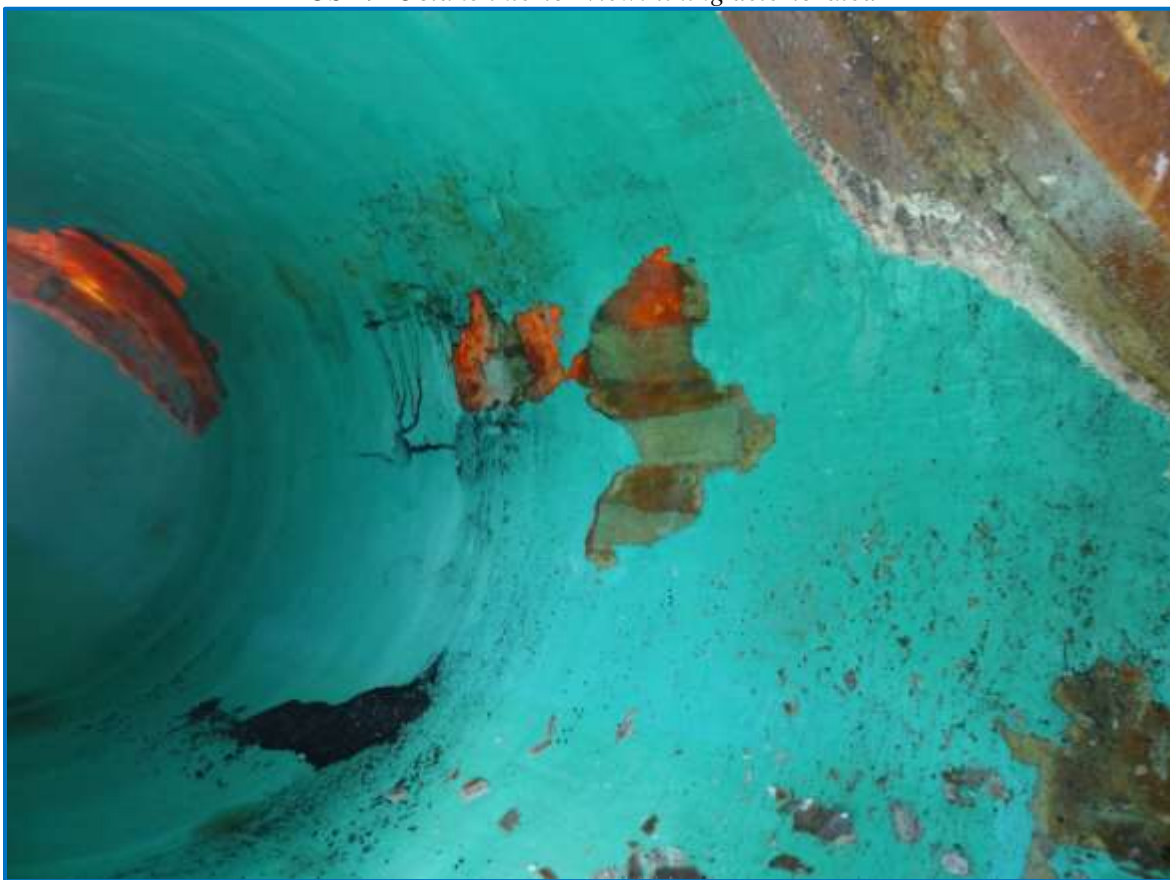
UST 92Octane interior view: lining deteriorated

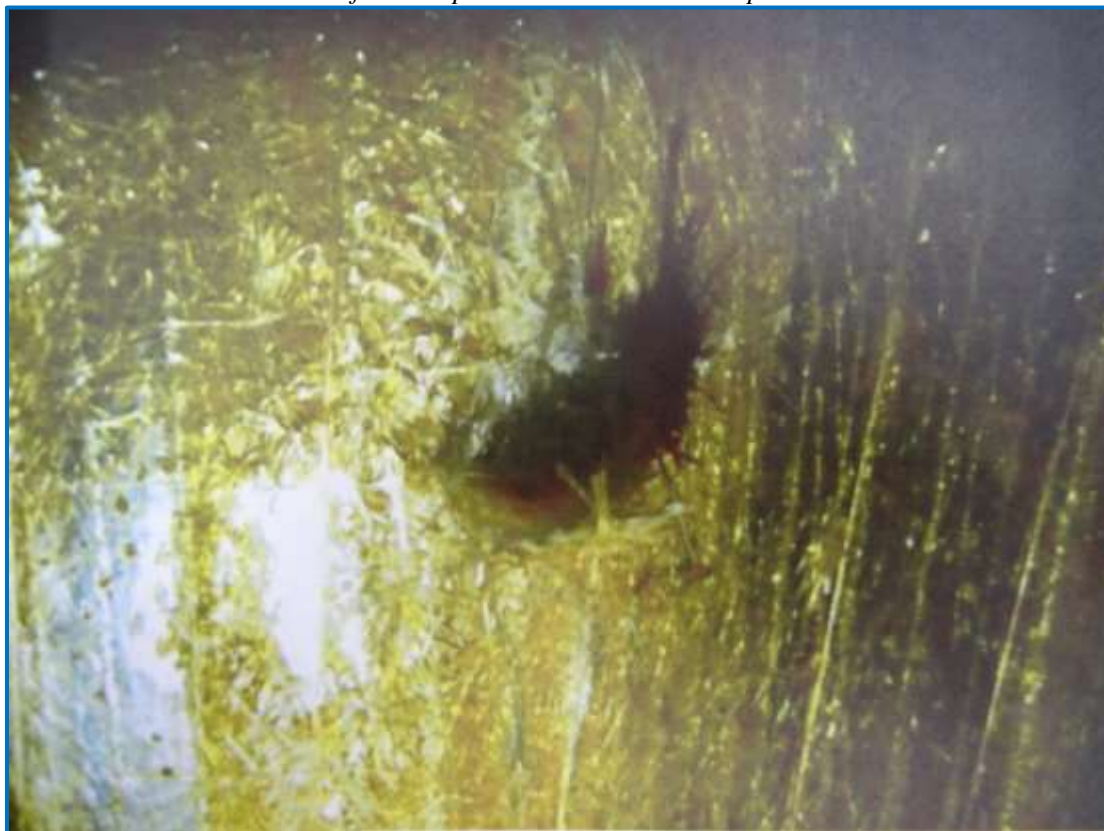
Prior to storing blended fuel, UST stored unleaded 92 octane. It was believed that the tank was interior cleaned prior to switching product. Tank was placed on a TOU status on 9/23/2009 for relining and brought back in service on 3/24/2010. Tank was again TOU on 7/16/2011 because product was found in the interstice. The tank was lined for a second time and then was brought back in service on 12/16/2011. Currently, tank is TOU since 8/6/2012 due to breach in the inner shell

UST fibers exposed due to chemical exposure

Tank was lined twice and is currently TOU

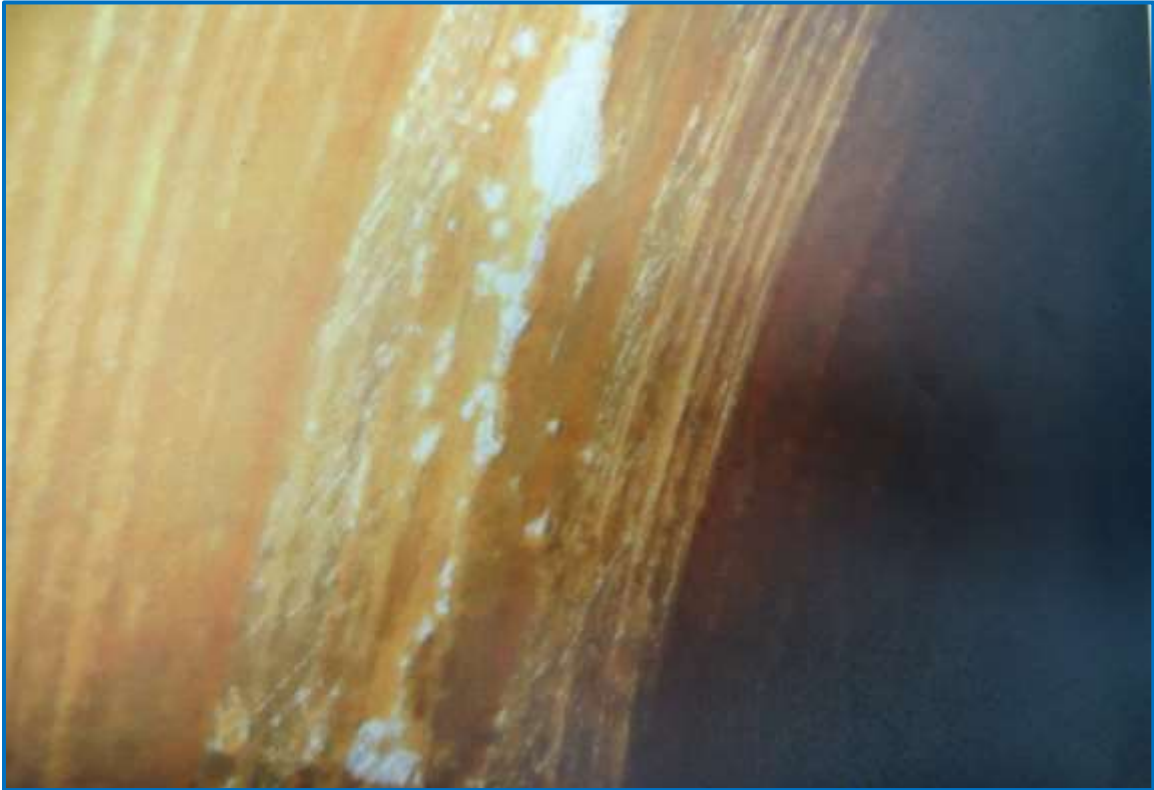
92 Octane UST deteriorated gel-coat causing delamination

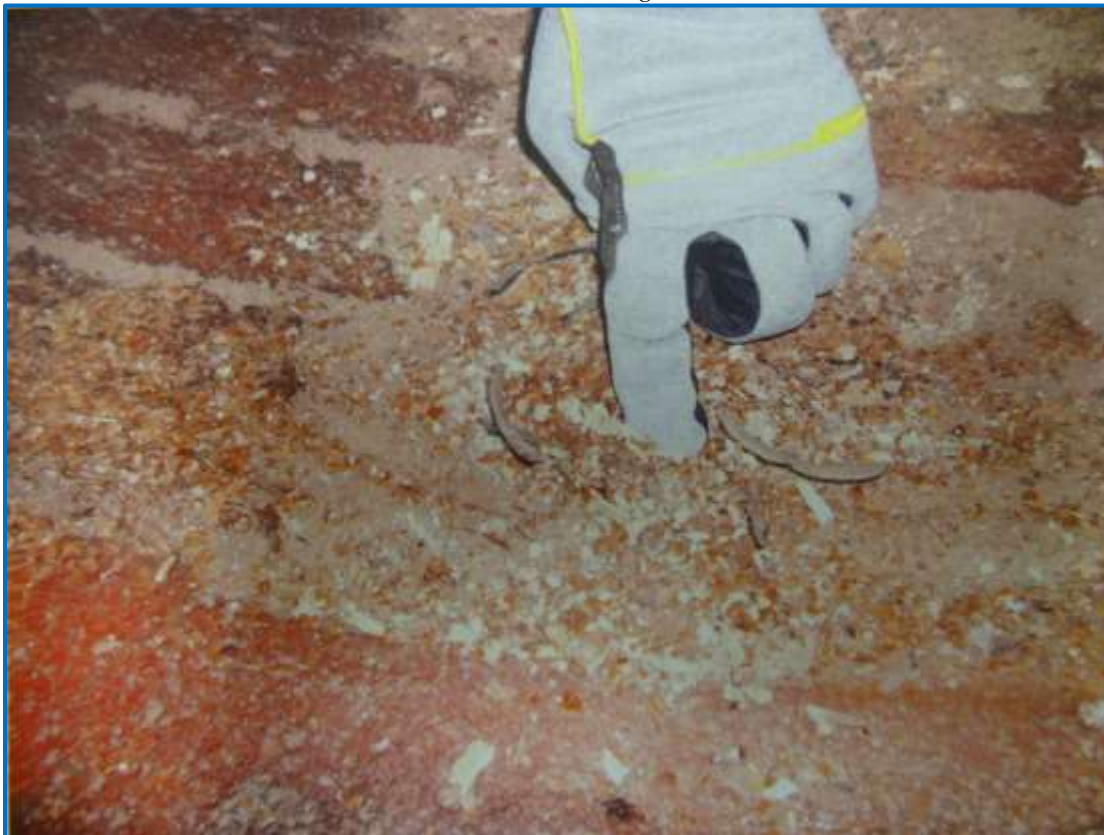
UST 87 Octane internal view: gel deterioration

All three USTs showed severe deterioration of internal Gel coat with exposure of fiberglass fibers. There were visible cracks as well as a 2.5 feet long crack on the bottom center and at both ends of the premium UST. There was one (1) large area of crazing in the plus tank. All tanks were eventually lined and returned to service on 10/21/2009.

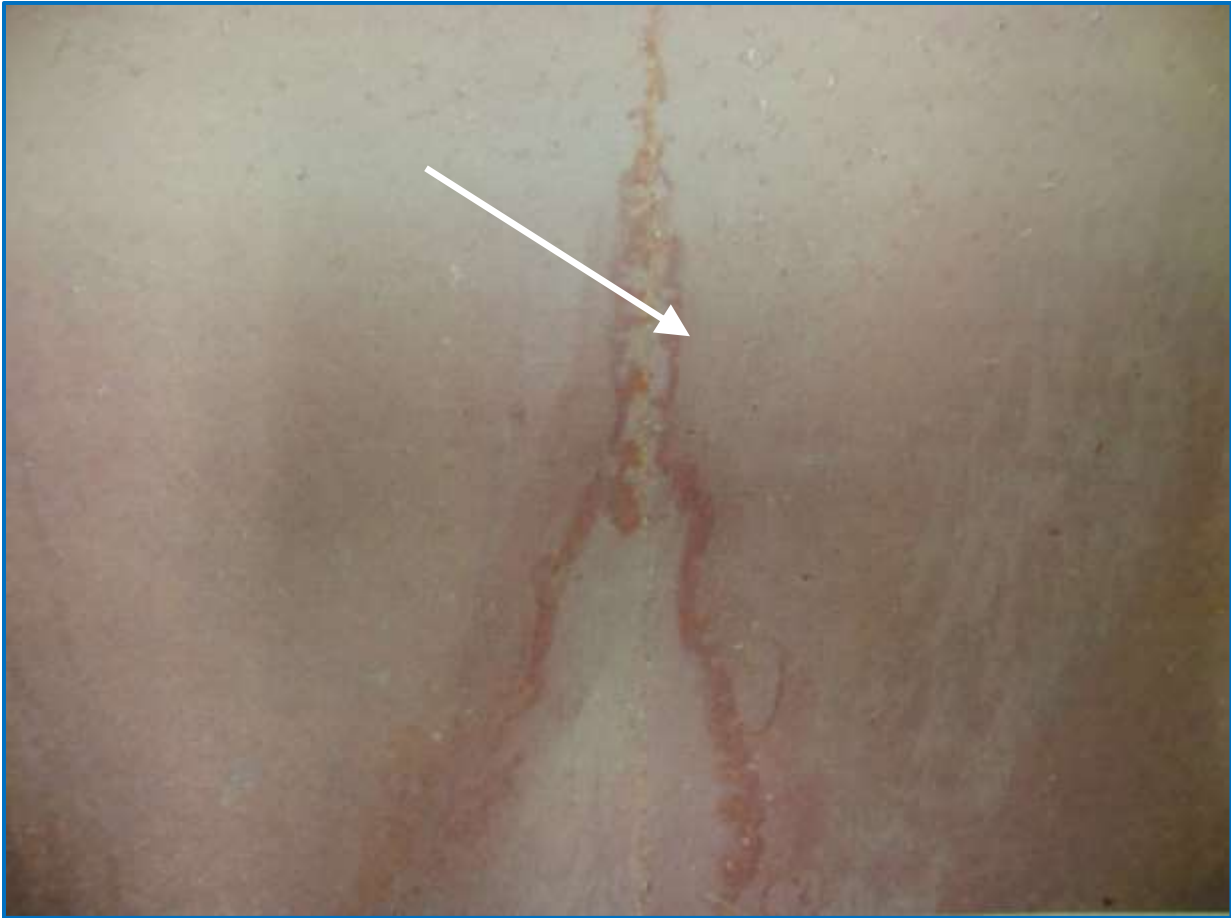
UST 89 Octane internal view: crack

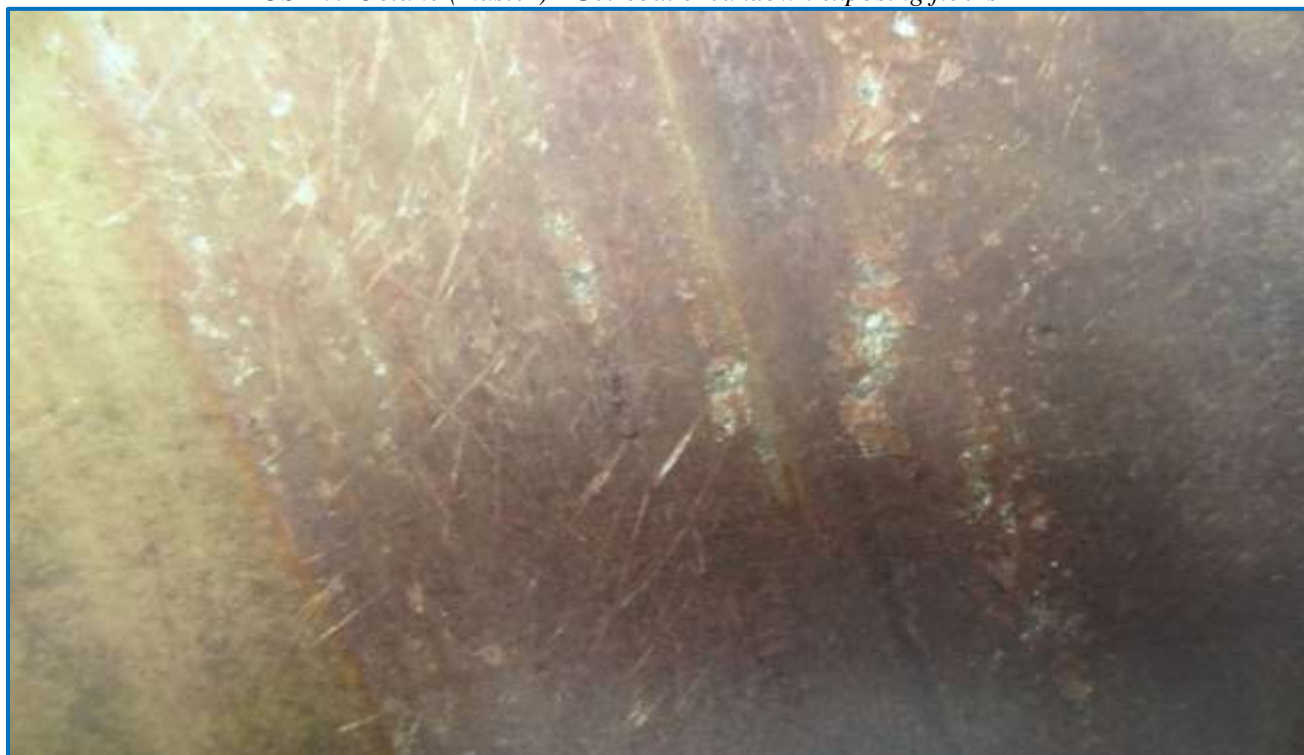
UST 87 Octane (master) - Gel-coat breakdown exposing fibers

- Super Tank: was in unsatisfactory condition. The gel coat exhibited breakdown and laminate layers contained creases that resulted in buckles between the stiffening ribs. Chemical attack was observed throughout the tank shell and the bulkheads. On 3/29/2011, the tank was permanently closed in place.
- Regular Tank: Master and slave tanks both exhibited some early signs of breakdown within the gel coat and laminate layers of fiberglass on the shell and bulkheads. The USTs were eventually lined.

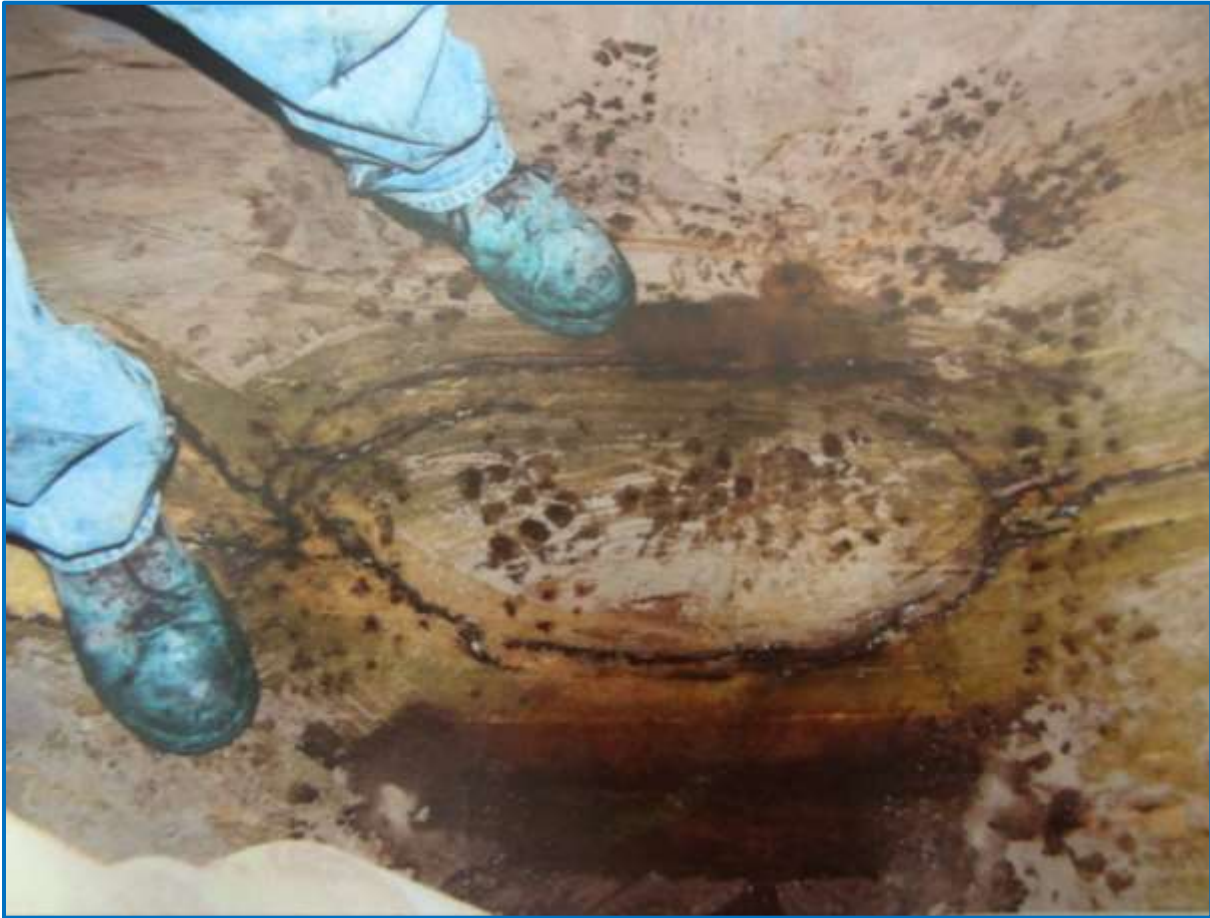
UST 92 Octane interior – cracked shell
