CATEGORY: Safety

Business unit:	Fort Nelson	Incident date:	February 21, 2011
-----------------------	-------------	-----------------------	-------------------

Location:	Horn River	IMS Incident Number:	I2011-00373
------------------	------------	-----------------------------	-------------

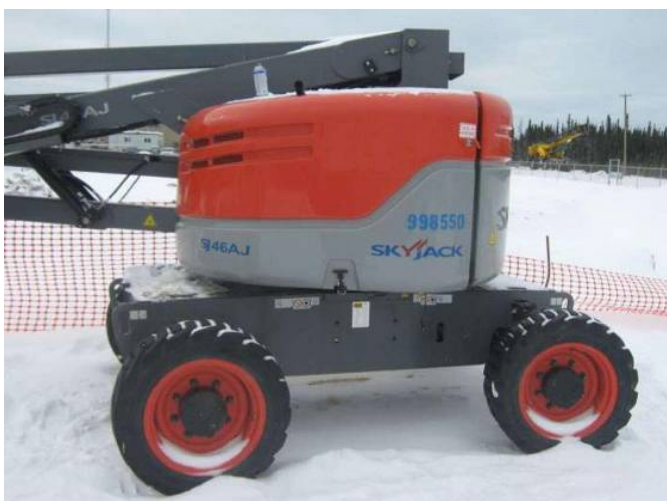
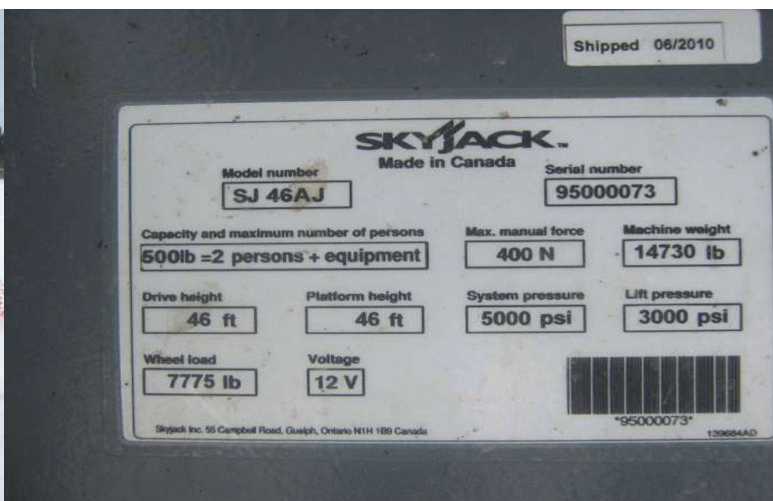
On March 17, 2011, a detailed examination was undertaken on the remaining two boom lifts by a non-destructive testing company. Both lifts were found to have weld cracking in all four corners of the main lift cylinder attachment. These two machines were immediately taken out of service.

Results of NDT on another unit showing failure point in same location
