## FIRE AND EXPLOSION AT EDCO

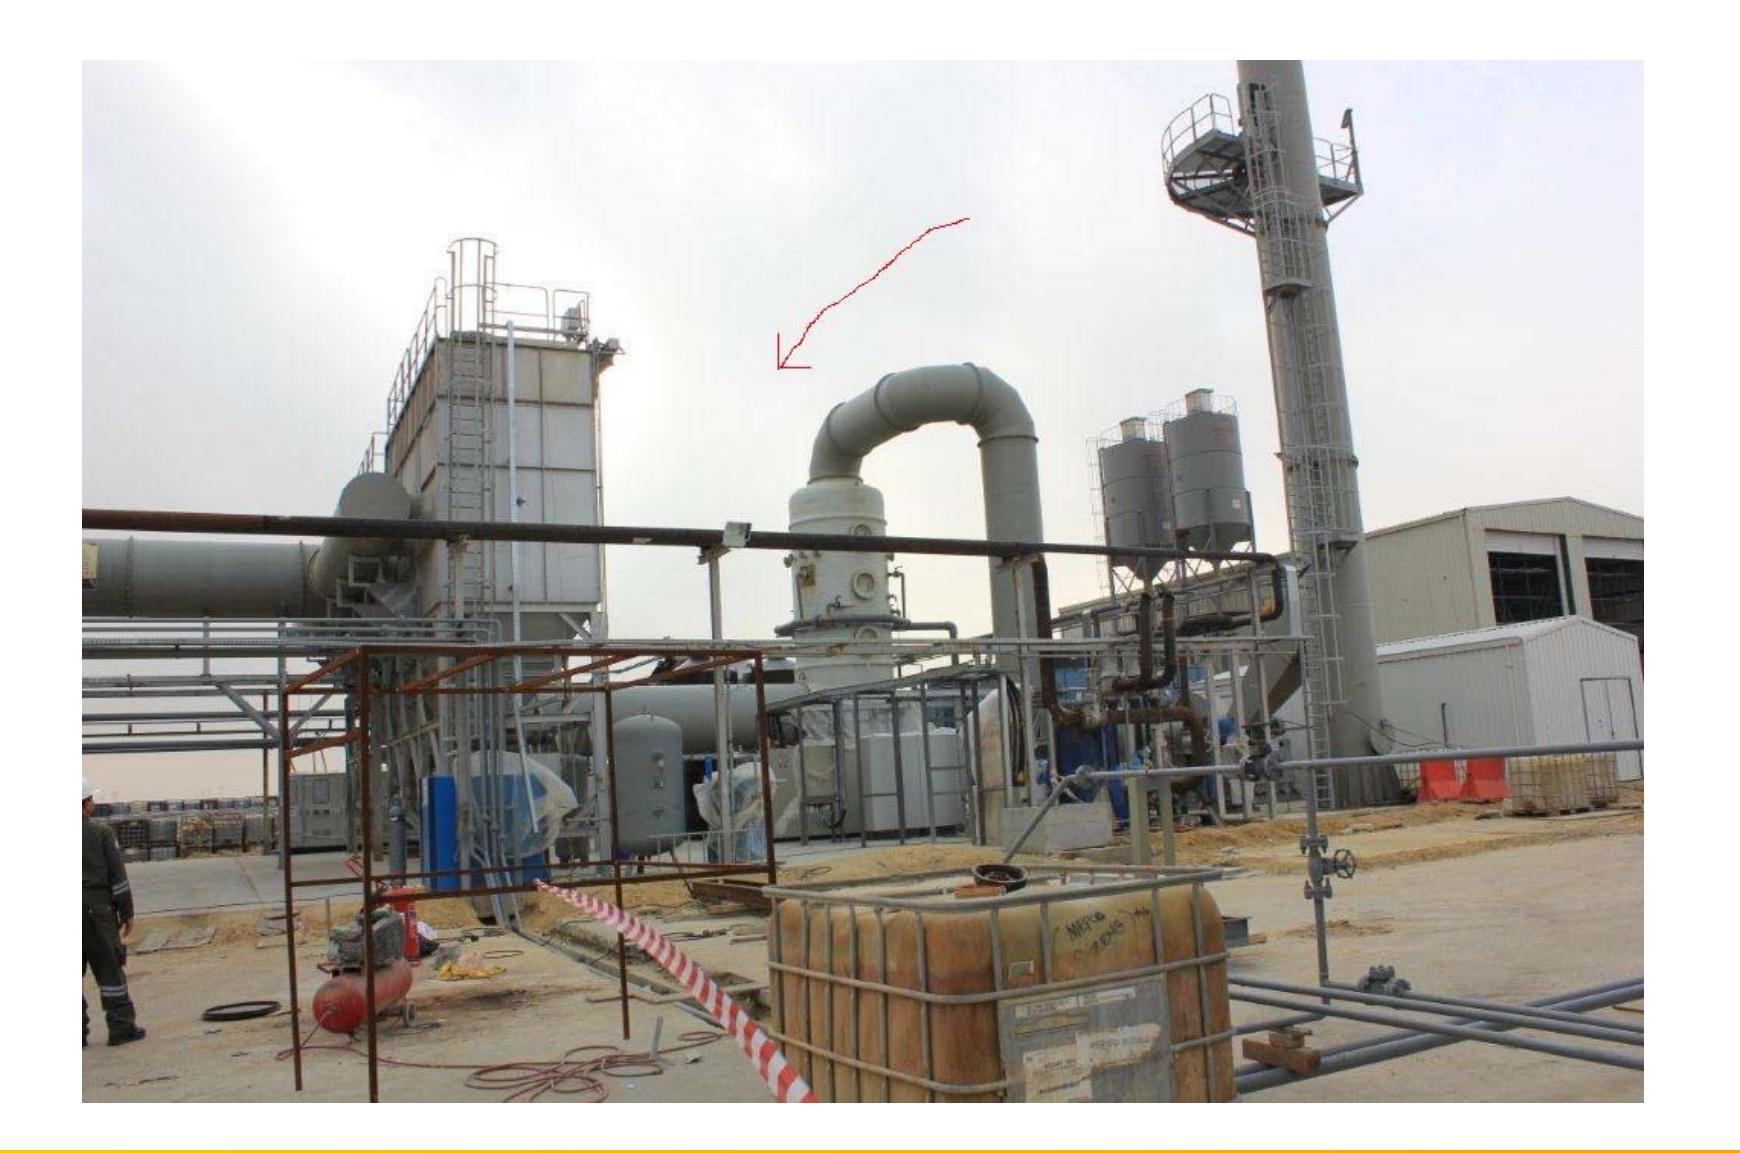
We see here a picture the plant where it is clear to us that it was not affected by this, it indicates that the tank did not hit any part of the process plant, thereof and The means that the tank was flying in a vertical rise of at least 15 meters
