## Monday Safety Topic – Near Miss & ALERT

### Near Miss – Boom Chain on Powered Industrial Truck

## ***SAFETY ALERT***

**UNEXPECTED TELESCOPIC FORKLIFT DROPPED LOAD DUE TO CHAIN FAILURE: Highlights need to verify maintenance & inspections**

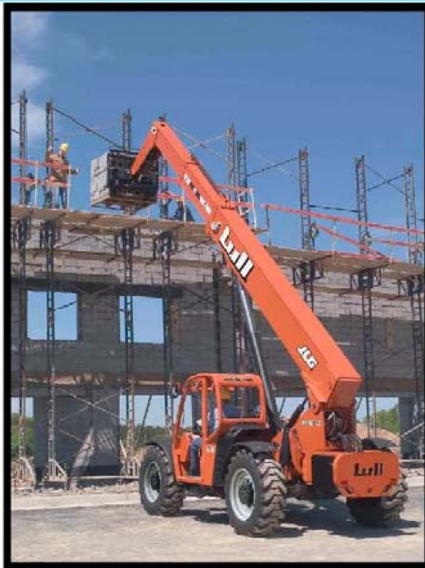
Photo shows missing chain on boom spine after a chain failure. Boom section is designed with a chain that travels the length of the boom.

**Clearly delineate responsibilities for maintenance and inspections of any heavy equipment (especially when renting) before work begins – NAVFAC QA program representatives will spot check documentation.**
