## Hazard Alert - Grinding Disk Rupture

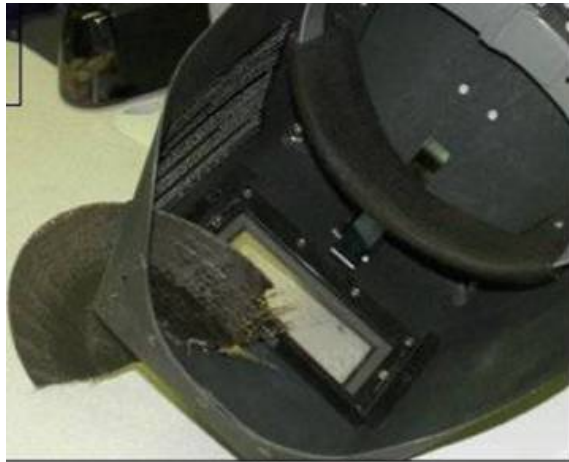
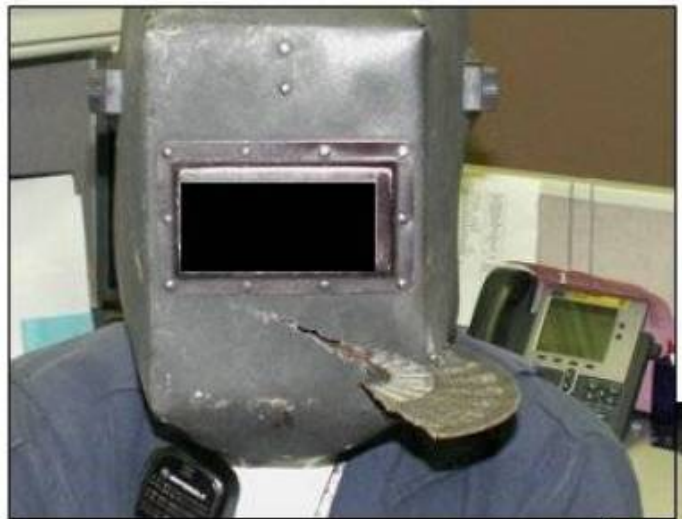
The welder was lucky that at least he had on his welding face shield when he was grinding. If not, this would have been a different outcome.

Apparently a welder was cutting a 1/16" thick plate when the cutting wheel he was using broke apart. One piece of the wheel lodged in the welder's helmet he was wearing and another piece went clear through and resulted in a shallow cut on the cheek. These grinding wheels are dangerous.

This welder's hood was not adequate PPE for cutting with a disk. It was not rated 'High Impact (AS/NZS 1337)

Please look at your personal protective equipment used in your grinding operations to ensure that it is impact resistant. We should not be using welding helmets for face protection during grinding operations unless they are resistant to high impacts.

Please ensure grinders and cutting tools are used properly and have the proper guards in place with the correct PPE being worn. The message is that welding helmets are not designed to be used when grinding.
