Location of Incident: Vessel 64C-109 in Plant 64

Date of Incident: January 17, 2009

Incident Number: 53984

Nature of Incident: Incident with Loss

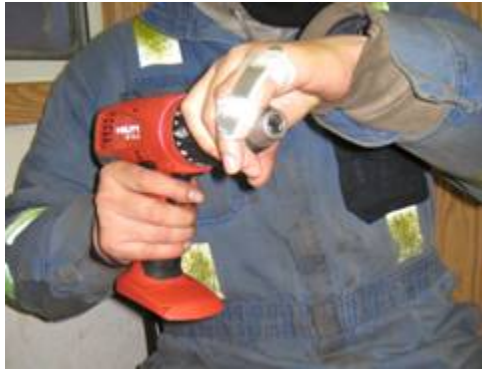
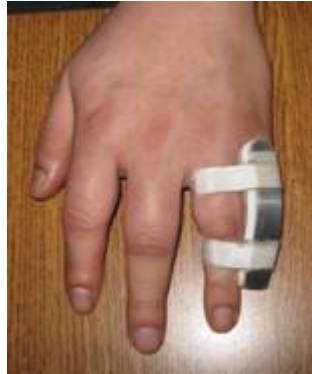
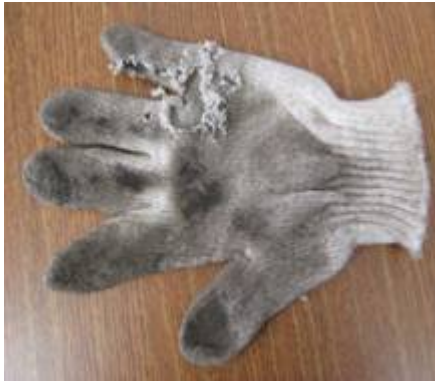
Description of Incident: On January 17 an electrician was working on installing 4" cable tray in the area around vessel 64C-109. During his work activities he needed to change the drill bit in his cordless drill. At this time the worker was wearing a cotton glove liner and held the drill chuck as seen in the picture above left. The worker held the chuck with his finger and thumb and proceeded to power the drill, so the rotation of the drill, combined with holding the chuck would loosen the bit. As the bit started to spin it caught the workers glove and pinky finger causing it to bend awkwardly. The worker did not report the injury on the day it occurred, however when he returned to work the following morning his finger was swollen and sore. He notified his foreman of his injury and visited first aid. X-rays at NLRHC later showed that the worker had suffered a hair line fracture to his finger.

1. Power source for cordless drill was not removed prior to attempting to release drill bit. There was no clear procedure for the safe operation of cordless power tools.
2. Improper motivation. Worker stated that he felt this way was faster rather than using two hands to loosen the chuck on the drill.
3. Inadequate risk assessment. The worker failed to identify any hazards associated with operating a drill or power tools.
4. Worker was not wearing proper PPE at the time. While carrying out this work the worker was wearing cotton glove liners which offer inadequate hand protection. The cotton glove became entangled on the drill bit when he pulled the trigger to power drill.

1. Issue bulletin to all crews regarding manufacturer's recommendations for changing drill bits on cordless drill. Remove power source prior to changing bits. Reinforce with workers not to take short cuts or to deviate from procedures.
2. Reinforce with workers the need for detailed FLRA's specific to the tasks they are completing. Supervision to monitor for compliance and quality.
3. Stand down held with electrical crew regarding immediate reporting of incidents.
4. Contractor to issue safety bulletin to create awareness and help eliminate the potential for reoccurrence.

Disconnect battery pack from tool or place the switch in the locked or off position before making any adjustments, changing accessories, or storing the tool. Such preventive safety measures reduce the risk of starting the tool accidentally.
