First Report of Recordable Injury

Date: March 22, 2009
Contractor (refractory contractor)

Recordable Classification: Restricted Work Case (RWC)

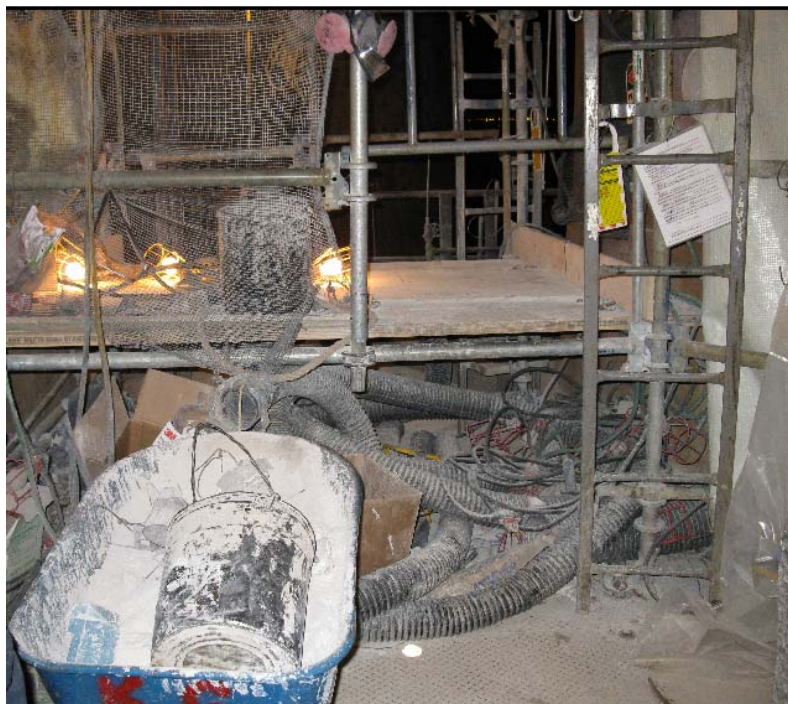
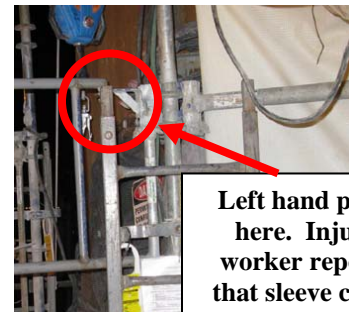
Description: At 3:30 this morning (Sunday), a refractory contractor working inside of the FCC reactor experienced a recordable injury as he was attempting to descend from one scaffold level to the next --- a difference of about three feet. In the process of descending, the worker's left sleeve got entangled on the top of the ladder. He was descending the ladder without having both hands on the ladder. Due to this fact and the momentum caused by the speed of the worker's descent and his body weight, the worker suffered a hyper-extended elbow injury.

Left hand placed here. Injured worker reported that sleeve caught on top of vertical ladder rail.

1. Appropriate medical attention was provided by EMTs and Paramedics at the Turnaround Medical Clinic
2. The incident is under investigation and the MSR is scheduled for Monday p.m.
3. Worker may have attempted to improperly descend the ladder with a bucket in his hand --- which would not allow him to follow the 3 Points of Contact Rule for safely descending ladders. The worker clearly took a low level risk by attempting this unsafe behavior.
4. Since this is 3rd recordable that has occurred on night shift of Turnaround, we are adding additional safety coverage on all future night shifts.
5. A site-wide bulletin will be sent out concerning this incident and general expectations.
