SAFETY ALERT #382

Dated: Sunday, 29th NOVEMBER 2009

Title: FATAL GRINDER INCIDENT

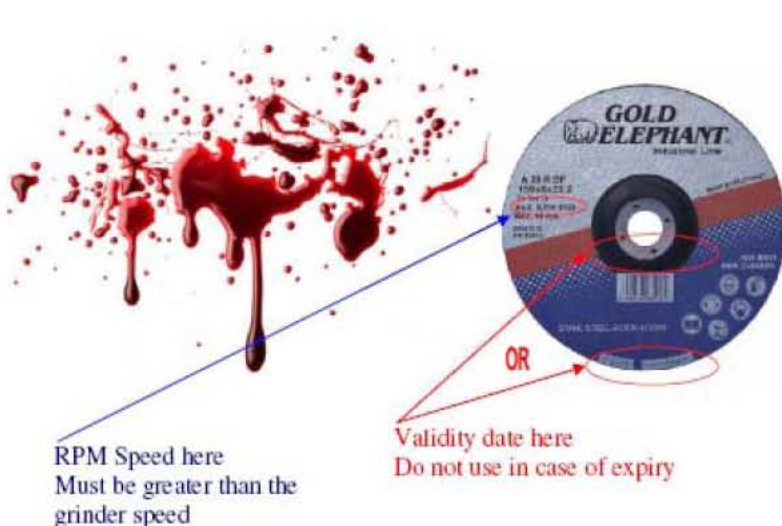
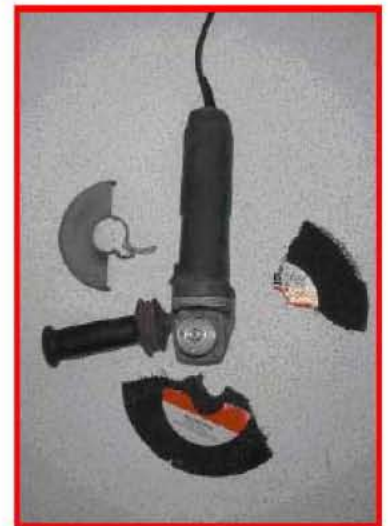
Angle grinder and disintegrated disk

The hand-held angle grinder was fitted with a 230 mm diameter cutting-off wheel and when it disintegrated, fragments penetrated the victim's chest and abdomen. He was rushed to hospital by rescue helicopter but died the same day.

Initial inspections show that the grinding machine and cutting disk were not compatible and the grinder was not fitted with a guard.

Grinding machines and abrasive wheels should always be used in accordance with the manufacturer's instructions.

- Always ensure the maximum speed (the no load rpm) marked on the abrasive wheel is greater than the rated speed of the grinder.
- Do not use grinding wheels that are larger than the maximum recommended size, or worn down wheels from other grinders.
- Never use grinding wheel power tools without the wheel guard attached to the tool and positioned for maximum safety.
- Store and handle abrasive wheels with care and inspect them for chips or cracks before installing. Do not use any wheel that may be damaged.
