SAFETY FLASH

Hammer falls from crane and injures operator

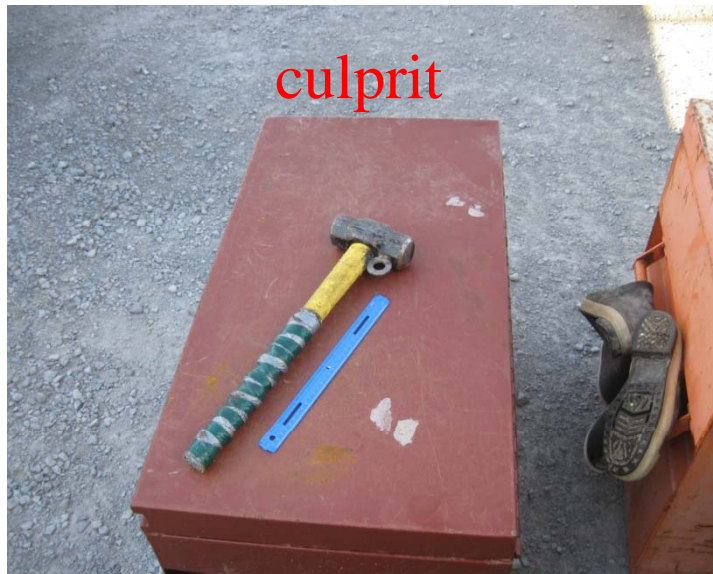
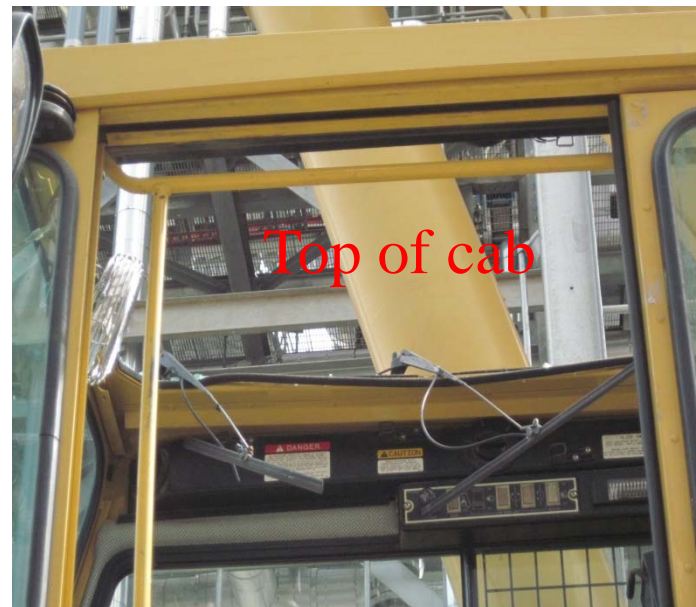
- On April 27th, 2010 at the Baton Rouge SMR a crane operator with Turner was injured when a hammer crashed through his safety glass roof. The contractor had a gash in his head and it is unknown as to what actually caused the cut.
- He was making a difficult lift with no hard hat which is industry practice and typically not required when inside an enclosed vehicle.

- **One of our core values is that all accidents are preventable. In this case many things could have prevented this from becoming an injury.**
 - 1. The hammer should have never been left on the boom**
 - 2. The operator could have taken a little more time looking at his equipment**
 - 3. A painter working on another job noticed the hammer and did not report it to the proper personnel**

- **As a result of the A.C.E we will be making some requests to the APCI standards committee.**
 - **Update the Appendix D of the crane inspection requirement to include conducting a visual inspection of all surfaces to ensure they are free of debris.**
 - **Determine If APCI policy should address hard hat requirements while working in an enclosed vehicle.**
 - **Investigate alternative head impact PPE that could be worn so as not to obstruct the view during crane operations.**
 - **Bump cap**
 - **Bicycle helmet**

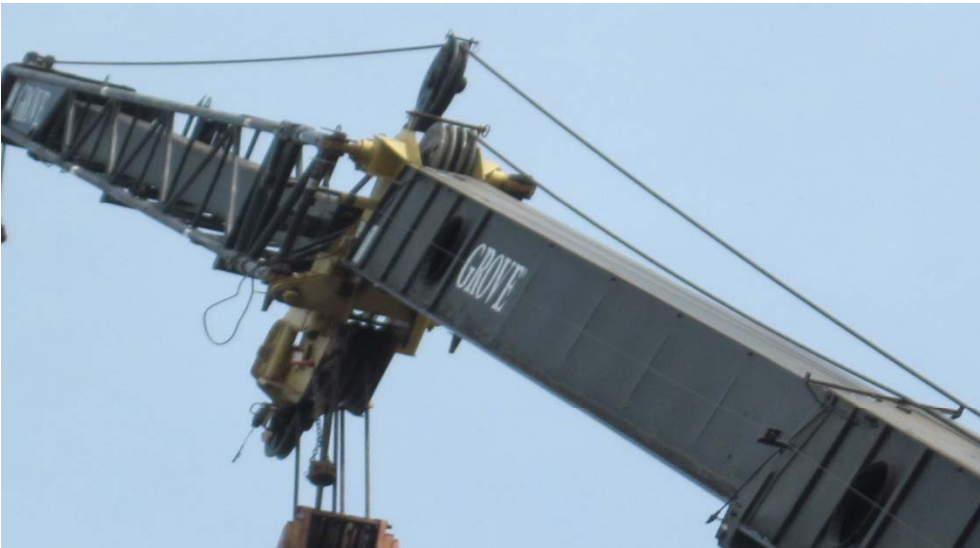
- **The hammer was left on the crane by an iron worker assisting the operator to swing the jib out. The iron worker claims that he thought the operator would need it later and was pulled to another job.**
- **The operator did a pre lift inspection according to his check list but was unable to see the hammer.**

The hammer was on the yellow part of the boom.

- **Permit and require JSA on all crane operations, modifications, set up, and the actual lift.**
- **Communication is key! Everyone involved needs to know exactly what's going on. A lift plan and a lift permit can not cover setting up or modifications to equipment. The tools they are using need to be documented and accounted for. LSO training “crane safety-basic” is available and may be added to operations list at a later date.**
- **Consider requiring a hard hat if it will not obstruct the operators view.**

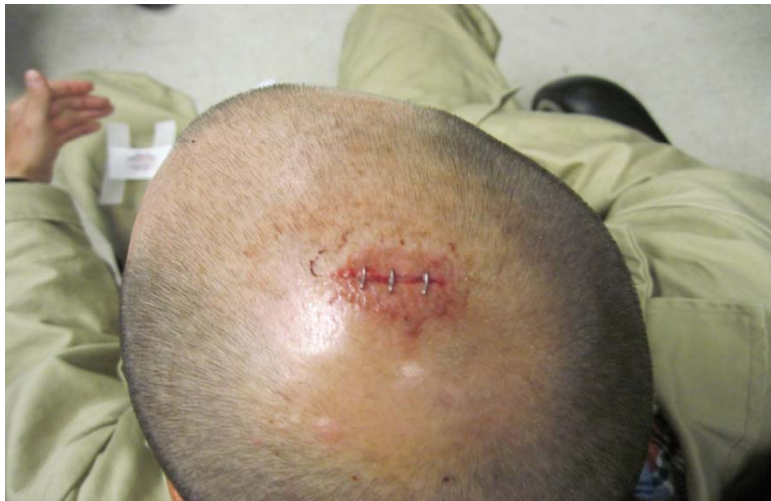
- From the size of the cut it was obvious treatment was needed. At this point an AP tech stopped the bleeding and cleaned around the wound. The foreman took his employee /contractor to the emergency center.
- A total of 3 staples were needed to close the cut.
- Because of the staples this was an OSHA recordable injury. The contractor did return to work on his next scheduled day.
