SAFETY ALERT

INJECTION OF HYDRAULIC FLUID

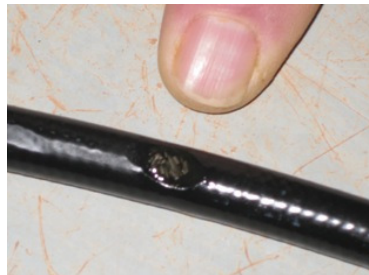
The incident in this case involved finding the source of a small hydraulic leak on a drilling rig – WE in Recycling can relate this to finding hydraulic leaks on our mobile and fixed plant & equipment.

The fitter found the small leak and requested the machine to be shut down so that the hose could be replaced.

When the machine was shut down the fitter placed his double gloved index finger over the wear spot on the hose so as not to lose the location of the leak.

The fitter was not aware that the machine system remained pressurised and actually increased pressure (back pressure hazard) for approximately 2 seconds after the machine is shut down

Hydraulic Fluid burst through the wear spot on the hose and injected through the double gloves into the fitter's index finger.

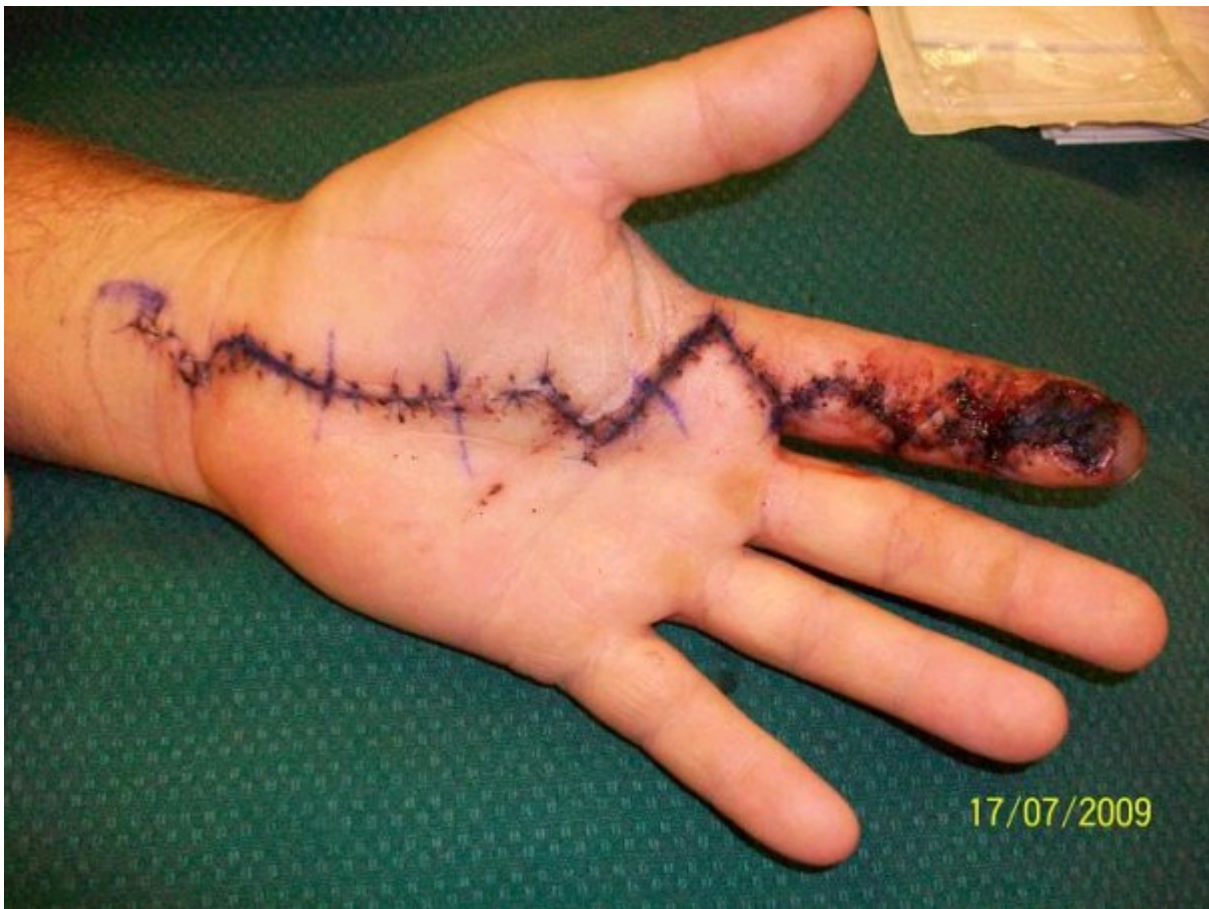
Major surgery was required to track and remove the injected hydraulic fluid from the fitter's finger and hand.
