STURGEON SAFETY ALERT

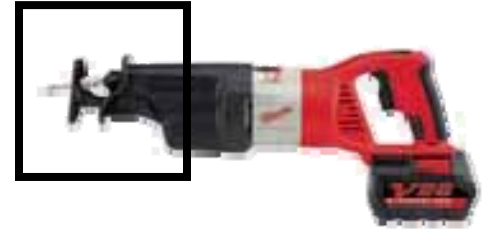
Employee was using a Milwaukee cordless V28 Sawzall reciprocating saw (shown here) to demo flex in wall while performing customer requested rework to relocate a panel we had already installed. While performing the necessary demolition, the blade of the sawzall got pinched, causing the sawzall to move in lieu of the blade. This abrupt bucking motion caused the employee's hand to slip over the molded hand guard, with the ring finger of his left hand entering the unprotected area between the ram and the housing of the blade, tearing open a deep cut on the tip of finger.

Contributing factors to this injury were the awkward angle/position of the sawzall and the inadequate protection around the large opening in ram and housing area.

The Safety Committee is investigating other brands of reciprocating saws to determine if there is a model with more effective hand and finger protection covering this area, which they could recommend to the Tool Room. They have identified a corded model with very good protection.

Due to the large number of cordless Milwaukee sawzalls on our jobsites, it is recommended that use and safety concerns regarding this tool be a topic for discussion during Foreman Morning Huddles anytime this tool is to be used.
